Pilots: Prevent Carbon Monoxide Poisoning

- The risk of carbon monoxide poisoning is overlooked and underestimated!

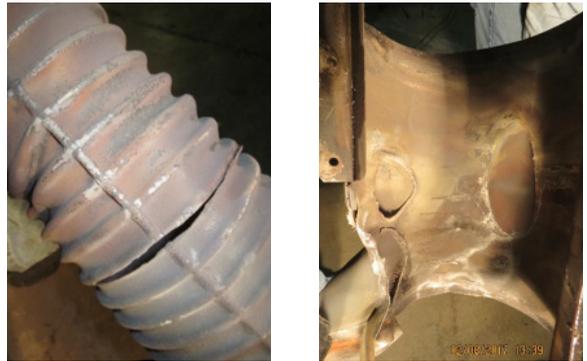
Shortly after departure, the pilot lost consciousness and air traffic control was unable to contact the pilot. The airplane continued to fly for about 1.5 hours until the fuel in the selected tank was exhausted. The pilot's CO level was at least 28% (and likely higher) at the time of the accident. CO levels between 10% and 20% can result in confusion, impaired judgment, and difficulty concentrating. Postaccident examination of the airplane found a fracture in the exhaust/heater muffler (see left photograph in figure 1) and exhaust deposits inside the muffler shroud (right photograph in figure 1). This allowed the exhaust gas to enter the cabin, exposing the pilot to CO. ([CEN17LA101](#))

Figure 1. Photographs of a cracked muffler and exhaust deposits in the muffler shroud.

- **During preflight inspections, check the security and condition of the exhaust system. Look for cracking at the ends of the muffler; if you see signs of soot or exhaust flames, don't fly the airplane until it is examined by a mechanic. If you cannot see the muffler, inspect the shroud for any evidence of soot that might indicate cracking in the muffler.**

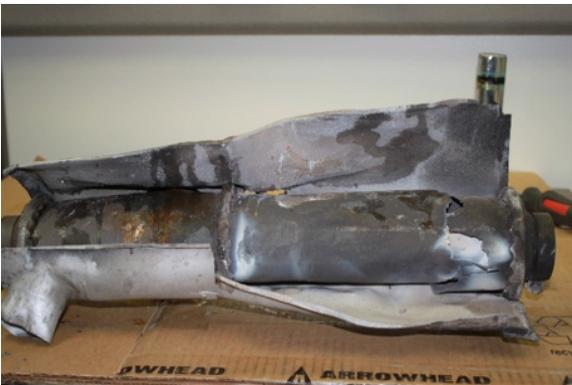
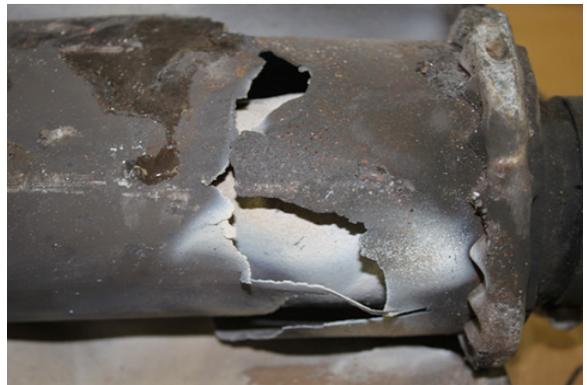
- **Witnesses observed an experimental amateur-built, Hefty Polar Cub airplane flying erratically at a low altitude before impacting terrain.** A postcrash fire ensued, and the pilot was fatally injured. Toxicology testing revealed that the pilot's CO level was 48%; no soot was found in his airways, indicating the CO was not a result of the fire; thus, the NTSB determined that the pilot's severe CO impairment likely caused the pilot's loss of control. Examination of the airplane's exhaust system revealed that the exhaust/heater muffler was fractured, allowing CO to enter the cockpit (see figure 2). ([ANC16FA065](#))

Figure 2. Fractured exhaust muffler from a Hefty Polar Cub airplane (left) and a close-up photograph of the fracture in the exhaust muffler (right).
