# Mechanics: Prevent Carbon Monoxide Poisoning

- The risk of carbon monoxide poisoning is overlooked and underestimated!

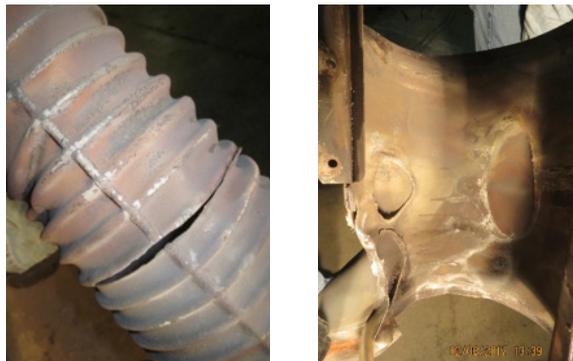
Shortly after departure, the pilot lost consciousness and air traffic control was unable to contact the pilot. The airplane continued to fly for about 1.5 hours until the fuel in the selected tank was exhausted. The pilot's CO level was at least 28% (and likely higher) at the time of the accident. CO levels between 10% and 20% can result in confusion, impaired judgment, and difficulty concentrating. Postaccident examination of the airplane found a fracture in the exhaust/heater muffler (see left photograph in figure 1) and exhaust deposits inside the muffler shroud (right photograph in figure 1). This allowed the exhaust gas to enter the cabin, exposing the pilot to CO. ([CEN17LA101](#))

**Figure 1.** Photographs of a cracked muffler and exhaust deposits in the muffler shroud.

- **Inspect exhaust systems, air ducting, firewalls, and door/window seals thoroughly at every 100-hour or annual inspection to reduce the chance of CO being introduced into the cockpit.**
- **Inspect heater air inlet cockpit vents for evidence of sooting, consistent with the presence of CO.**
- **Talk to pilots about installing electrochemical CO detectors with aural and visual alerts in the cockpit.**
- **Be informed and review and comply with any airworthiness directives and service bulletins regarding the exhaust system. Speak with the owner about regular inspections and the replacement schedule of parts.**

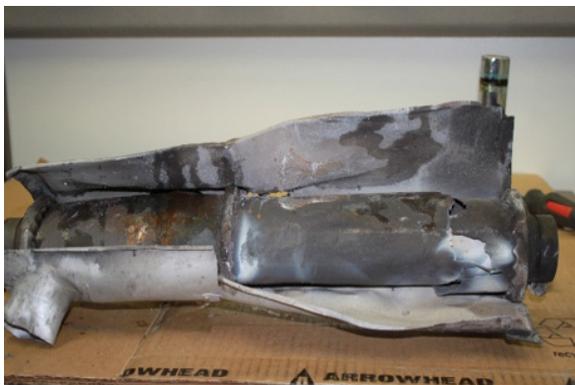
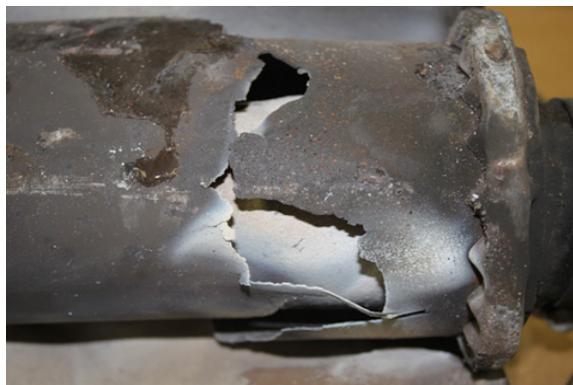
- **Witnesses observed an experimental amateur-built, Hefty Polar Cub airplane flying erratically at a low altitude before impacting terrain.** A postcrash fire ensued, and the pilot was fatally injured. Toxicology testing revealed that the pilot's CO level was 48%; no soot was found in his airways, indicating the CO was not a result of the fire; thus, the NTSB determined that the pilot's severe CO impairment likely caused the pilot's loss of airplane control. Examination of the airplane's exhaust system revealed that the exhaust/heater muffler was fractured, allowing CO to enter the cockpit (see figure 2). ([ANC16FA065](#))

**Figure 2.** Fractured exhaust muffler from a Hefty Polar Cub airplane (left) and a close-up photograph of the fracture in the exhaust muffler (right).
