**AIRWORTHINESS GROUP CHAIRMAN'S FACTUAL REPORT
ATTACHMENT III: Honeywell, Inc. (Engine) Teardown
Report No. 21-11090**

**Sunjet Aviation, Inc.
Mina, South Dakota
October 25, 1999**

**TEARDOWN REPORT
OF TWO TFE731-2-2B TURBOFAN ENGINES
SERIAL NUMBERS P-74264 AND P-74265**

21-11090

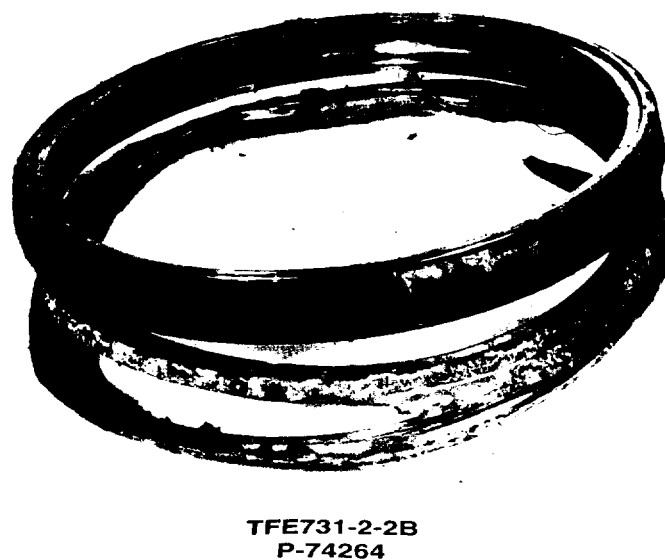
Figure 30. (Photo No. 33-9) Damaged Second- and Third-Stage LP Compressor Vane Tip Shrouds.

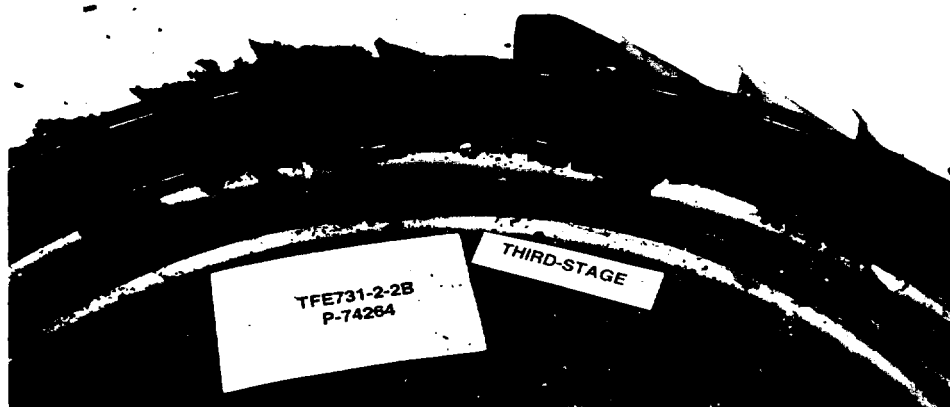
Figure 34. (Photo No. 36-25) Platform Rub on the Third-Stage LP Compressor Blades.

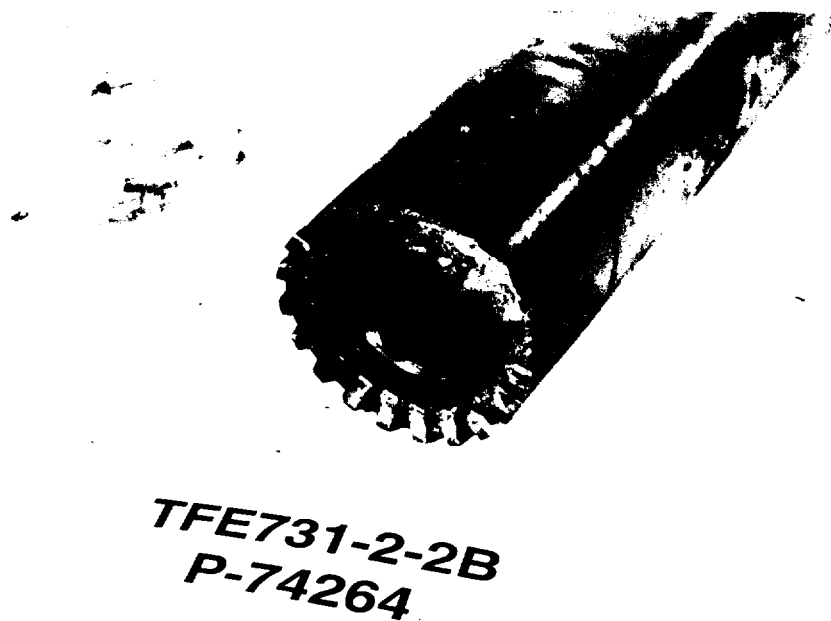
Figure 48. (Photo No. 36-19) Damaged Curvic Coupling.

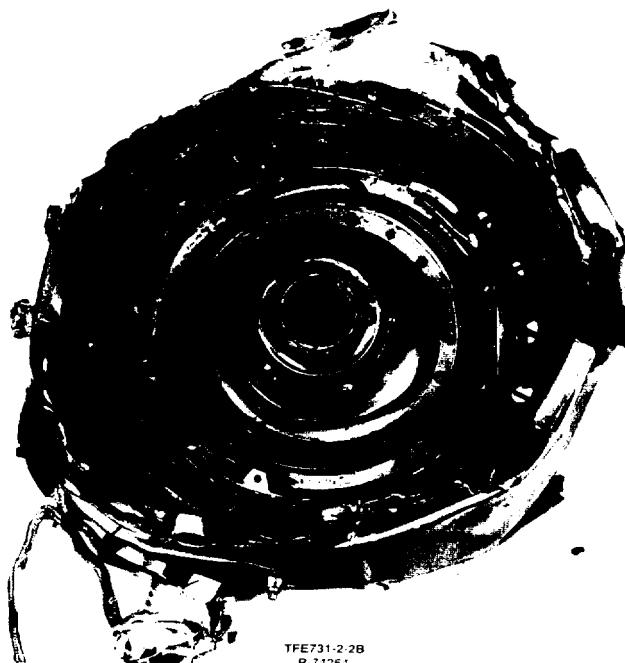
- (d) Compressor interstage diffuser (housing):
- Both the forward mount flange (Figure 51) and the aft mount flange (Figure 58) were damaged.
 - The compressor housing displayed compression wrinkles and torn sheet metal (Figure 58).

- Housing partially crushed (Figures 43, 46, and 51).
 - Housing displayed rotational score marks (Figure 43 and 46), with corresponding rotational score marks on the aft face of the fourth-stage LP compressor rotor disk (Figure 42).

Figure 51. (Photo No. 33-31) Damaged Fourth-Stage LP Compressor Stator Vanes.

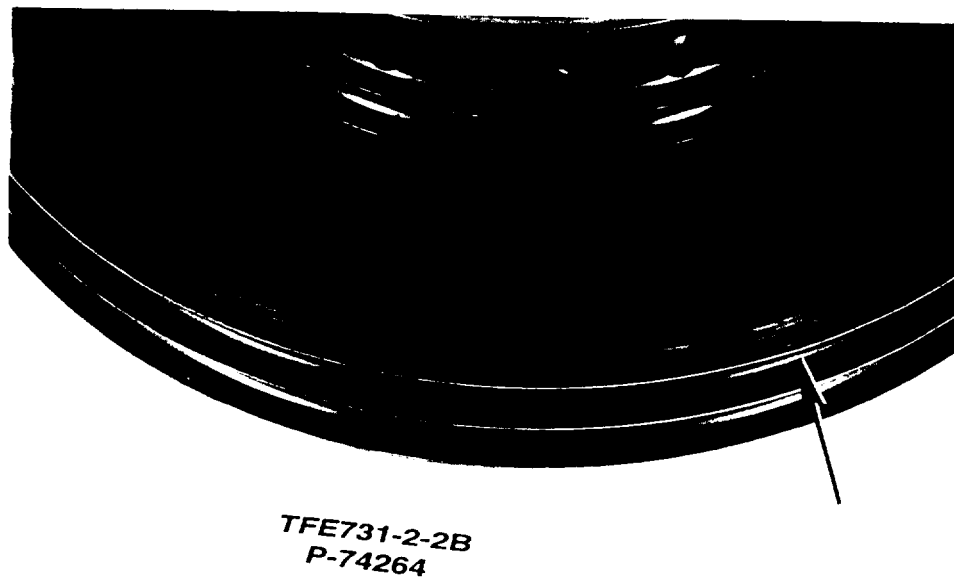
Figure 77. (Photo No. 36-15) Scored HP Center Curvic Coupling.

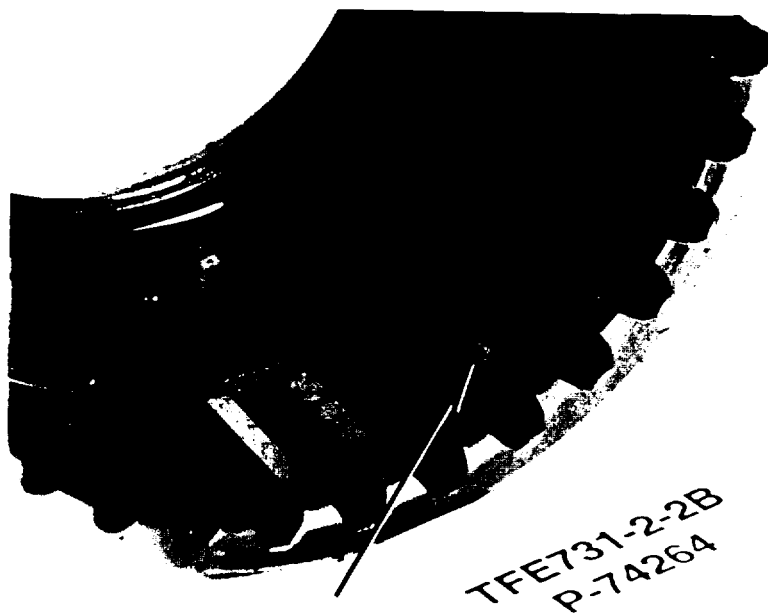
Figure 82. (Photo No. 29-10) Contact Mark on the N1 Speed Pickup Gear.

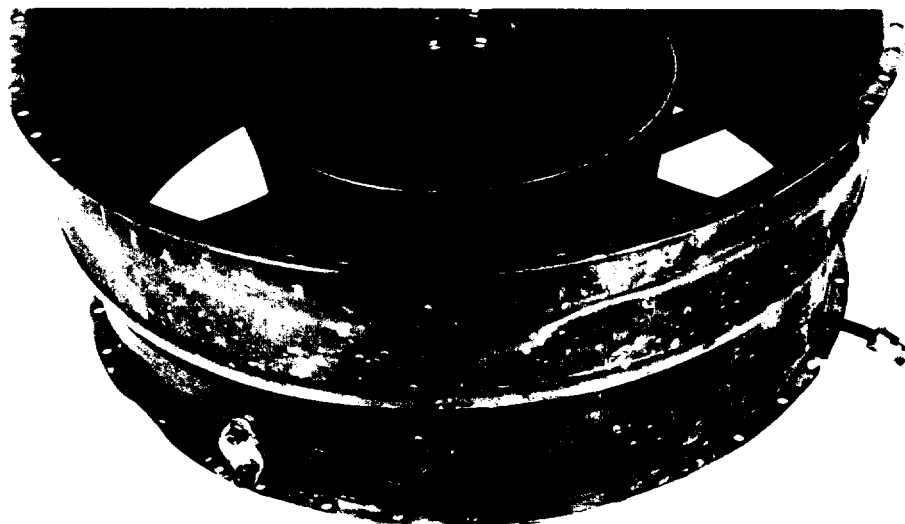
Figure 86. (Photo No. 29-17) Wrinkled Thrust and Exhaust Nozzle.

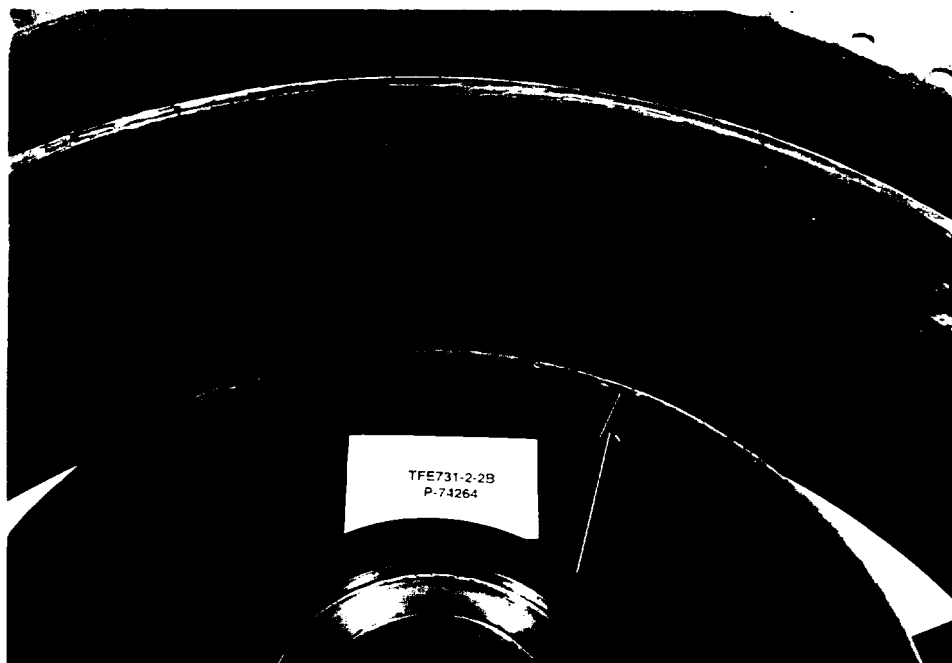
- There was a platform rub on the aft side of all of the rotor blades (Figure 89), with corresponding rotational score marks on the thrust and exhaust nozzle inner support housing (Figure 87).

Figure 87. (Photo No. 33-22) Scored Thrust and Exhaust Nozzle.

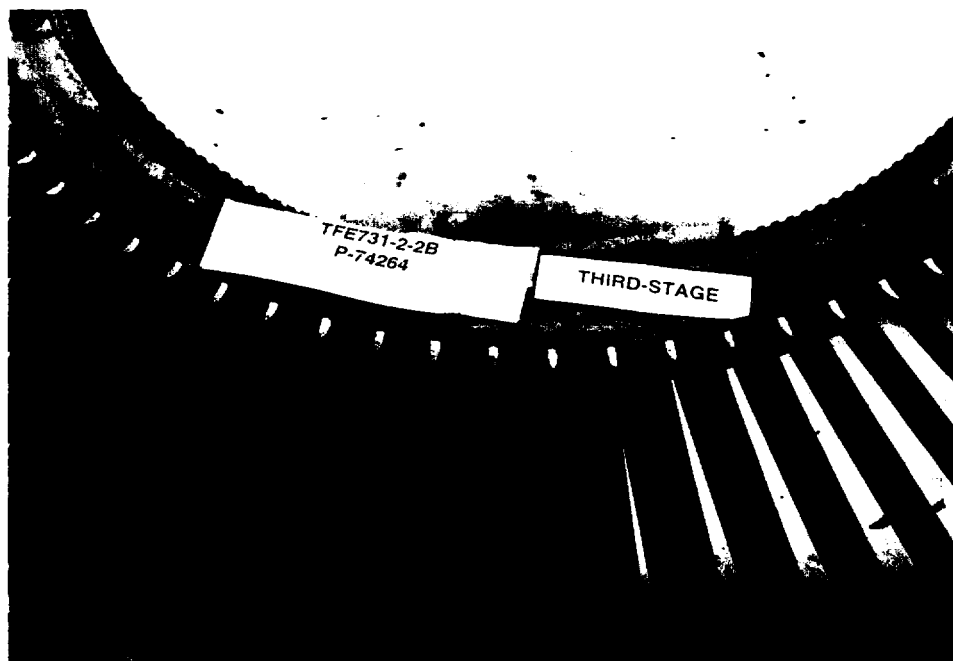
- There was a platform rub on the aft side of all of the rotor blades (Figure 99), with corresponding rotational score marks on the forward side of the third-stage LP turbine stator vanes (Figure 100).

- (j) Third-stage LP turbine stator:
- There were rotational score marks on the inboard leading-edge of the stator vanes (Figure 100), with a corresponding platform rub on the aft side of all of the second-stage turbine rotor blades (Figure 99).

Figure 100. (Photo No. 31-8) Scored Third-Stage LP Turbine Stator Vanes.

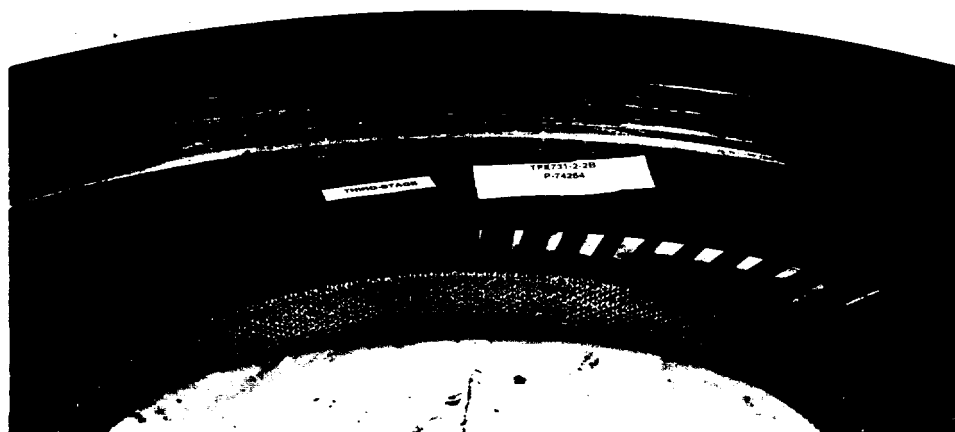
- There was a blade-tip rub on all of the rotor blades (Figure 109), with corresponding rotational score marks on the blade-tip shroud (Figure 110).
 - The knife-edged seal was undamaged.

- There were rotational score marks on the blade-tip shroud (Figure 110), with a corresponding blade-tip rub on all of the third-stage LP turbine rotor blades (Figure 109).

Figure 110. (Photo No. 31-9) Scored Blade-Tip Shroud.

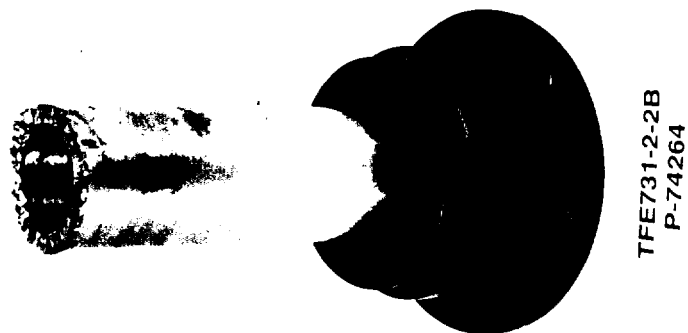
- (l) LP turbine tie shaft:
- Undamaged (Figure 114).
- (m) LP shaft and seal assembly:
- There were rotational score marks on the OD of the LP shaft and seal assembly (Figures 64 and 115), with corresponding rotational score marks on the aft ID of the HP shaft (Figure 63).

- The forward (small) Curvic coupling teeth were heavily damaged (Figure 115). The aft (large) Curvic coupling teeth were undamaged (Figure 116).
 - The Feltmetal seal displayed some (normal) wear.

Figure 115. (Photo No. 31-15) Damaged Curvic Coupling and Score Marks on the LP Shaft and Seal Assembly.

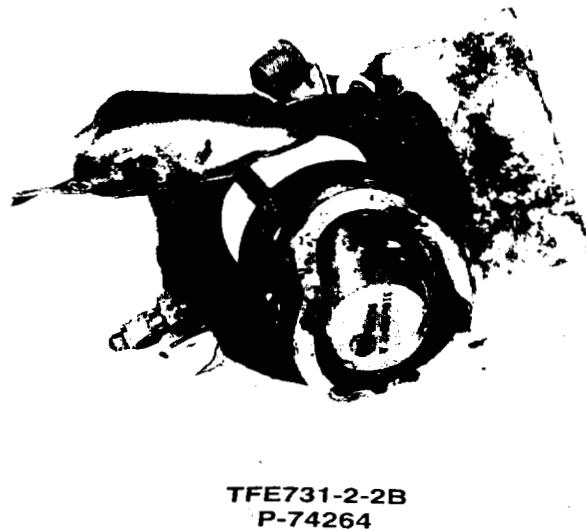
Figure 120. (Photo No. 33-7) Damaged Surge Bleed Valve.

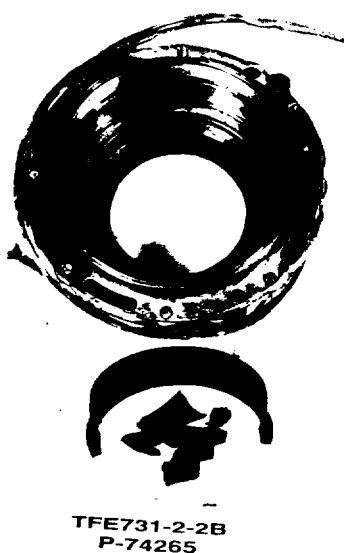
Figure 142. (Photo No. 38-19) Damaged No. 3 Bearing Housing, and Damaged No. 3 Carbon Seal.

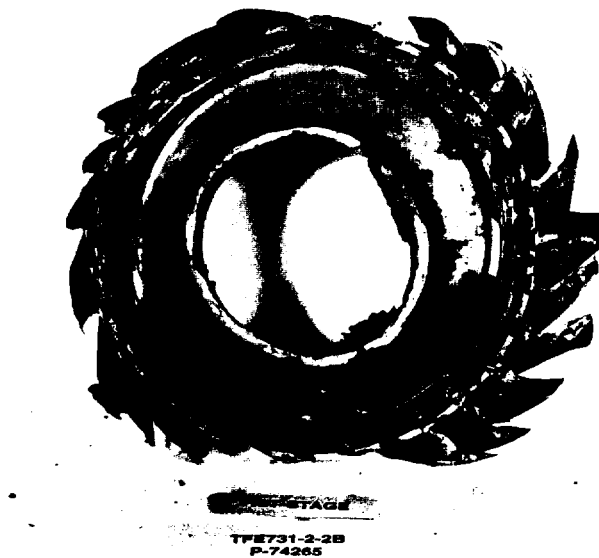
- Dirt and debris was packed between rotor blades (before decontamination).
- Six rotor blades were displaced out of their dovetail slots (Figure 145 and 146).

Figure 145. (Photo No. 41-11) Damaged First-Stage LP Compressor.

Figure 146. (Photo No. 41-12) Damaged First-Stage LP Compressor.

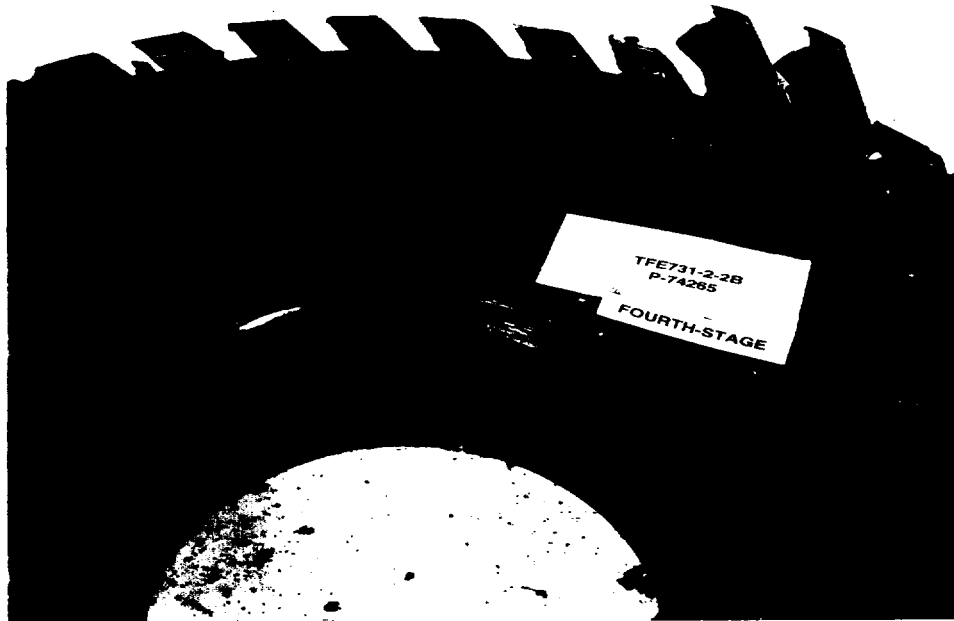
- Housing displayed rotational score marks (Figure 166), with corresponding rotational score marks on the aft face of the fourth-stage LP compressor rotor disk (Figure 165).

Figure 165. (Photo No. 41-29) Scored Fourth-Stage LP Compressor Disk.

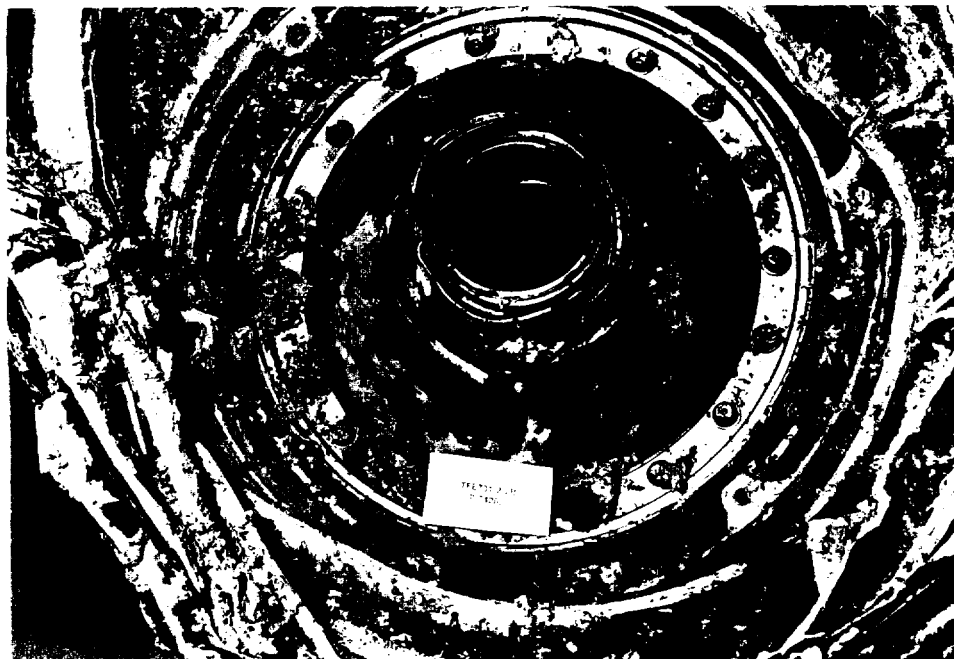
- Bearing not disassembled.
 - Air/oil carbon seal destroyed (Figure 166). No pre-impact wear or distress noted.
 - Air/oil seal rotor not disassembled.

Figure 166. (Photo No. 42-3) Scored No. 4 Bearing Housing, and Scored HP Shaft.

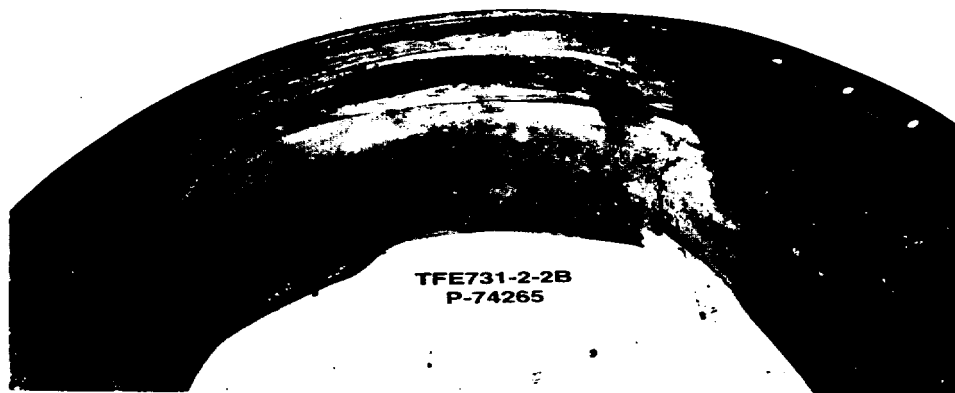
Figure 175. (Photo No. 44-4) Scored HP Impeller Shroud.

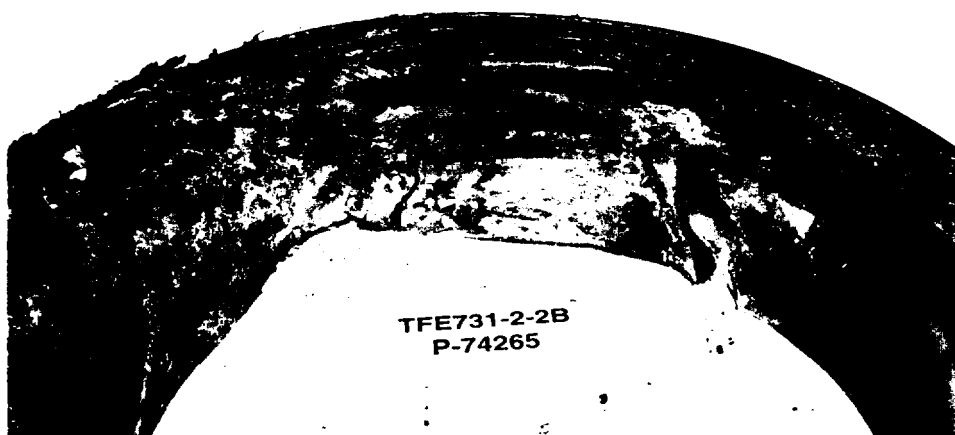
Figure 176. (Photo No. 44-5) Scored HP Impeller Shroud.

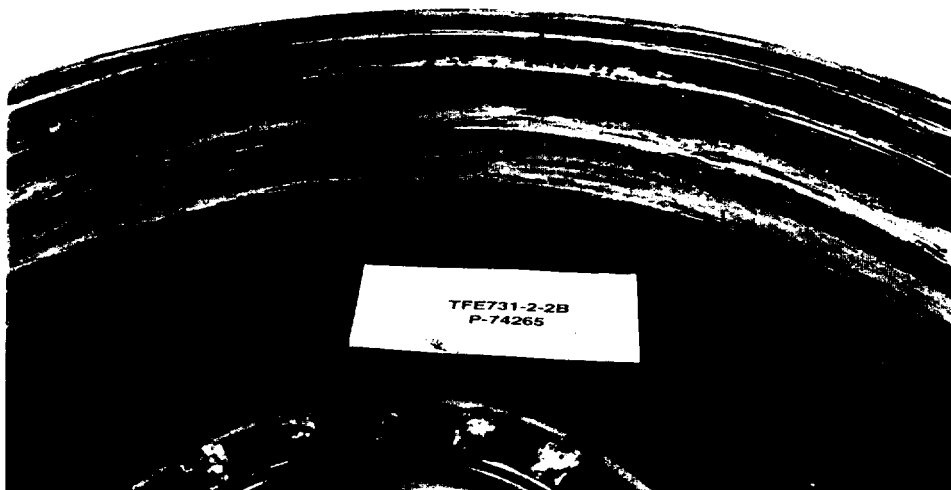
Figure 180. (Photo No. 44-9) Scored HP Compressor Impeller Backface.

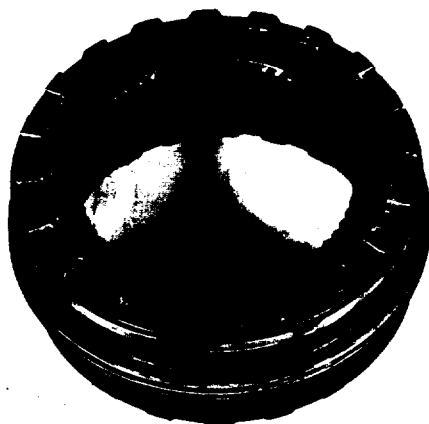
Figure 201. (Photo No. 45-24) Damaged Forward Curvic Coupling.

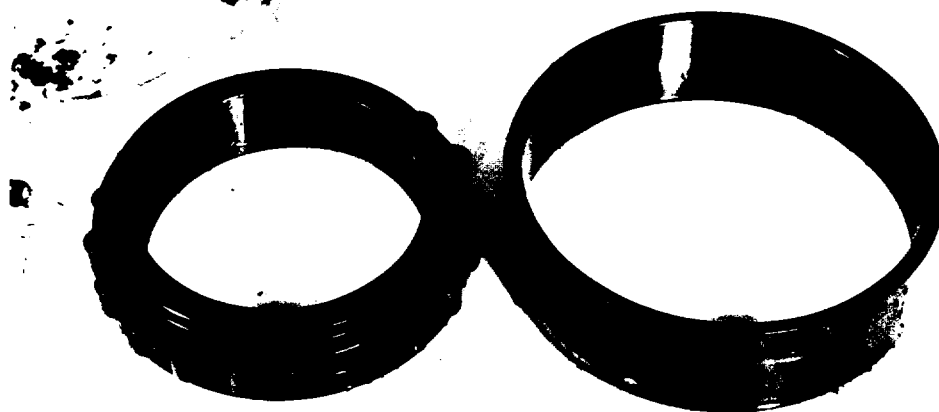
Figure 209. (Photo No. 39-8) No. 6 LP Rotor Aft Roller Bearing.

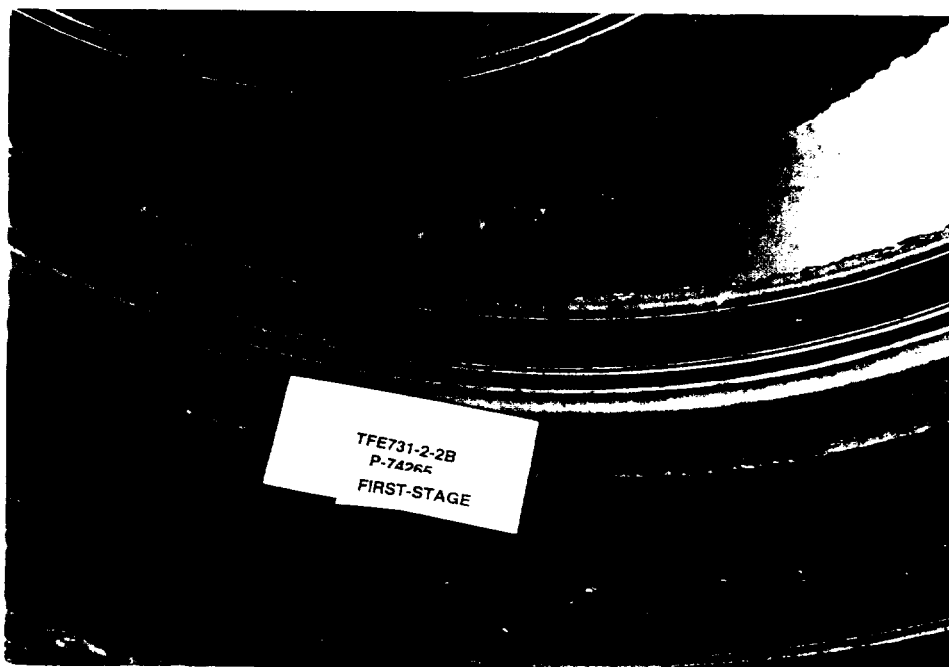
Figure 220. (Photo No. 39-15) Scored Blade-Tip Shroud.

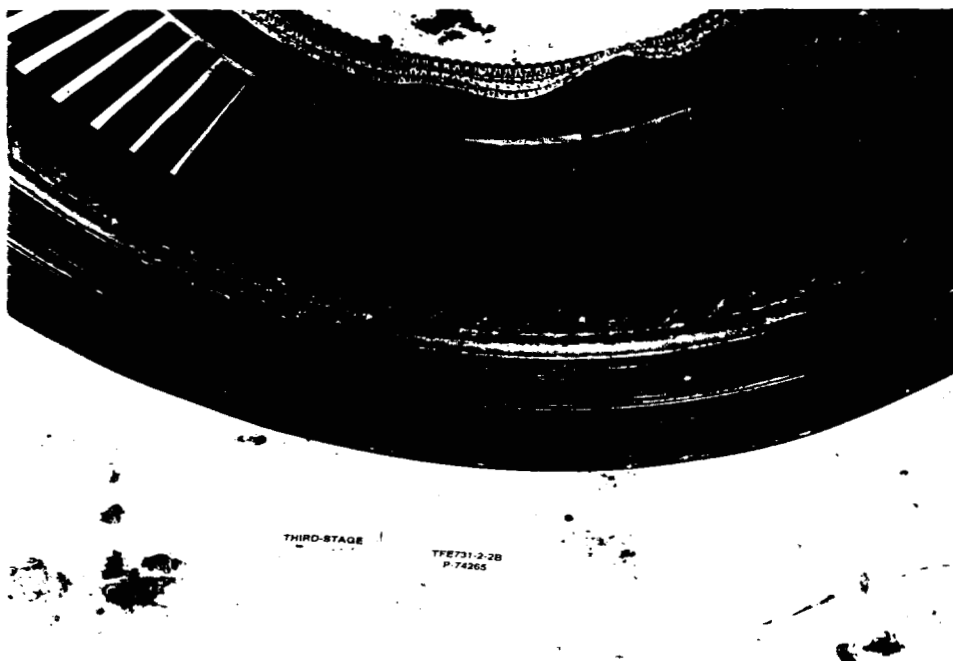
- There were rotational score marks on the blade-tip shroud (Figure 236), with a corresponding blade-tip rub on 67 third-stage LP turbine rotor blades (Figure 235).

- The honeycomb seal was worn with deep grooved; however, the seal was damaged during the teardown (Figures 234 and 236).
- (k) Thermocouple harness assembly:

Figure 236. (Photo No. 39-6) Scored Blade-Tip Shroud.

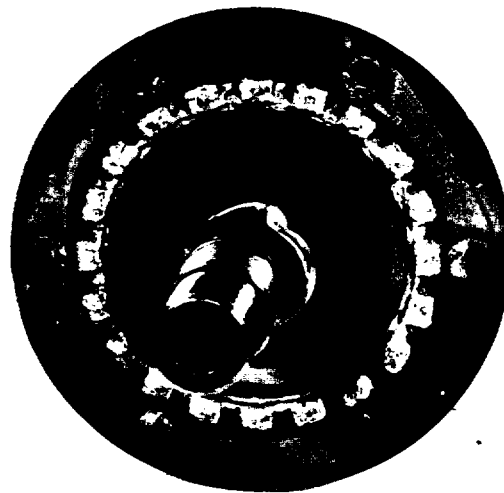
TFE731-2-2B
P-74265

- The shaft was broken (Figures 140 and 243).
 - The forward fragment could not be removed from the LP shaft and seal assembly (Figure 243).
- (m) LP shaft and seal assembly:

- The forward (small) Curvic coupling teeth were smeared (Figure 244). The aft (large) Curvic coupling teeth were undamaged (Figure 243).
 - The Feltmetal seal was worn.

Figure 243. (Photo No. 45-31) Broken LP Turbine Tie Shaft, and Damaged LP Shaft and Seal Assembly Curvic Coupling.

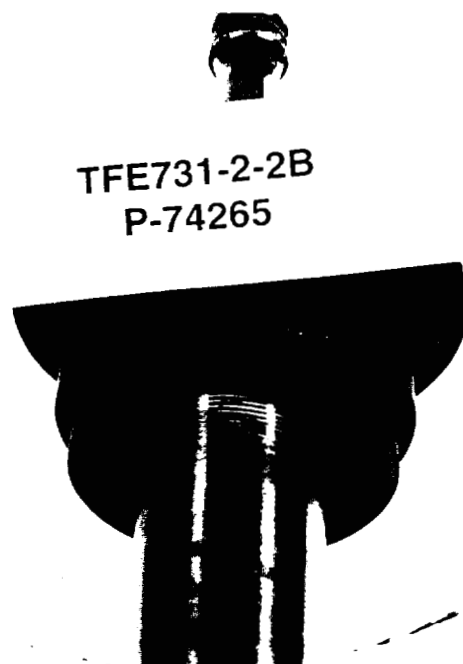
TFE731-2-2B
P-74265

Figure 245. (Photo No. 45-33) Scored LP Shaft and Seal Assembly.

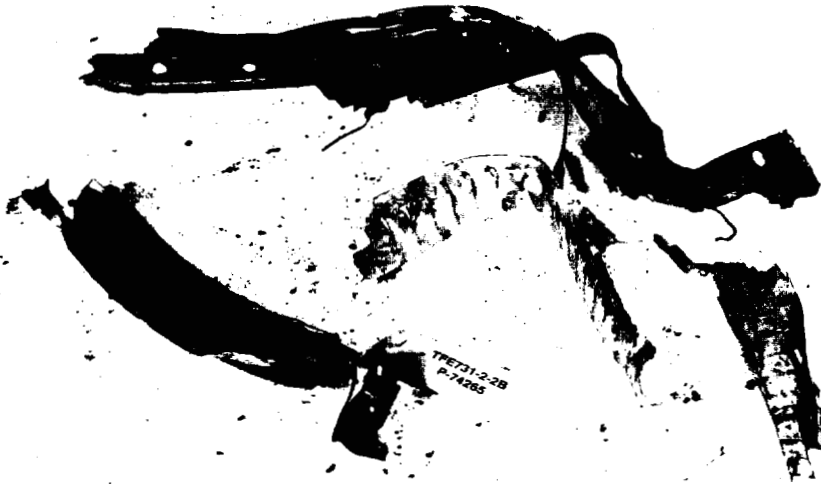
Component Name	Shipped With P-74264	Shipped With P-74265
Fan Inlet Housing	<ul style="list-style-type: none"> No sheet metal was returned. Fan blade containment ring was distorted (egg-shaped) (Figure 255). 	<ul style="list-style-type: none"> Several small, unidentifiable bits of sheet metal were returned. Fan blade containment ring was fractured, and the fragments were stretched and distorted (Figure 256)
Compressor Inlet Stator	<ul style="list-style-type: none"> No vanes were returned. Inner vane retainer ring was not returned. One small fragment of the outer vane retainer ring was damaged (Figure 257). 	<ul style="list-style-type: none"> No vanes were returned. Fragments of the inner vane retainer ring and the outer vane retainer ring were damaged (Figure 258).
Fan Bypass Stator	<ul style="list-style-type: none"> No vanes were returned. Inner vane retainer ring was not returned. One small fragment of the outer vane retainer ring was damaged (Figure 257). 	<ul style="list-style-type: none"> No vanes were returned. Inner vane retainer ring was not returned. Two fragments of the outer vane retainer ring were damaged (Figure 258).

Figure 258. (Photo No. 42-9) Fragments of Compressor Inlet Stator and Fan Bypass Stator.

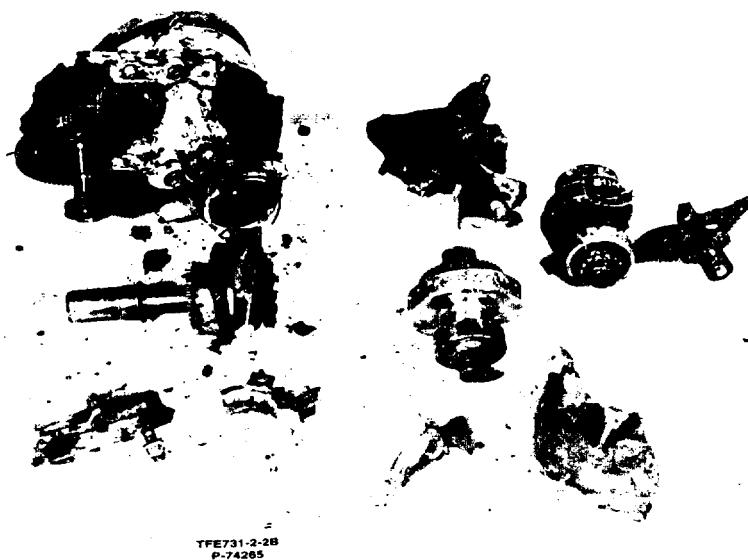
Figure 262. (Photo No. 40-12) Fragments of Accessory Drive Gearbox.

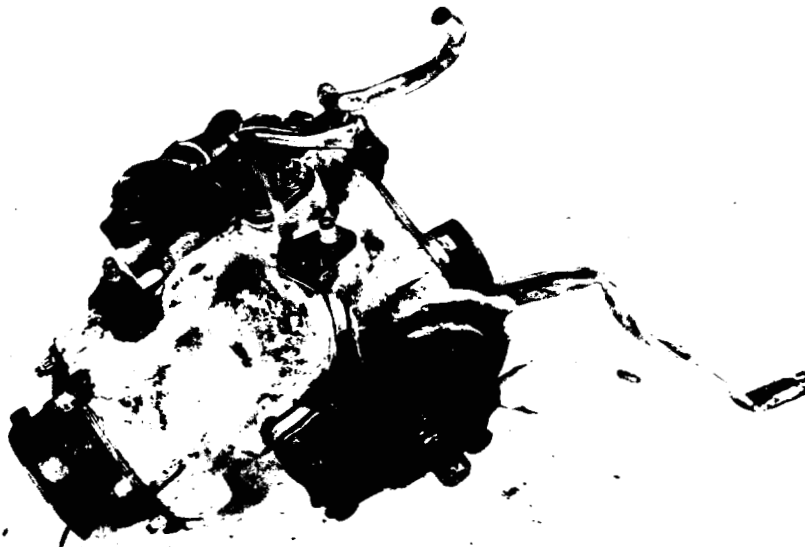
TFE731-2-2B
P-74265

Component Name	Shipped With P-74264	Shipped With P-74265
Fuel Pump Drive Shaft	<ul style="list-style-type: none"> Slightly bent. 	<ul style="list-style-type: none"> None.
Accessory Gearbox Drive Shaft	<ul style="list-style-type: none"> Bent (Figure 259). Splines intact. 	<ul style="list-style-type: none"> Bent (Figure 260). Splines intact.
Accessory Drive Gearbox	<ul style="list-style-type: none"> Housing fractured. Only fragments of housing returned (Figure 261). Only a few of the gears returned (Figure 261). P/N 3070003-XX¹ S/N unknown 	<ul style="list-style-type: none"> Housing fractured. Only fragments of housing returned (Figure 262). Only a few of the gears returned (Figure 262). P/N 3070003-XX¹ S/N unknown
Transfer Gearbox	<ul style="list-style-type: none"> Drive shaft intact (Figure 263). Impact damage to N2 monopole. P/N 3070093-12 S/N P-359 	<ul style="list-style-type: none"> Drive shaft intact (Figure 264). Impact damage to N2 monopole. P/N 3070093-12 S/N P-562

Figure 264. (Photo No. 40-9) Transfer Gearbox.

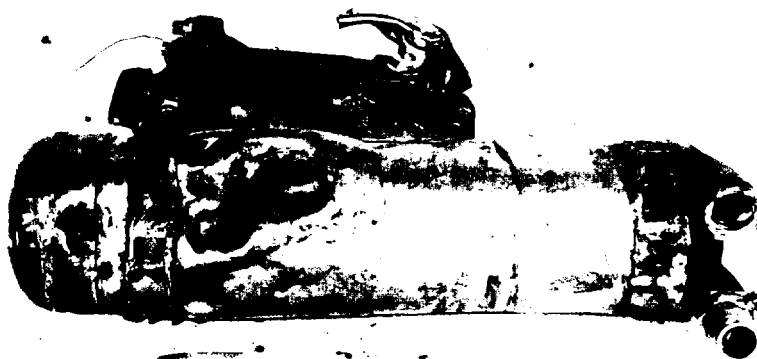
Figure 274. (Photo No. 38-34) Damaged Fuel/Oil Cooler.

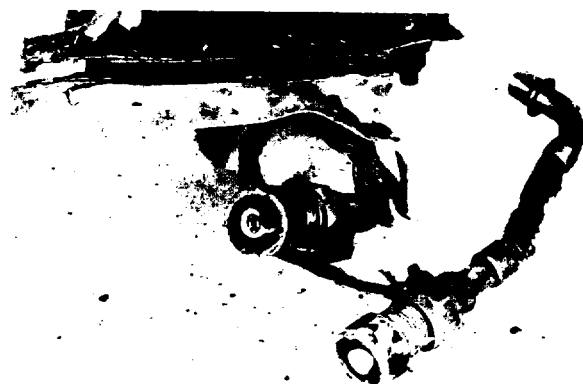
Component Name	Shipped With P-74264	Shipped With P-74265
Ignition Unit	<ul style="list-style-type: none"> • Output electrical connectors broken (Figure 283). • Body of unit not returned. • Ignition leads damaged (Figure 283). • P/N unknown • S/N unknown 	<ul style="list-style-type: none"> • Not returned.
Solenoid Controller Valve	<ul style="list-style-type: none"> • Solenoids separated from valve body (Figure 284). • Valve body damaged. • P/N unknown • S/N unknown 	<ul style="list-style-type: none"> • Not returned.
Electronic Engine Control (EEC)	<ul style="list-style-type: none"> • Housing damaged (Figures 285 and 287). • Specific gravity set at JET B. • P/N 2101142-44 • S/N 116-947 	<ul style="list-style-type: none"> • Housing severely damaged exposing internal components (Figures 286 and 288). • Specific gravity set at JET B. • P/N 2101142-1 • S/N 21-1365

Figure 283. (Photo No. 32-1) Damaged Ignition Leads.

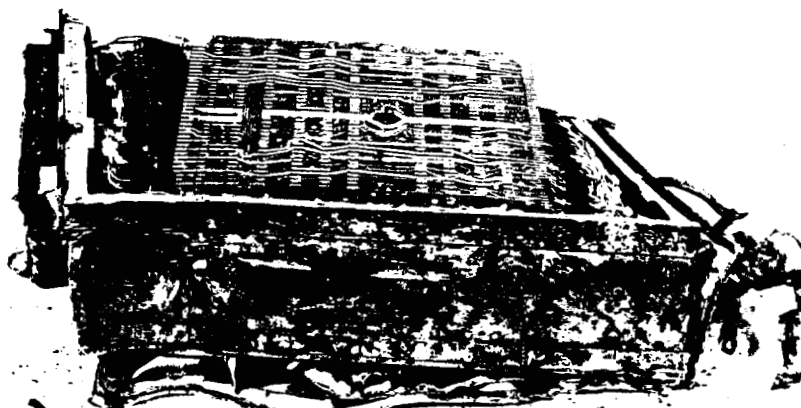
Figure 288. (Photo No. 38-37) Damaged EEC.
