NATIONAL TRANSPORTATION SAFETY BOARD

AIRWORTHINESS FACTUAL ADDENDUM LIGHTBULB RE-EXAMINATION AND STUDY

- A. **ACCIDENT:** DCA08MA098
- LOCATIONS:** Columbia, South Carolina
- DATE/TIME:** September 19, 2008
- AIRCRAFT:** Learjet Model 60, N999LJ, S/N 60-314

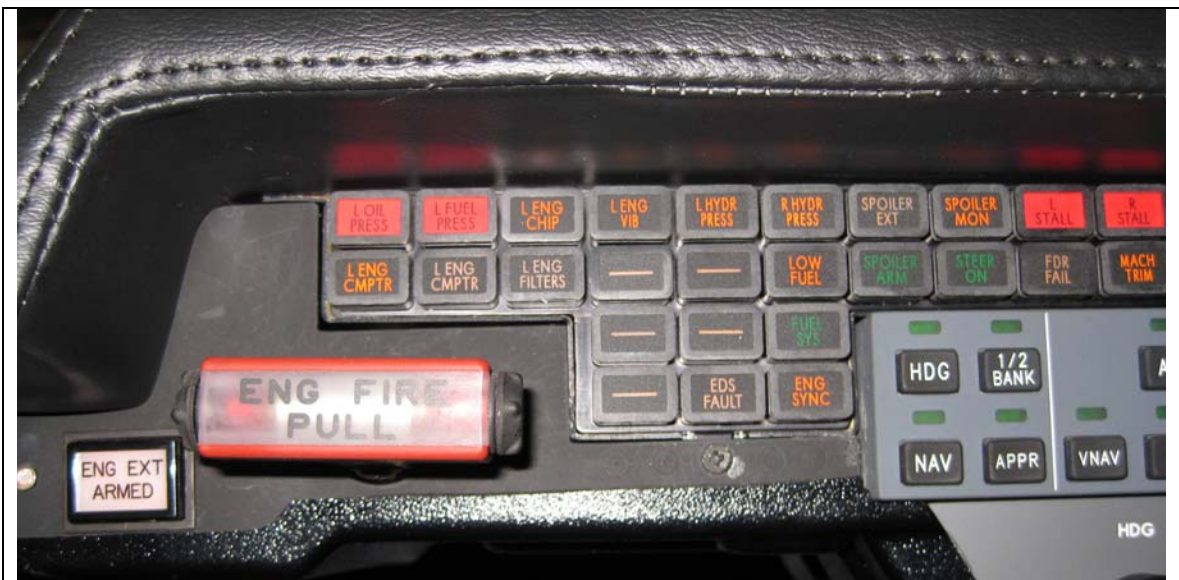
Figure 2B. Left portion of annunciator panel in a similar airplane.

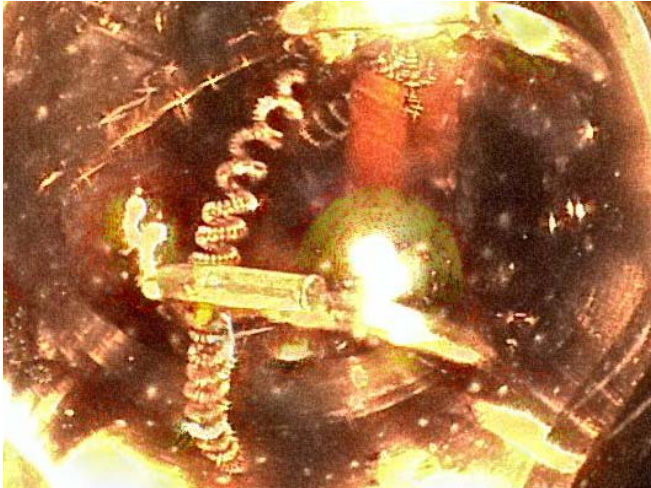
First Officer's master WARNING,
upper left bulb

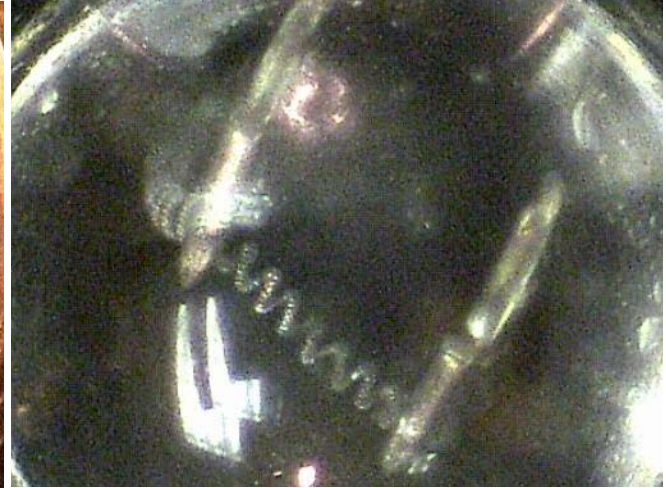
First Officer's master WARNING,
upper right bulb

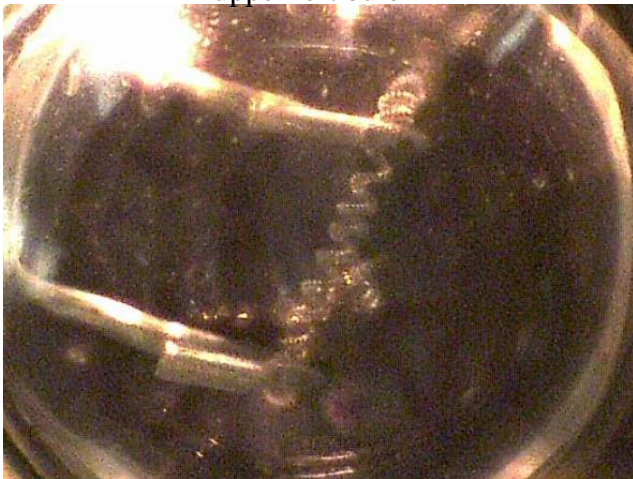
First Officer's master CAUTION,
lower left bulb

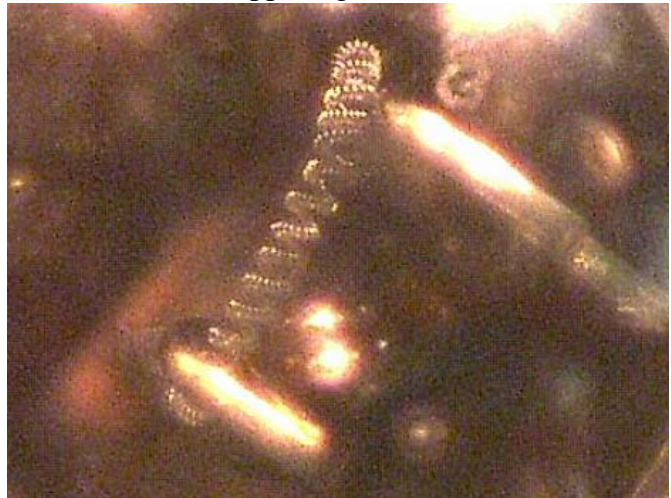
First Officer's master CAUTION,
lower right bulb

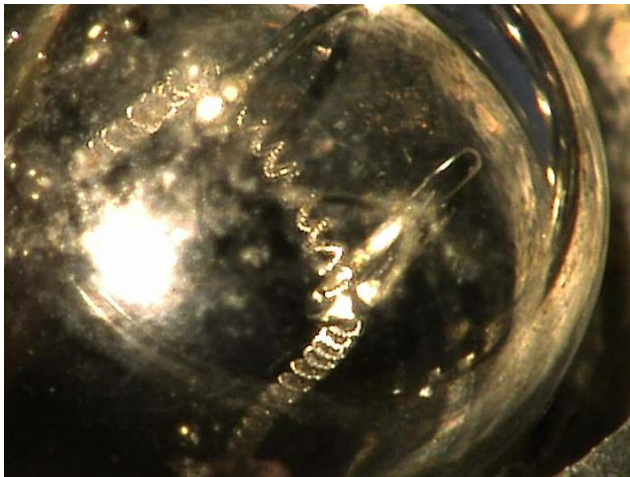
Left main landing gear,
first bulb examined
