**NATIONAL TRANSPORTATION SAFETY BOARD
OFFICE OF AVIATION SAFETY
WASHINGTON, D.C. 20594**

AIRWORTHINESS SPECIALIST'S REPORT OF INVESTIGATION

DCA11MA076

Operator: Gulfstream Aerospace Corporation
Aircraft: GVI (G650), Serial Number 6002
Location: Roswell, NM
Date: April 2, 2011
Time: 0934 MDT

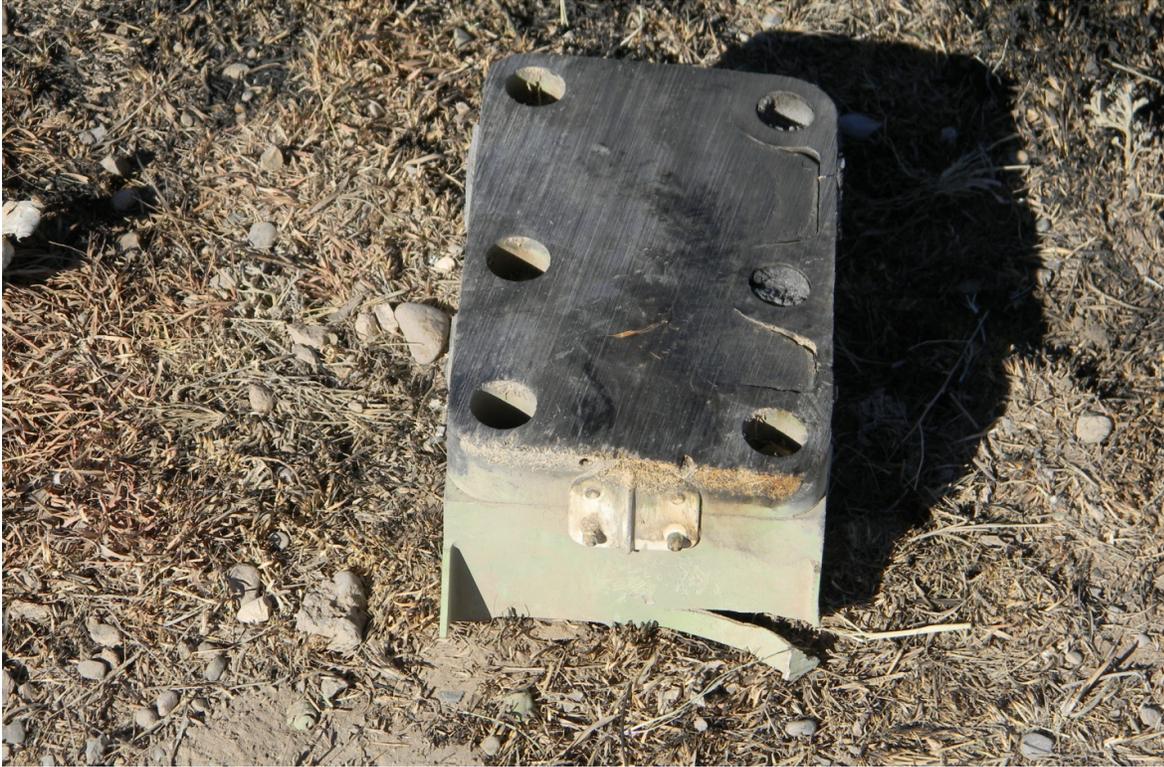
approximately 1002 feet from the centerline of Runway 21. Impact with the culvert occurred just to the right of centerline of airplane and caused extensive structural damage to the center wing box including rupture of the fuel tank. The forward skag was found about 15 feet from the culvert to the left of the line of travel of the airplane (Figures 8, 11). The aft skag was located approximately 245 feet to the left and past the culvert in the area of the left main gear parts (Figures 8,12). The airplane continued to slide and impacted a weather station (Figure 13), which compromised the leading edge and fuel compartments of the left wing and damaged the vertical and horizontal stabilizer. The weather station consisted of an approximately 30 ft pole next to a steel beam support for other instruments (Figure 14). One of the steel beam supports was found embedded in the left engine housing, and another steel beam support was found in the debris field beyond the aircraft. The airplane continued to slide and rotate until it came to rest approximately 300 ft from the control tower, oriented approximately 90 degrees to its path. The aircraft was extensively damaged by post impact fire damage and impact with objects on the ground.

Figure 11 Forward Skeg

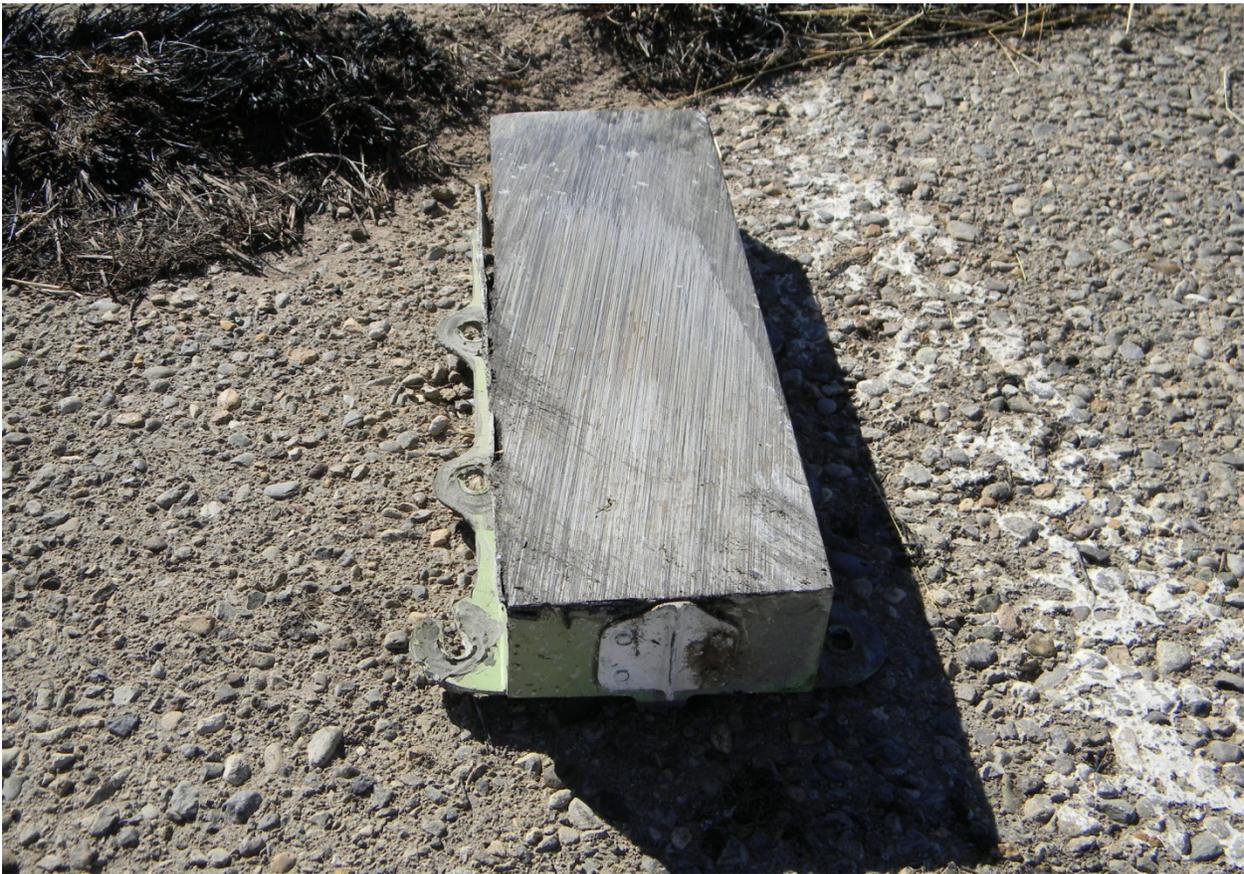
Figure 12 Aft Skeg

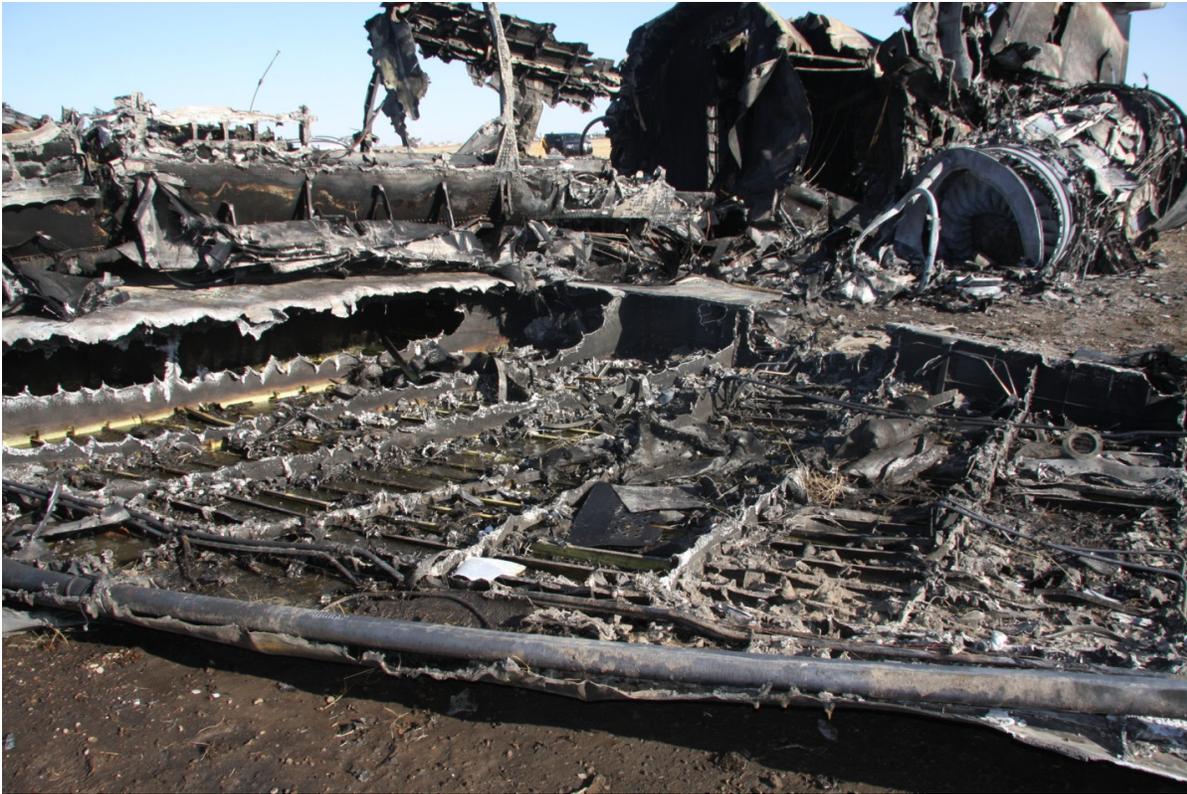
The left wing experienced structural damage from impact with the weather station and substantial fire damage from the post impact fire (Figure 15). Figure 16 shows the wing station locations. The upper skin and ribs were melted from butt line (BL) 62.0 to approximately rib baffle station (RBS) 250 (Figure 17). At the leading edge (LE) there was a 24" X 46" hole centered at RBS 242 and a 10" x 12" hole centered at RBS 322. The LE had no further damage outboard to the wing tip. At the trailing edge (TE), from the wing tip in through the aileron had no damage. The aileron surface, four hinge fittings and two actuator attach fittings were all intact.

Figure 17 Left Wing Inboard Leading Edge

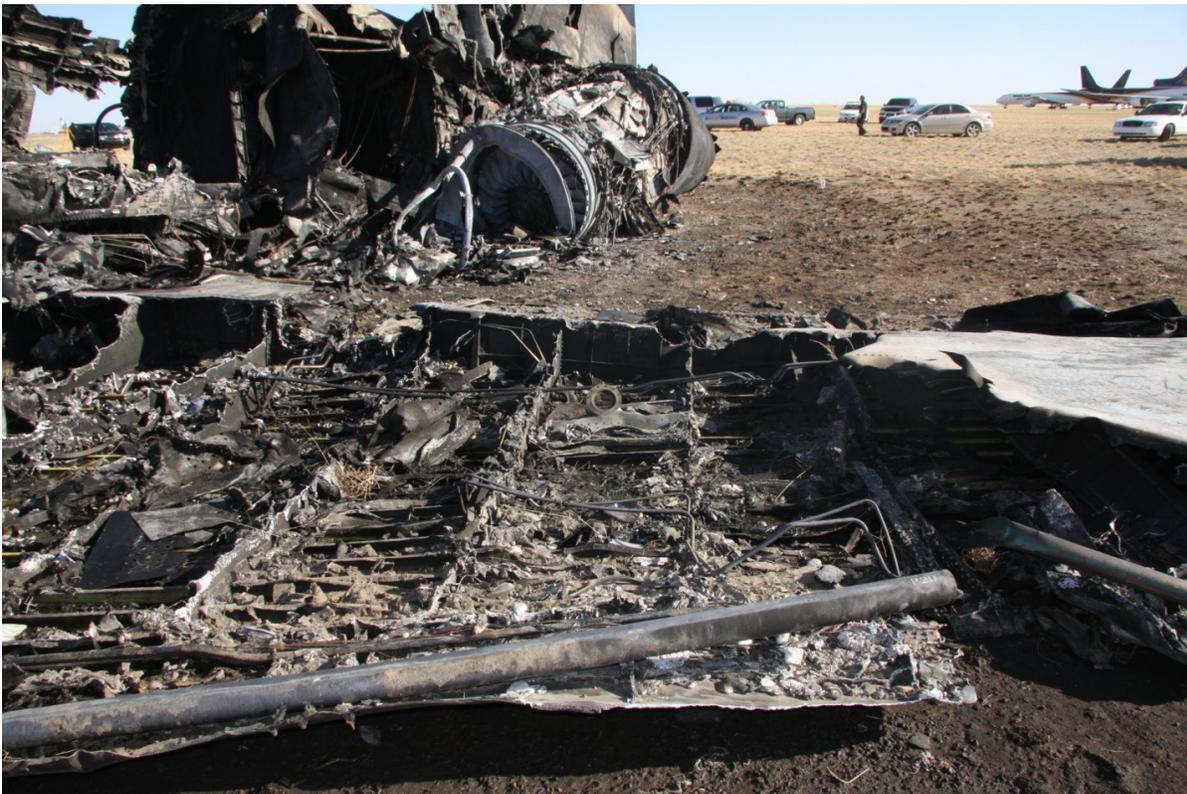
Figure 18 Left Wing Leading Edge

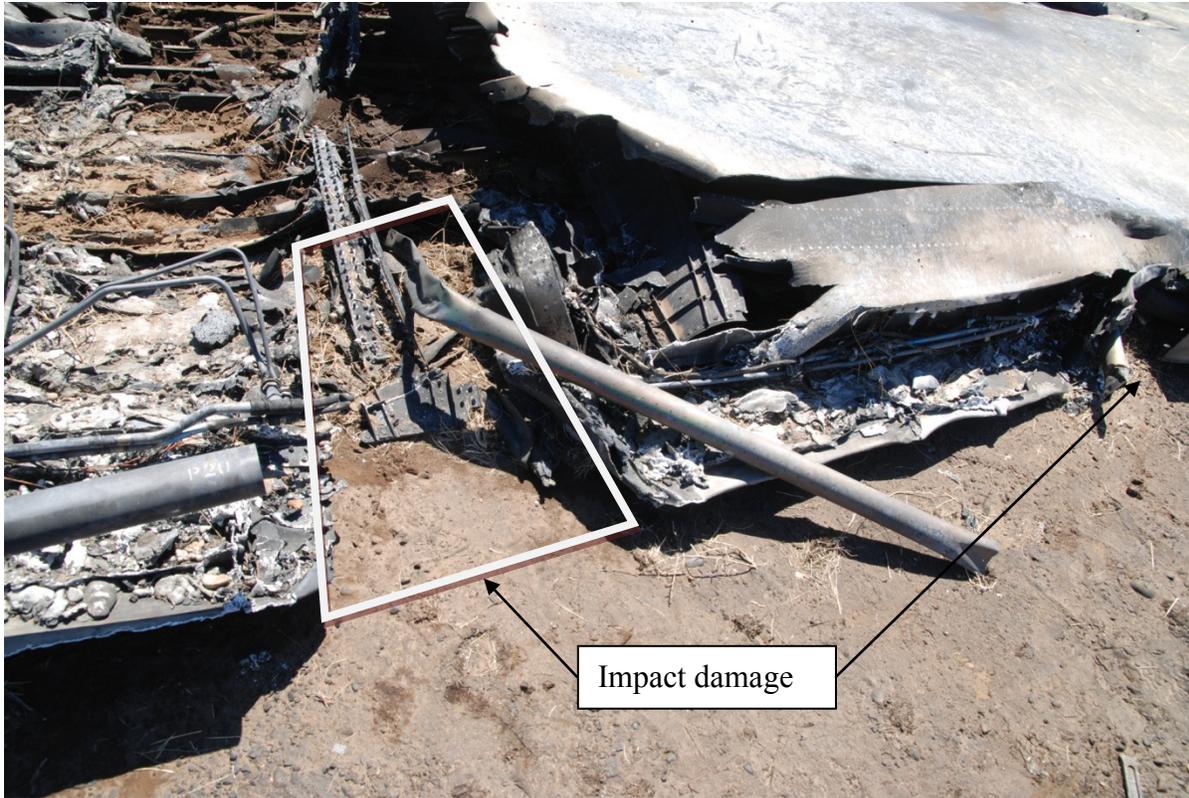
Figure 19 Left Wing Impact damage

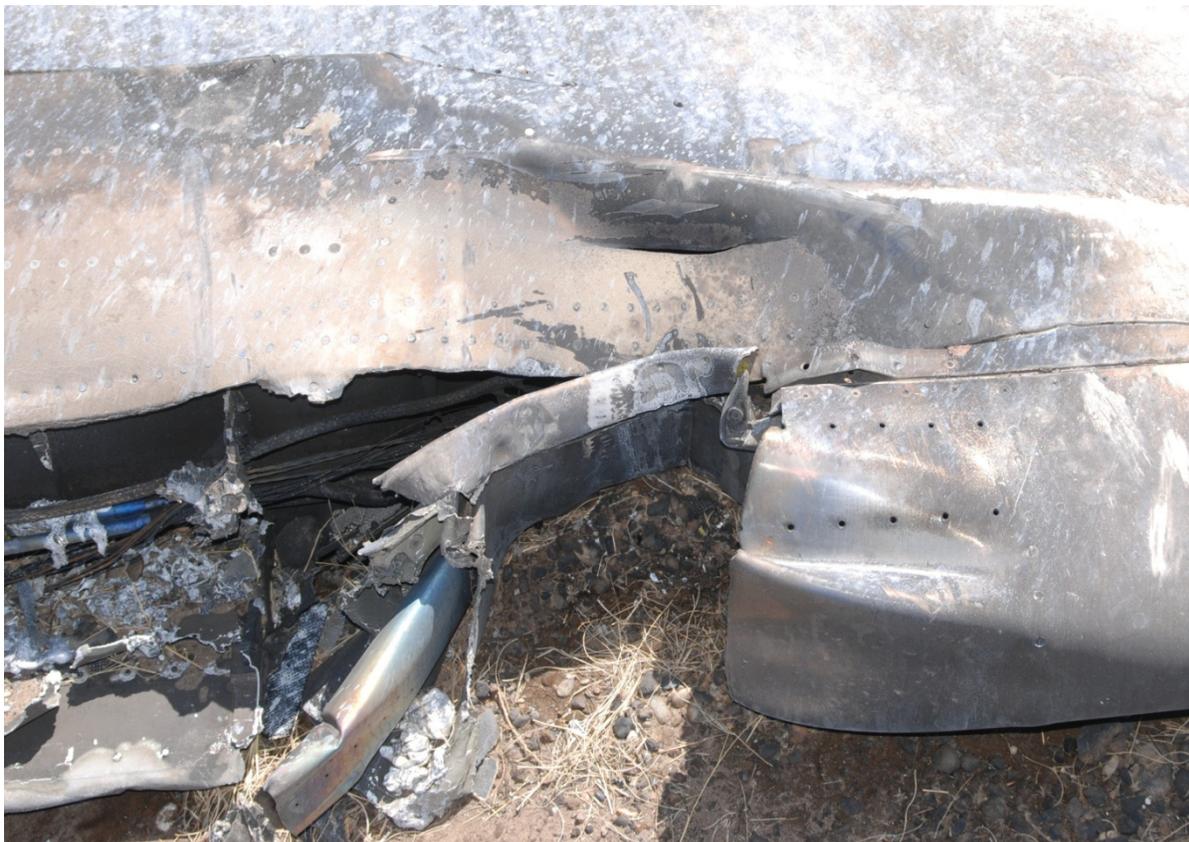
Figure 20 Left Wing Impact Damage

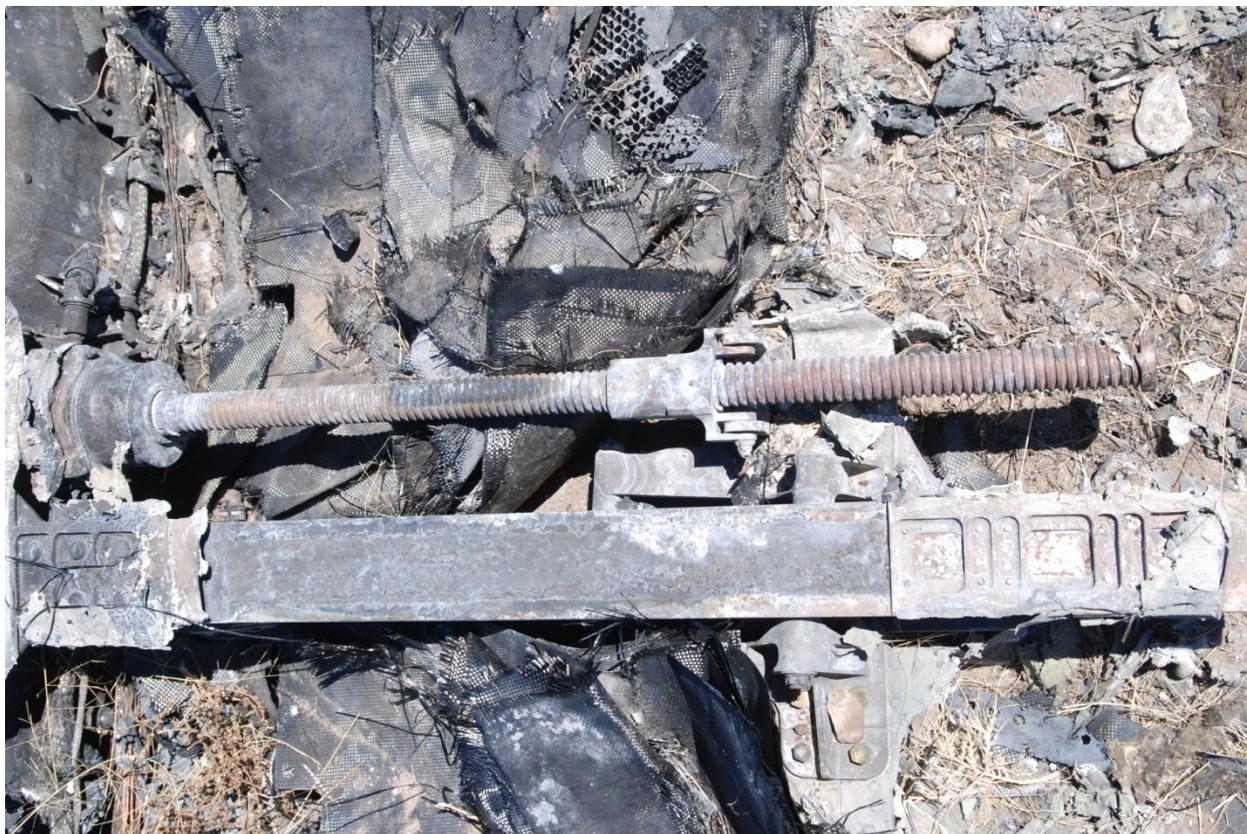
The flap surface was intact from the most outboard portion to approximately 2 feet inboard of the outboard track (Track D) (Figure 21). Inboard of that point the surface and attach points were mostly melted. Flap track A was intact with flap rollers detached, but in close proximity on the ground. Flap track B was intact with the carriage still attached to the jackscrew (Figure 22). The jackscrew position was measured from the up stop to top of ballscrew – 16 5/8 inches, and the downstop to bottom of ballscrew - 12 3/4 inches. Flap track C was intact with the carriage still attached to the jackscrew (Figure 23). The jackscrew position was measured from up stop to top of ballscrew - 13 3/4 inches, and the downstop to bottom of ballscrew – 10 3/8 inches. According to Gulfstream these measurements of the jackscrew position are consistent with flaps in the 10 degree position. Flap track D structure and attach fittings all intact and connected to unmelted flap surface.

Figure 22 Flap Track B and Jackscrew

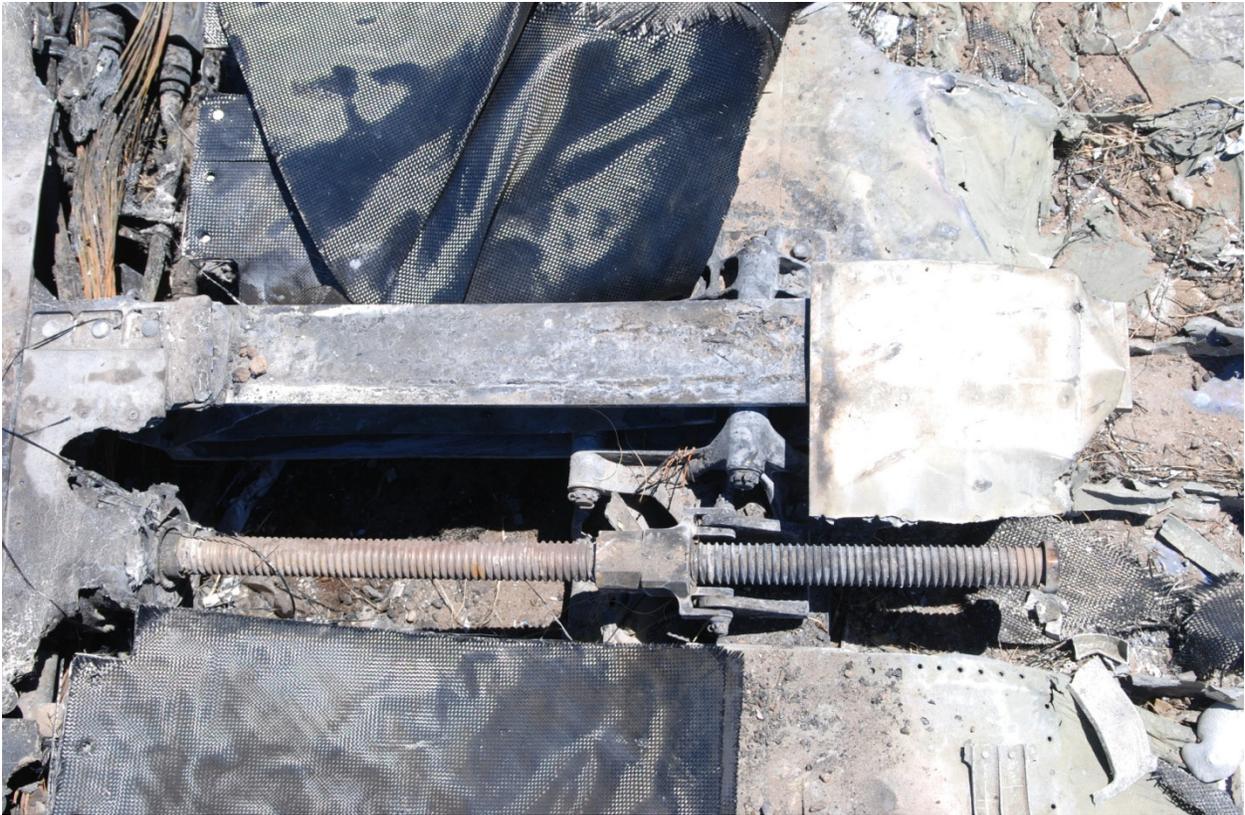
Figure 23 Flap Track C and Jackscrew

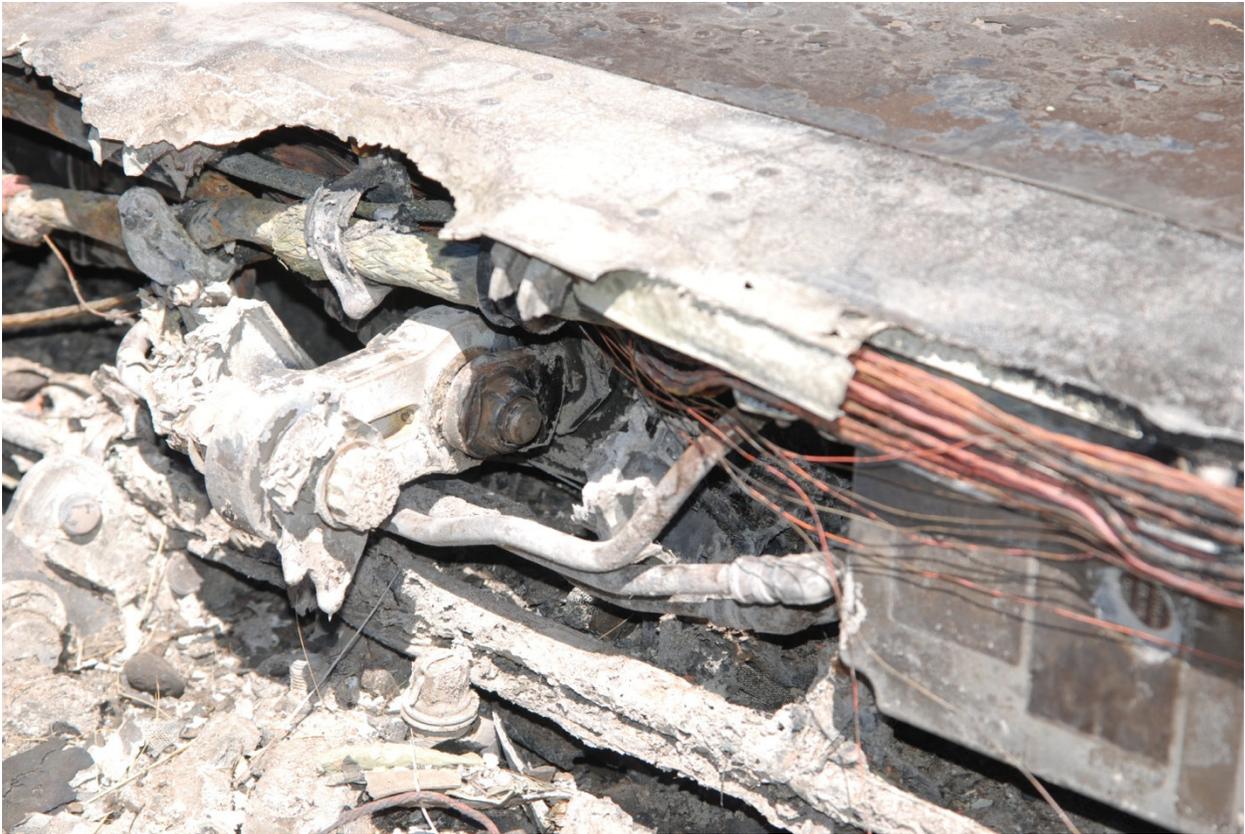
The composite spoilers had extensive heat damage. The outboard spoiler was delaminated and all four hinge fittings were detached and melted (Figure 24). The actuator and connecting link (toggle link) were intact, including attachment bolts (Figure 25). The middle spoiler was delaminated (Figure 26). The two hinges nearest the actuator were present with attach fittings, but heat damaged and fractured. The most inboard hinge was melted. The actuator and connecting link (toggle link) were intact, including attachment bolts (Figure 27). The inboard spoiler was delaminated and consumed (Figure 28), with all attach fittings melted.

Figure 25 Left Outboard Spoiler Actuator Fittings

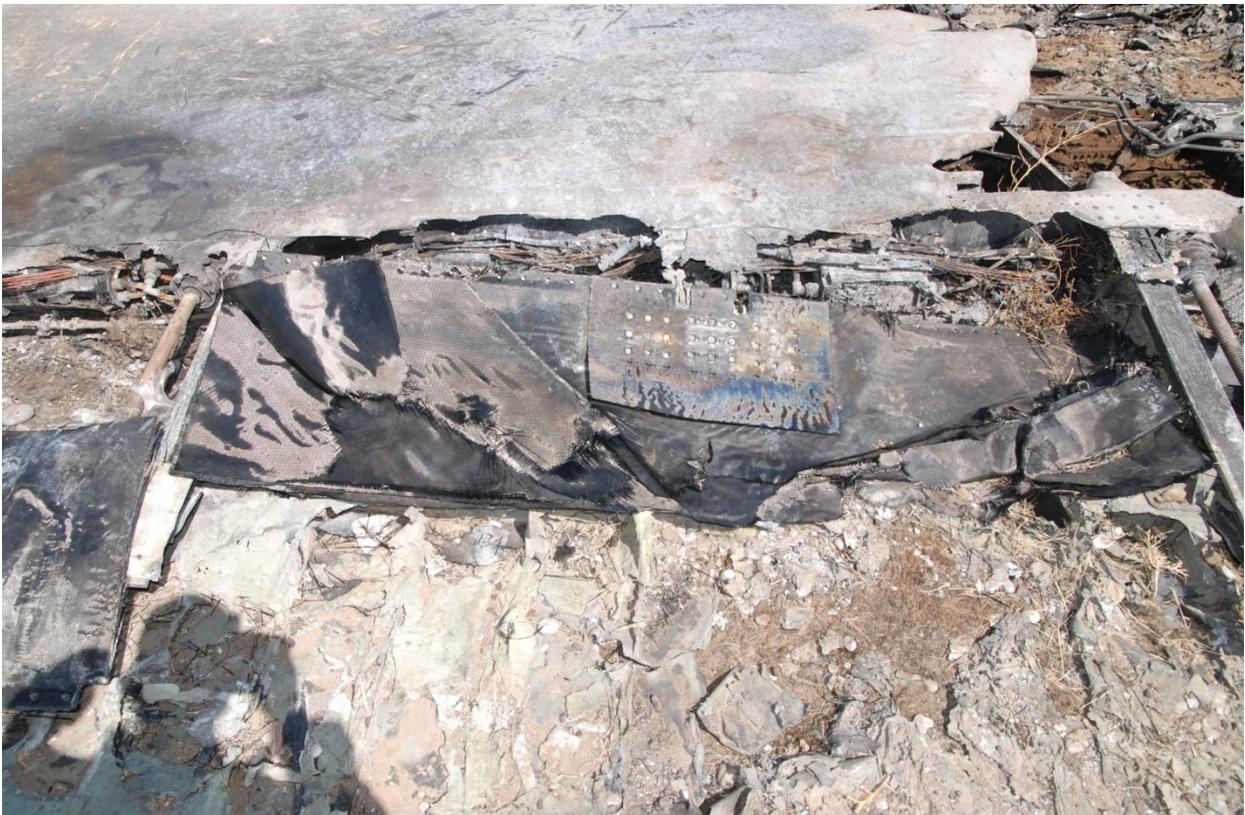
Figure 26 Left Middle Spoiler

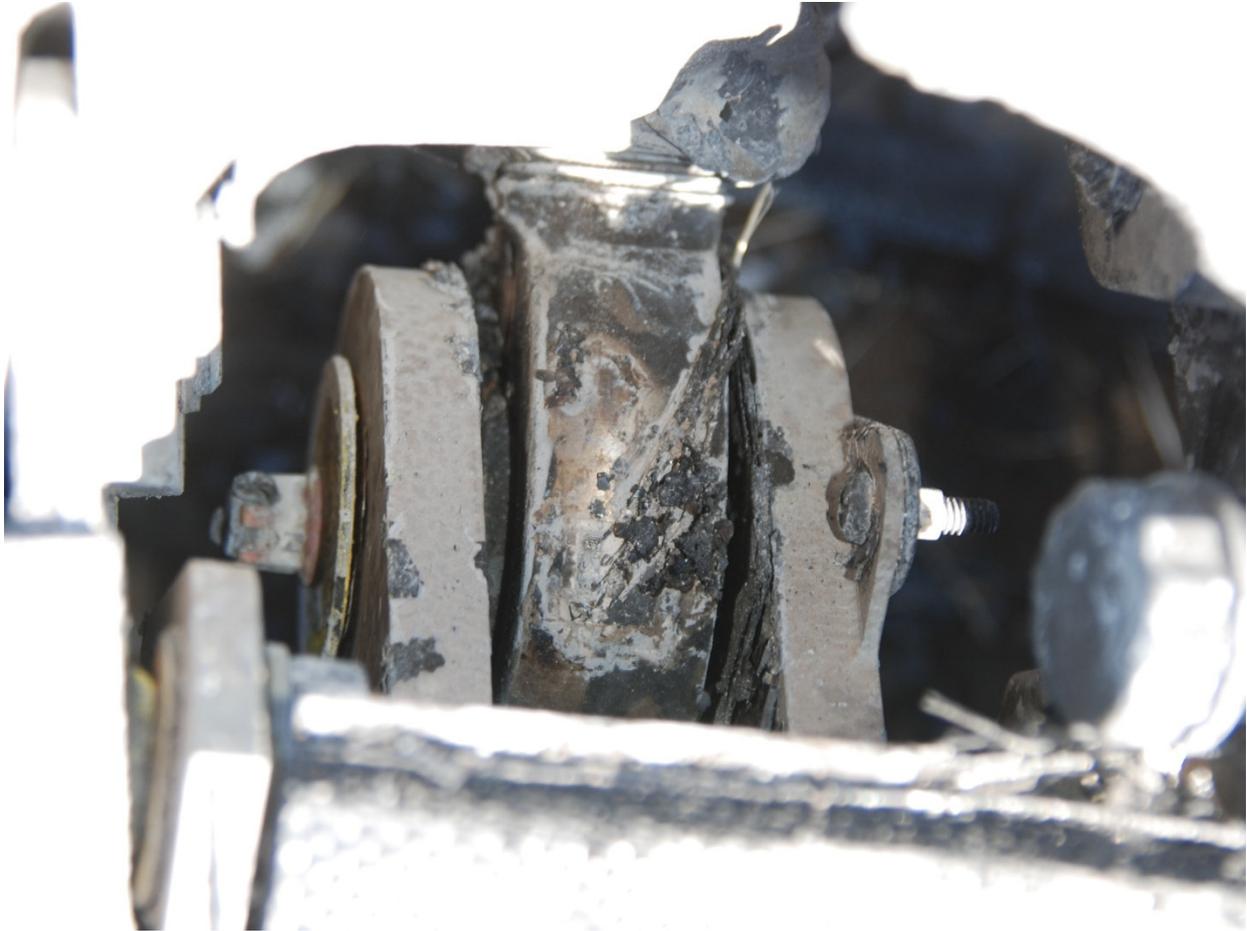
Figure 27 Left Middle Spoiler Attachment Fitting

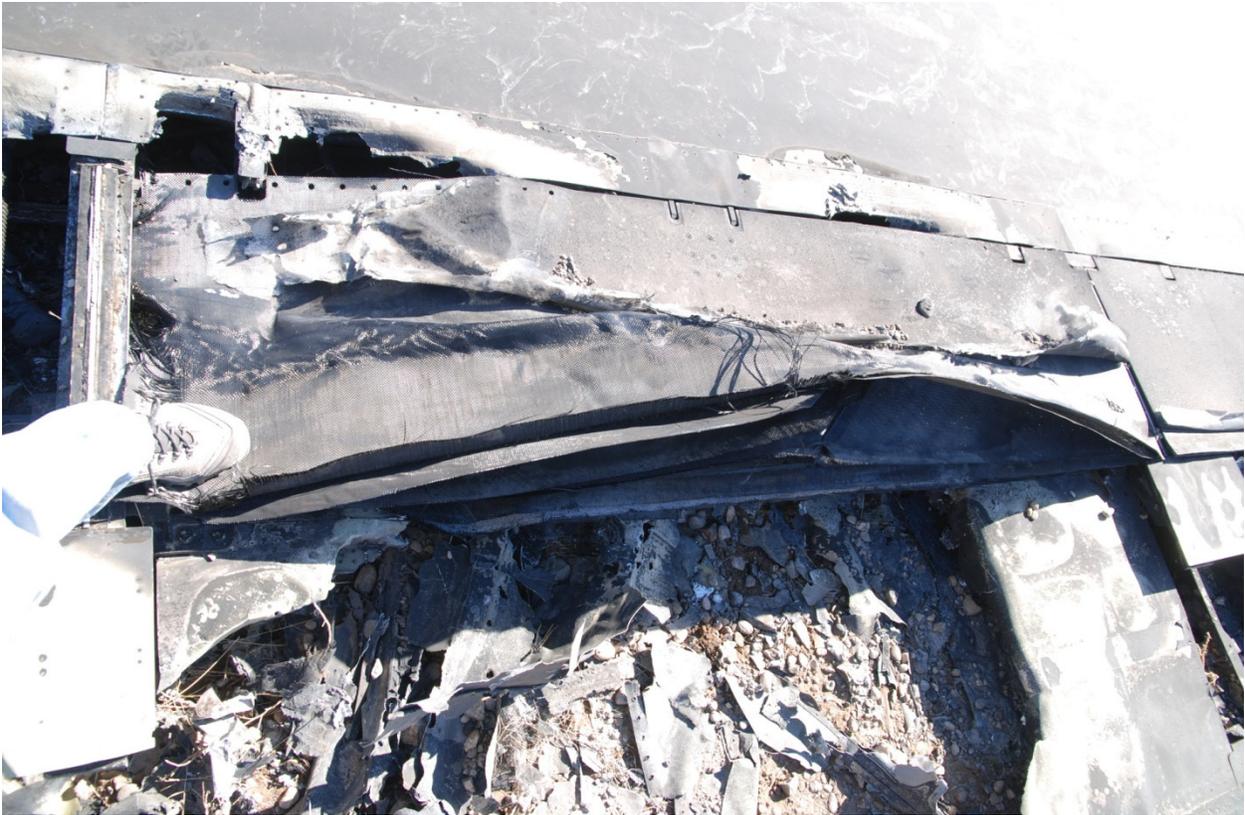
Figure 35 Right Middle Spoiler

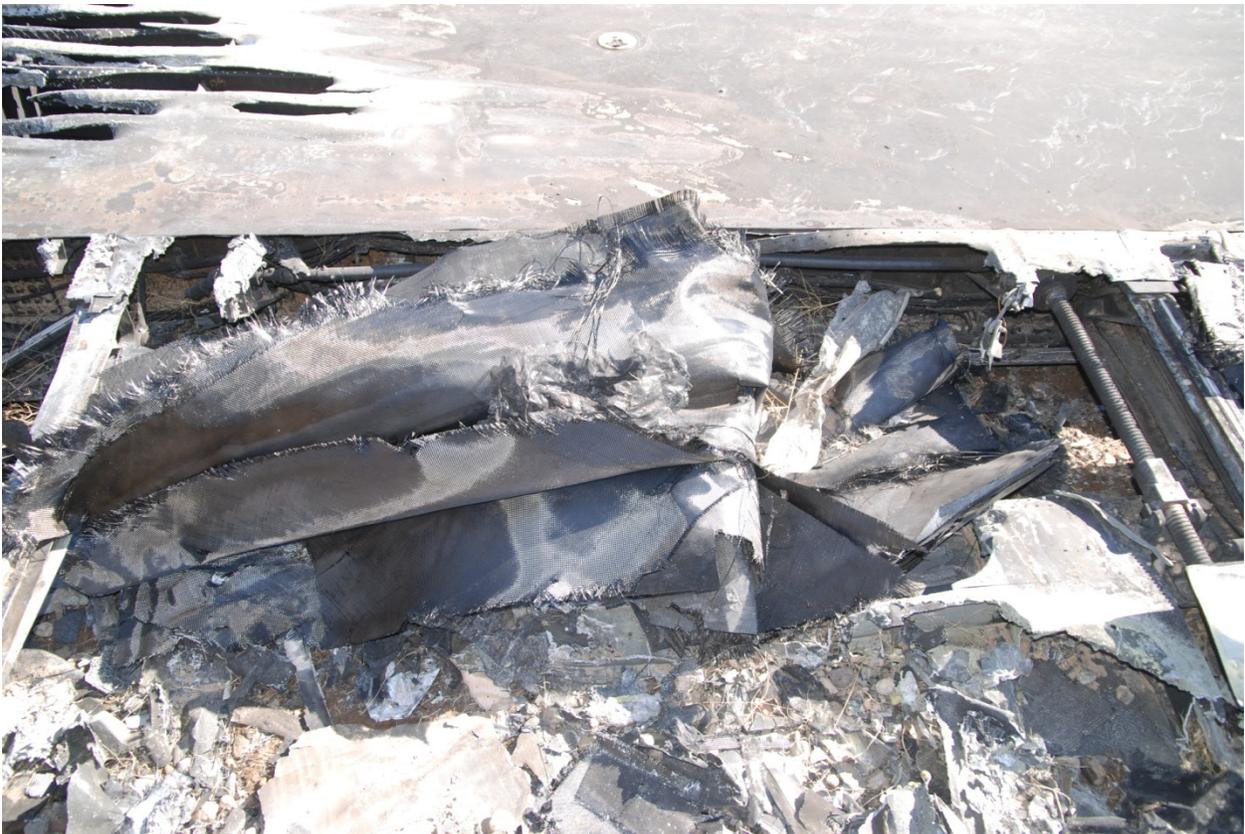
Figure 36 Right Inboard Spoiler

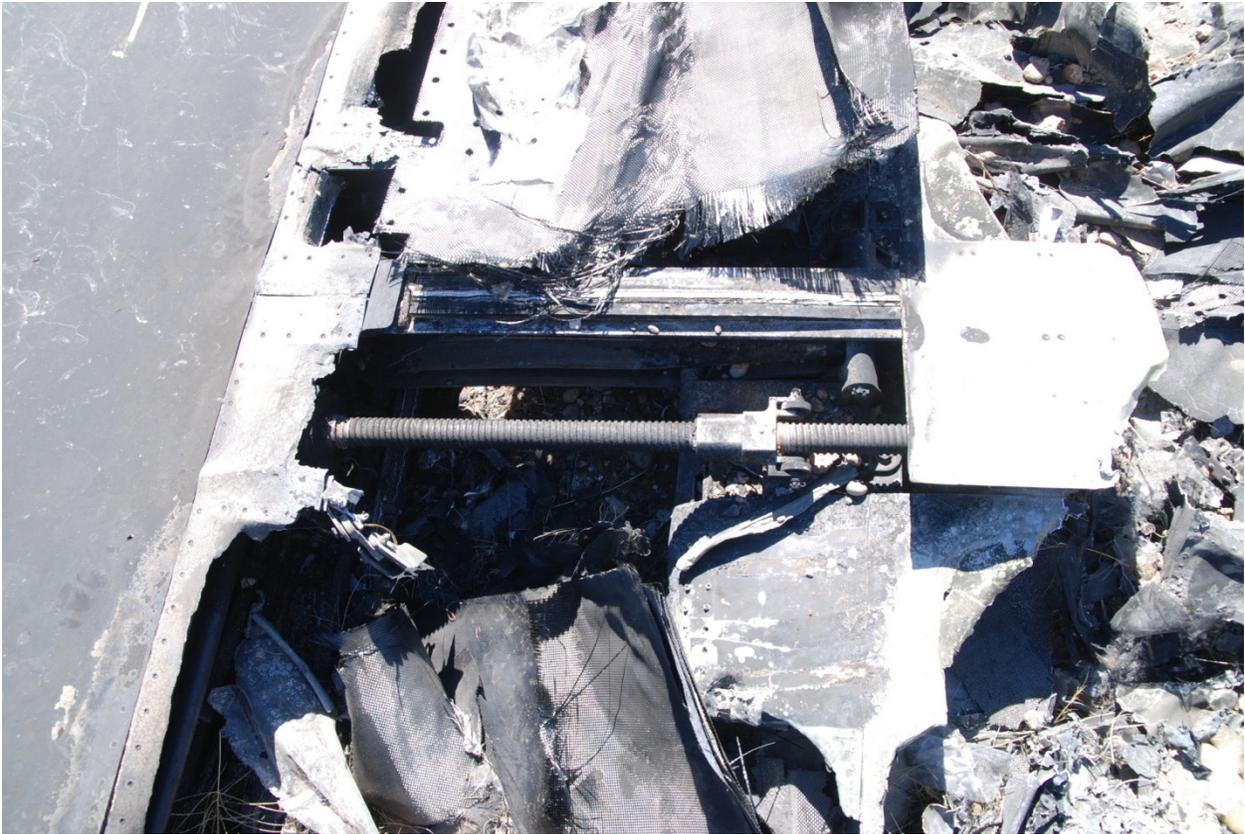
Figure 39 Right Flap Track B

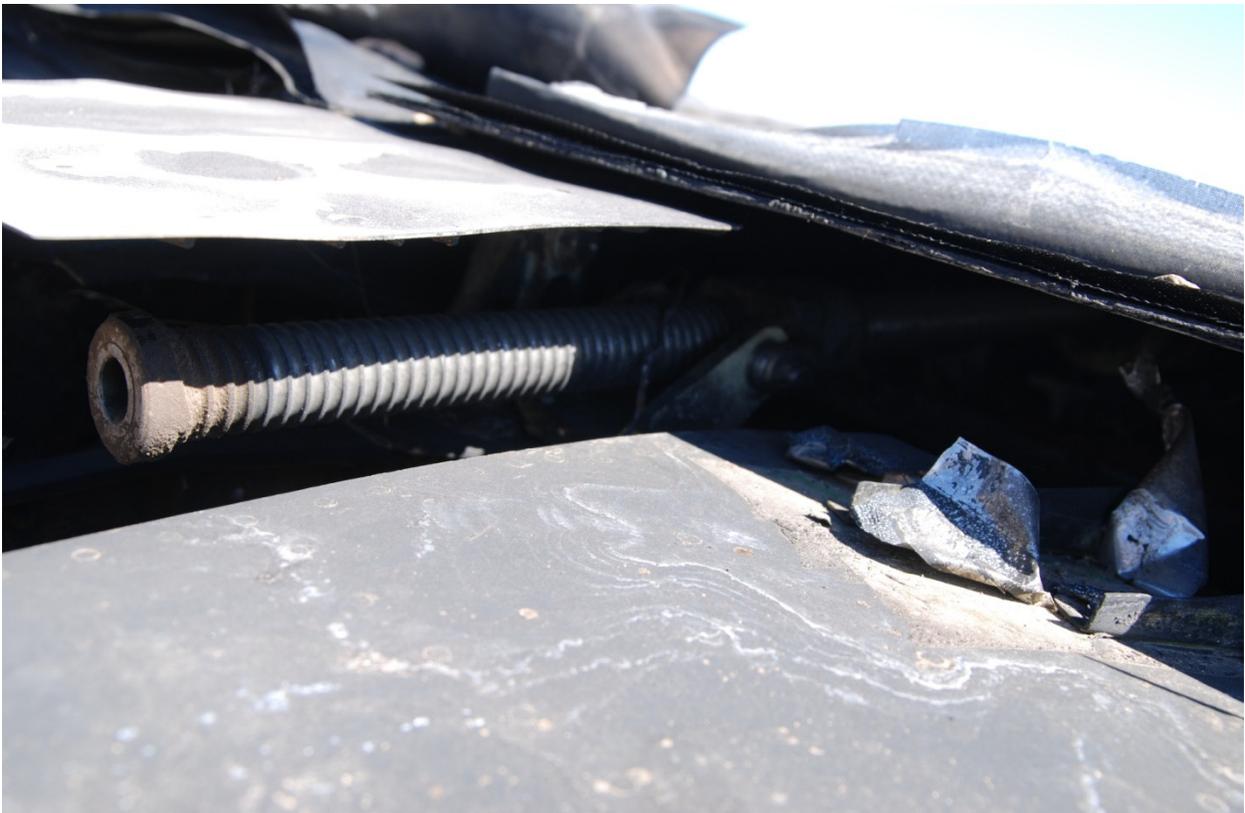
Figure 40 Right Flap Track C

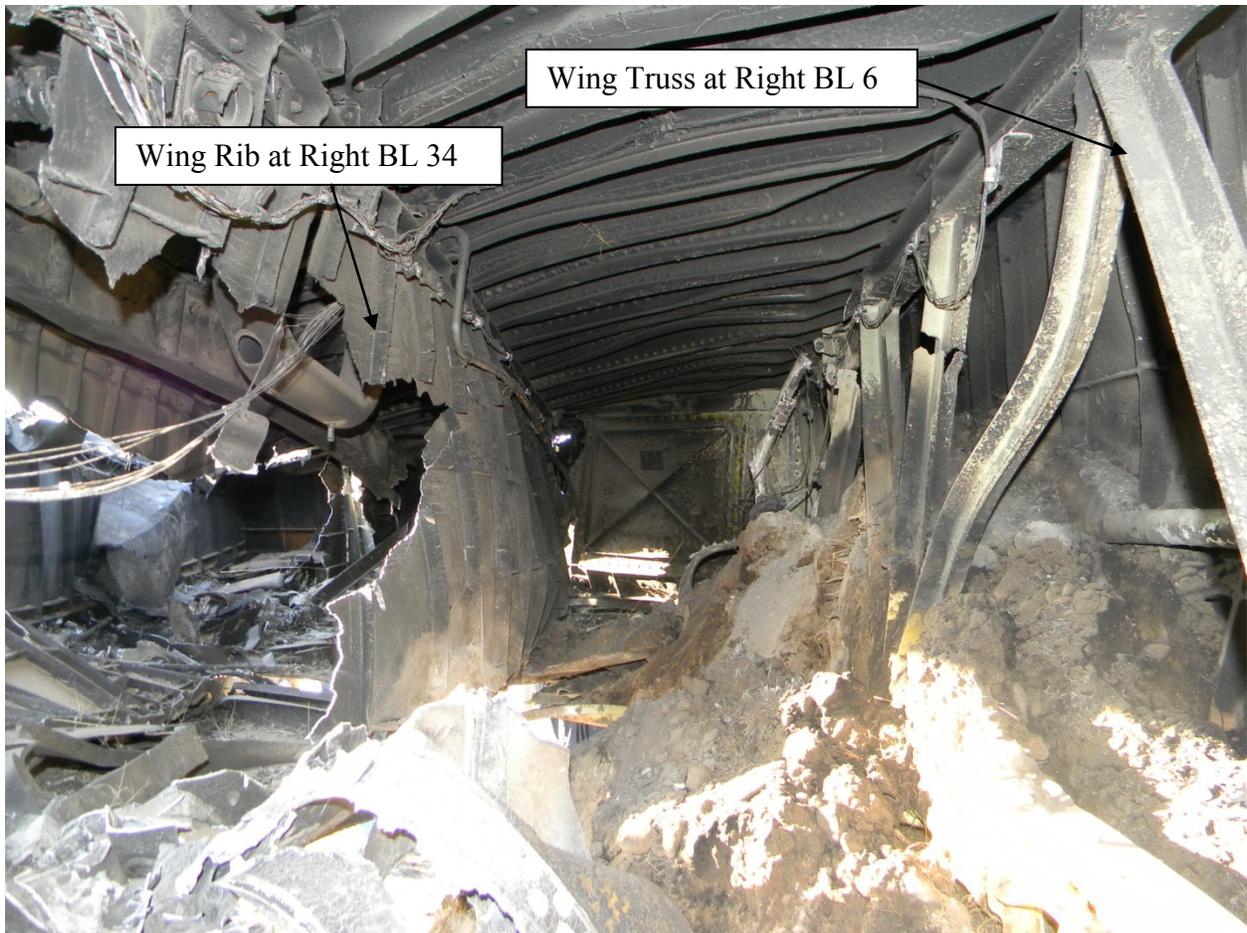
Extensive damage to the center wing box floor, ribs and trusses could be observed through the melted area of the right wing (Figure 41). This area is a portion of the fuel tank. There was an accumulation of dirt inside the wing box. During recovery the fuselage was lifted off the wing, providing access to the damage. The forward spar had a large hole to the right of centerline (Figure 42). The lower skin was bent up in the area and a crack spanned from the hole to the upper skin. The upper skin was bent and separated from the spar. Inside the wing box it was observed that the truss at right BL 6 was damaged, the rib at right BL 34 had a large hole, and there was an accumulation of dirt inside the wing box (Figure 43). The rear spar of the wing box had a large hole outboard of the rib at right BL 34, which extended from the top skin to the lower skin. The lower skin was also fractured and missing.

Figure 43 Center Wing Box Internal View looking Aft

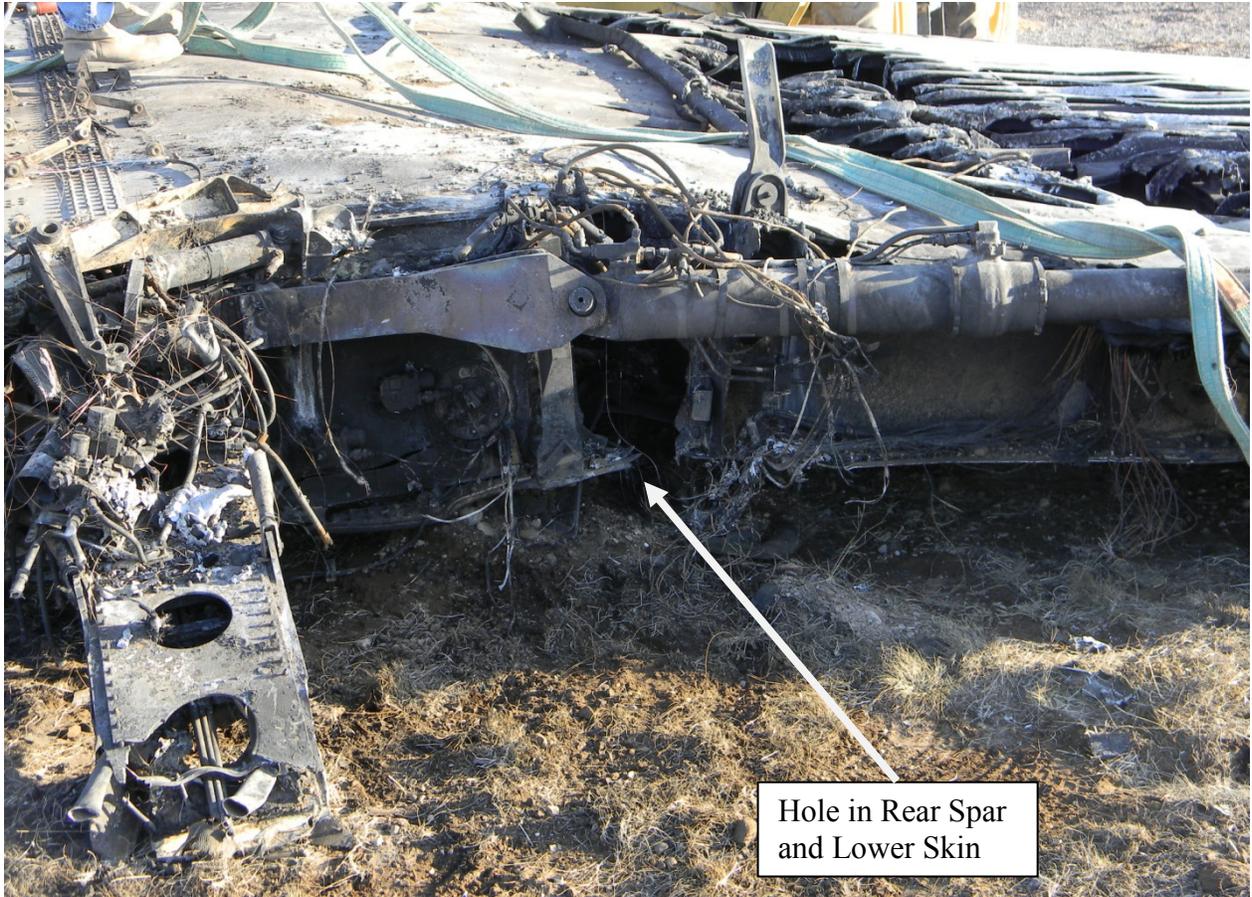
Figure 44 Center Wing Box Aft Spar Damage

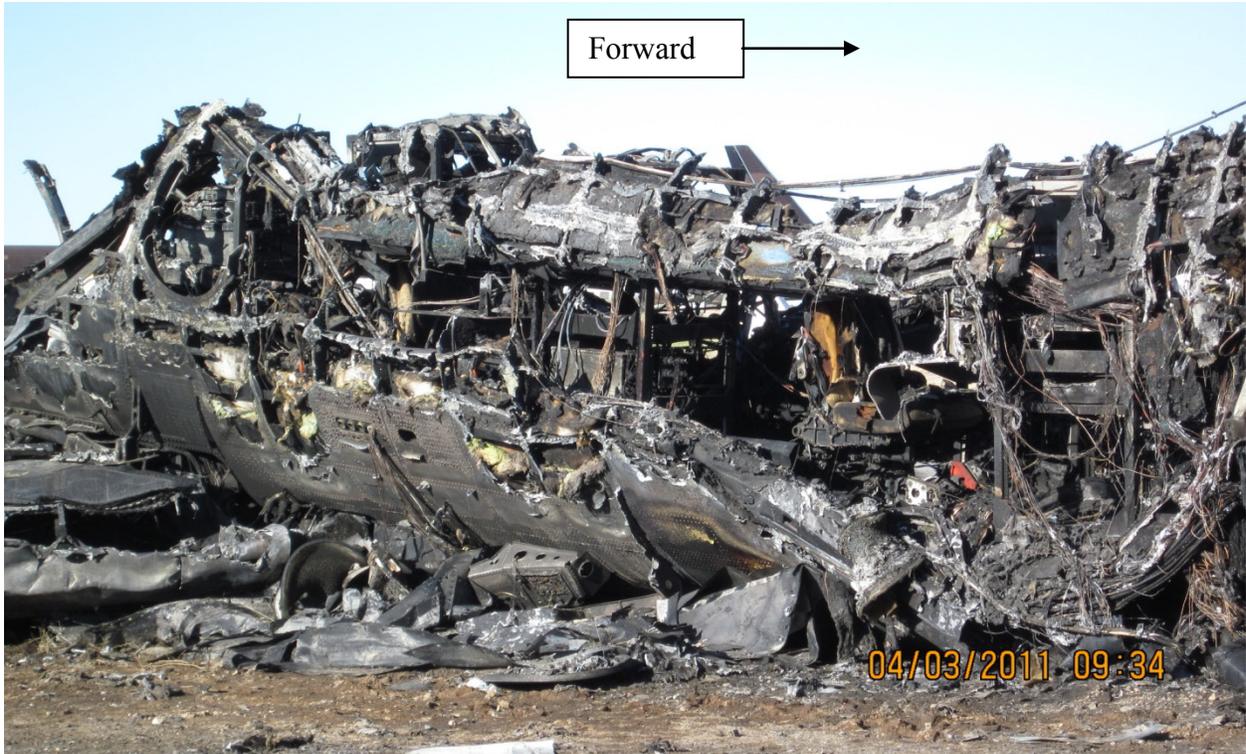
the forward, mid, and aft fuselage segments respectively from the right side. The fuselage was fractured at approximately fuselage station 580 (Figure 57). Figures 59-60 show the right wing to fuselage linkages. Figure 61 shows the overview of the fuselage from the left side. Figures 62 – 64 show the forward, mid, and aft fuselage segments respectively from the left side. Figure 65 shows the main entry door. Figures 66-67 show the left wing to fuselage linkages. Figure 68 shows the fuselage station diagram for the airplane.

Figure 56 Right Forward Mid Fuselage

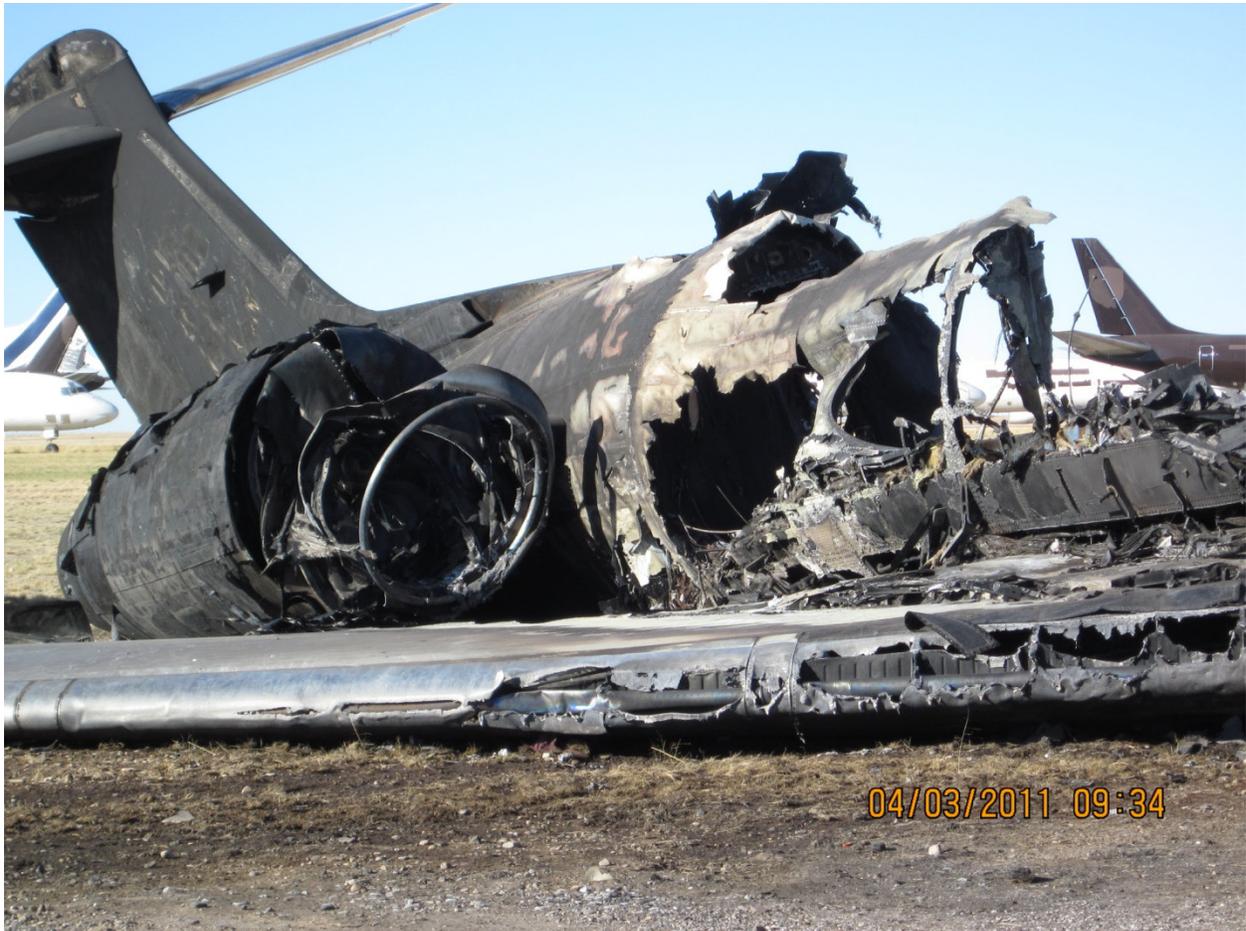
Figure 58 Right Aft Mid Fuselage

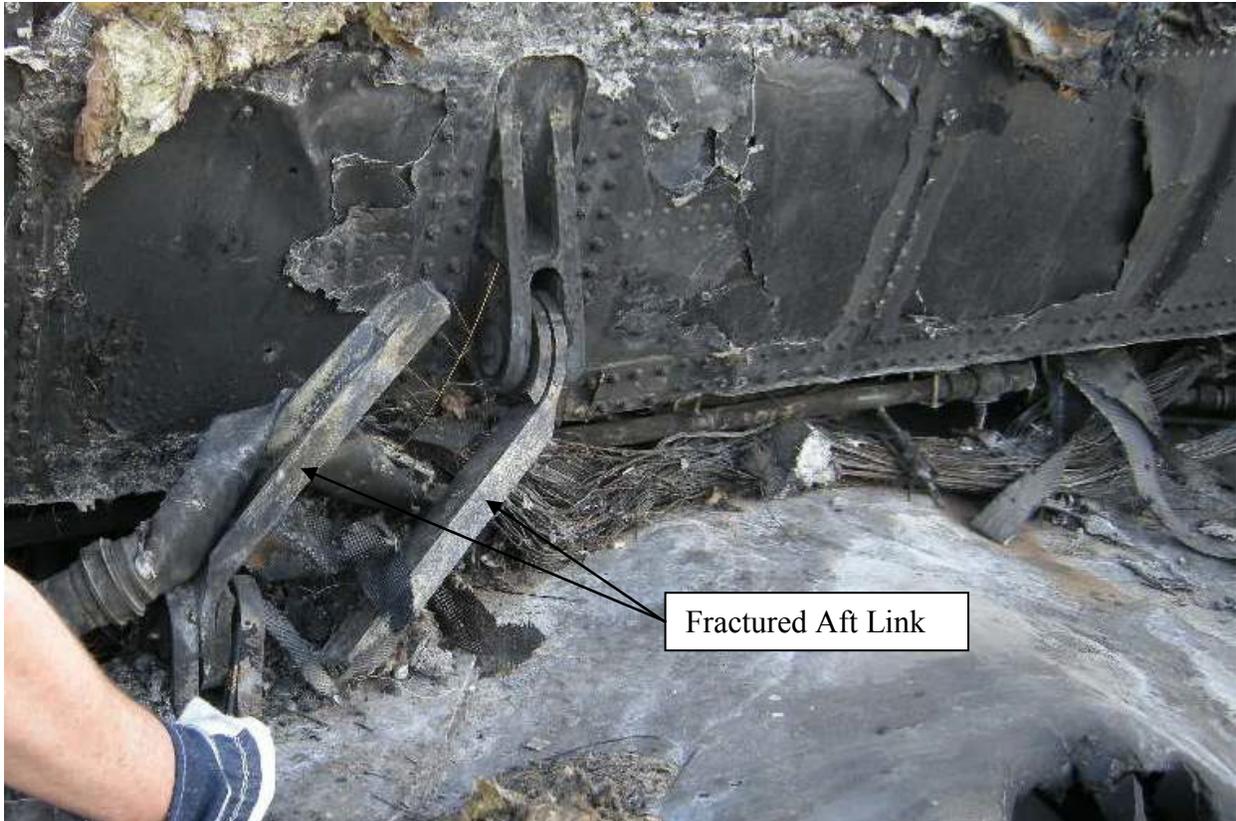
Figure 60 Right Aft Wing to Fuselage Link
