**NATIONAL TRANSPORTATION SAFETY BOARD
OFFICE OF AVIATION SAFETY
WASHINGTON, D.C. 20594**

AIRWORTHINESS SPECIALIST'S REPORT OF INVESTIGATION

DCA11MA076

Operator: Gulfstream Aerospace Corporation
Aircraft: GVI (G650), Serial Number 6002
Location: Roswell, NM
Date: April 2, 2011
Time: 0934 MDT

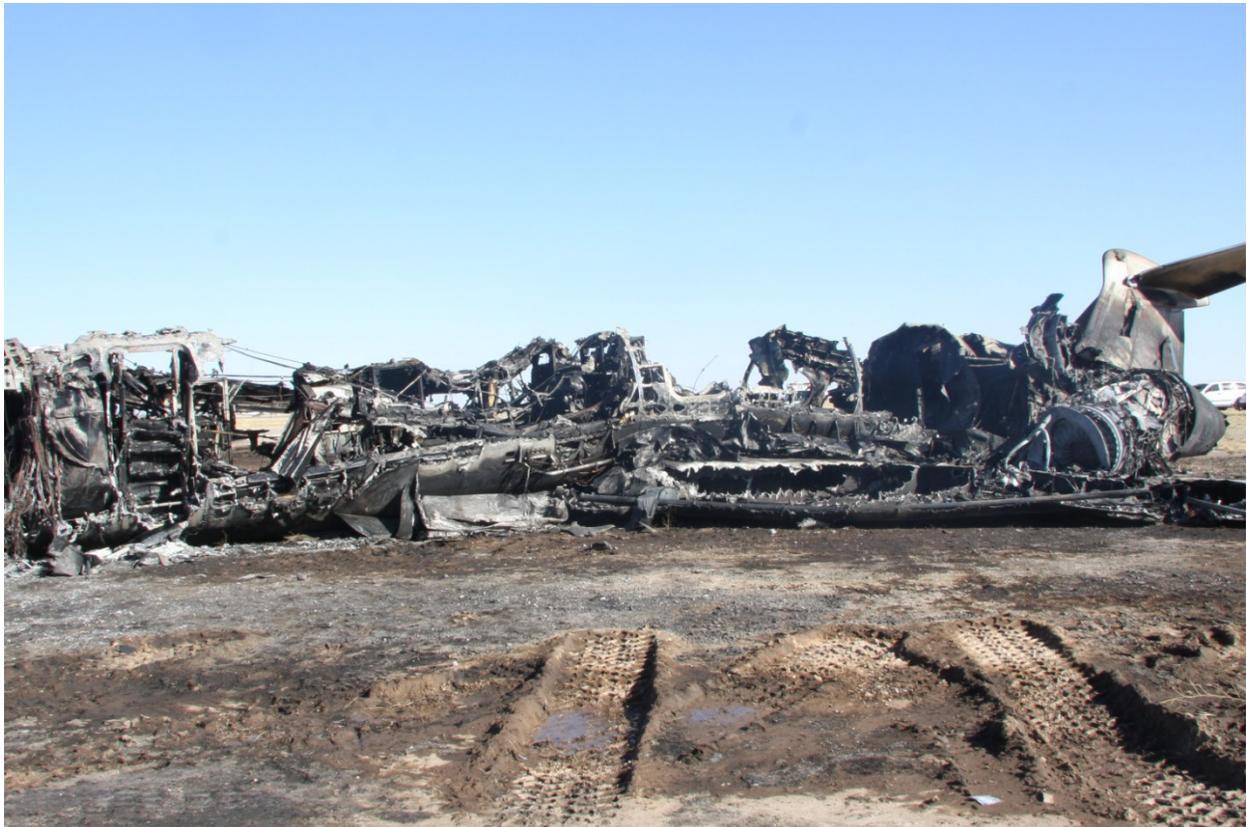
the forward, mid, and aft fuselage segments respectively from the right side. The fuselage was fractured at approximately fuselage station 580 (Figure 57). Figures 59-60 show the right wing to fuselage linkages. Figure 61 shows the overview of the fuselage from the left side. Figures 62 – 64 show the forward, mid, and aft fuselage segments respectively from the left side. Figure 65 shows the main entry door. Figures 66-67 show the left wing to fuselage linkages. Figure 68 shows the fuselage station diagram for the airplane.

Figure 61 Left Side Fuselage Overview

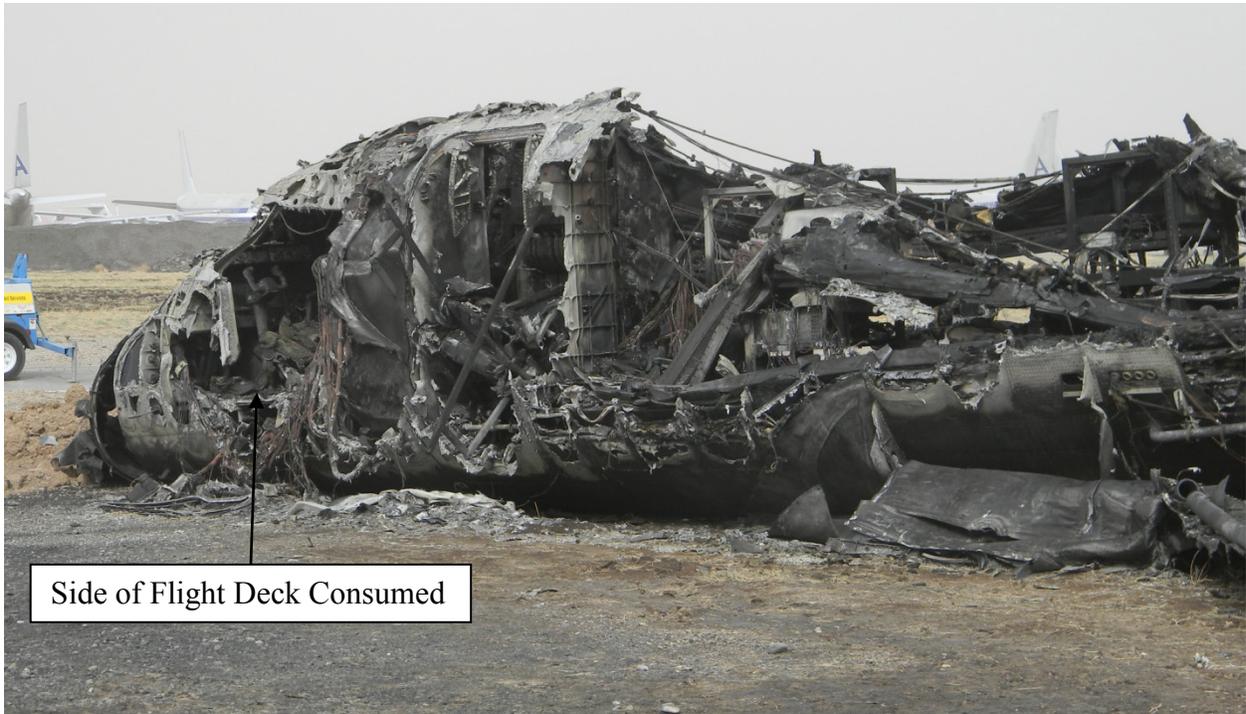
Figure 62 Left Fuselage Forward and Forward Mid Sections

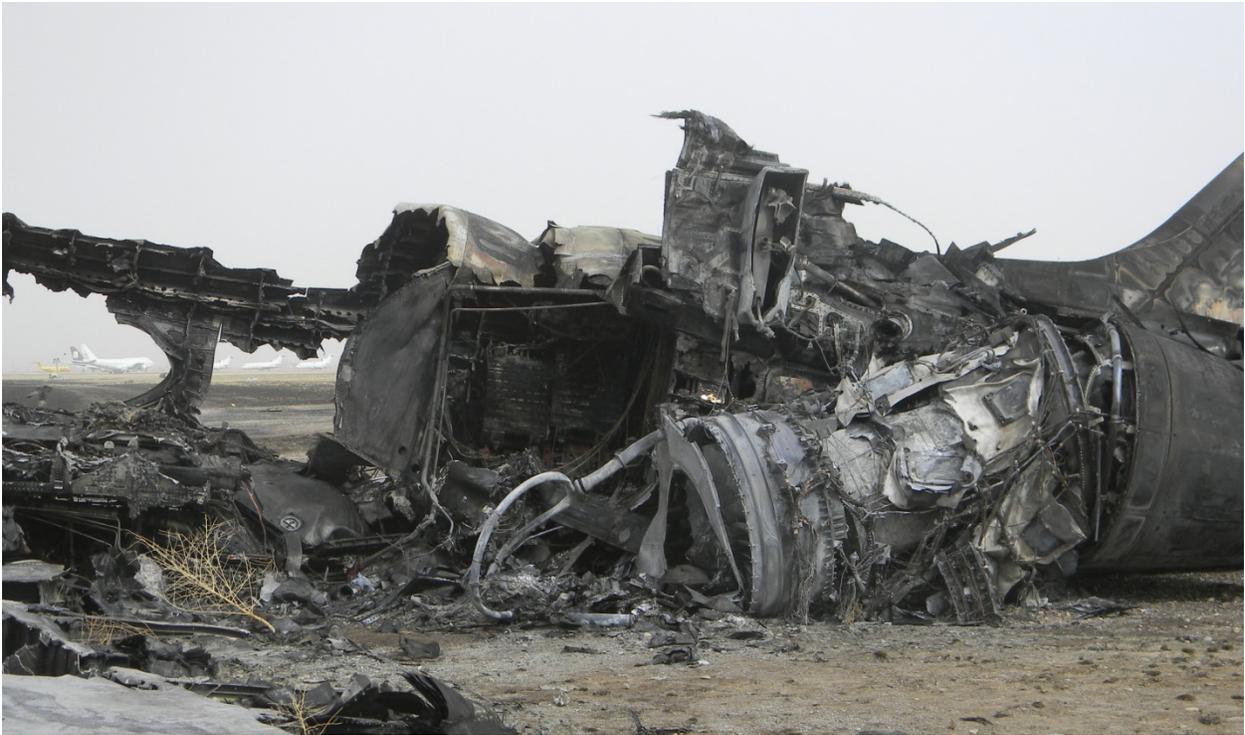
Figure 63 Left Fuselage Center Mid Section

The fuselage was severely damaged by the post crash fire (Figure 55). The crown of the airplane was mostly consumed from the flight deck to the aft pressure bulkhead. Figures 56 – 58 show
