DCA15MA019

Attachment #3 to Group Chairman's Electronic Devices and Flight
Data Factual Report

Integrated Electronics Engineering Center (IEEC) Report

December 11, 2014

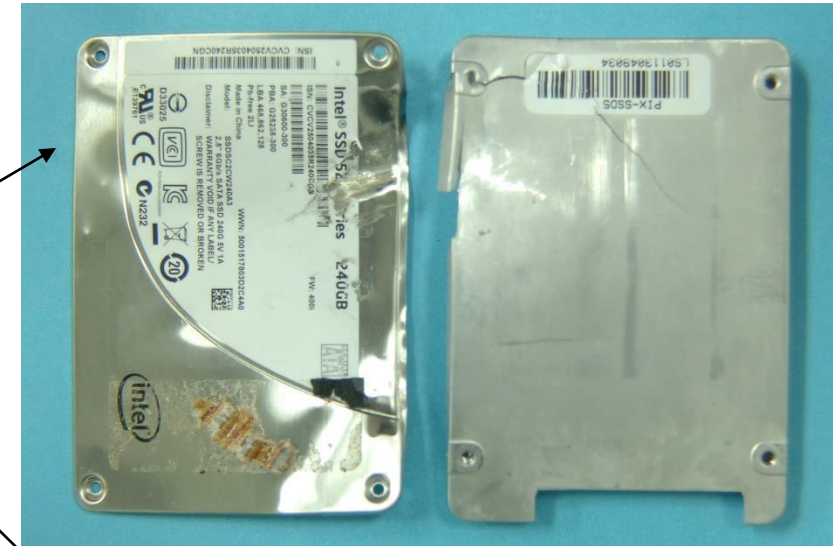
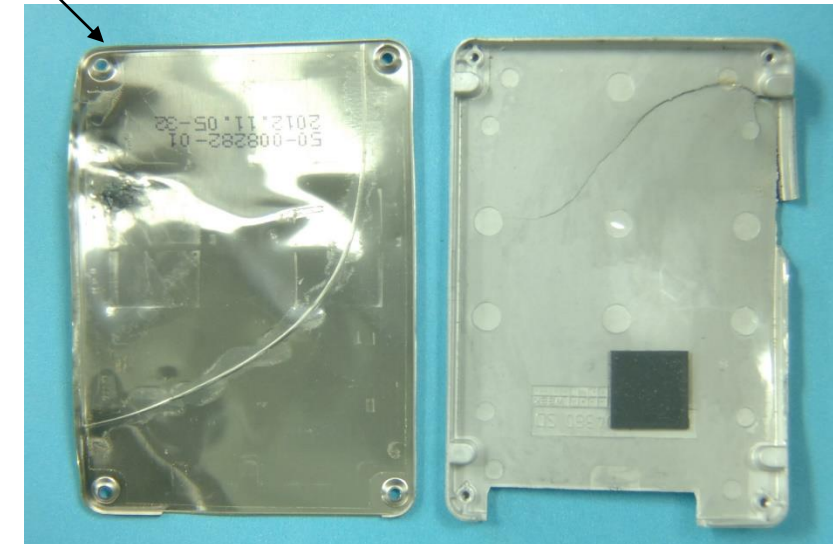
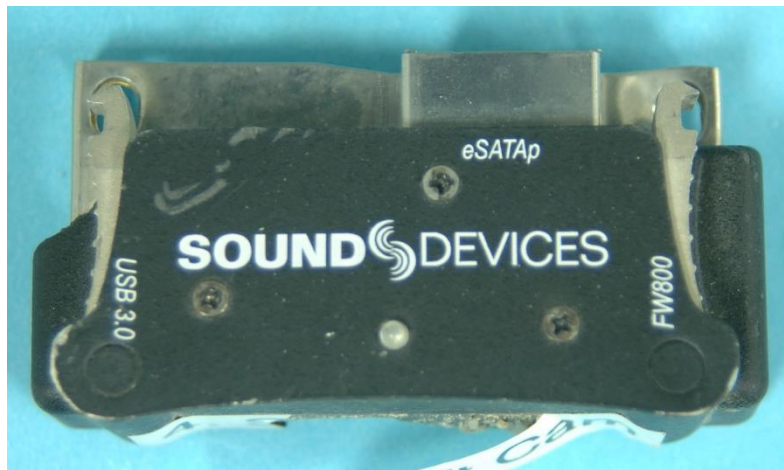
Bag 1: Card and Components

Casing badly bent,
components inside
badly fractured

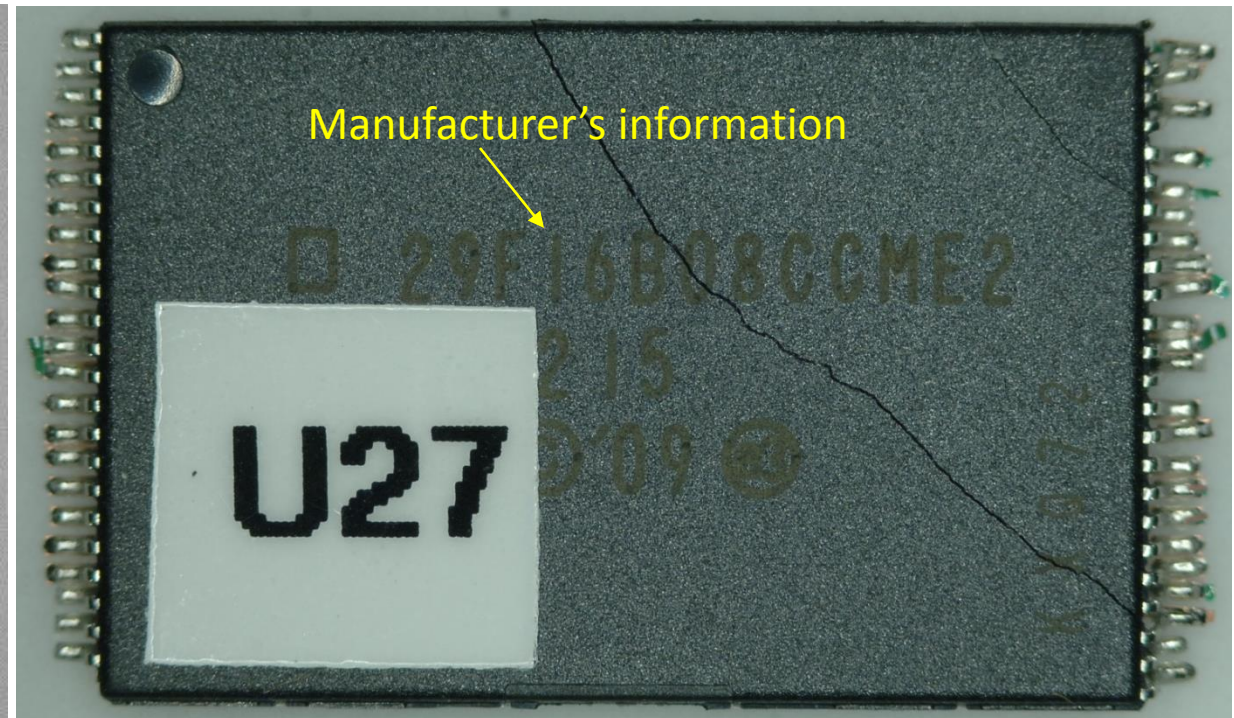
Basic Construction from Module U27 X-ray and Micrograph

When stamped manufacturer's information is upright, the wire bonds are on the bottom side of the module only. This allows a determination of which module in the back to back configuration has the broken wires

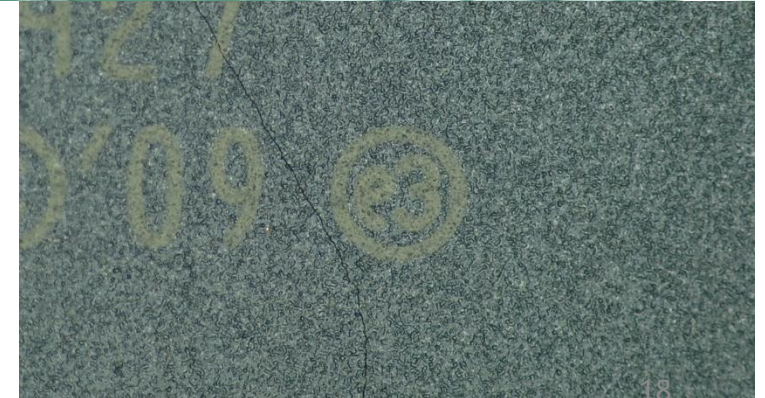
Module U19 / U23 Pair - Photos

Obvious crack in U19
Subtle crack in U23

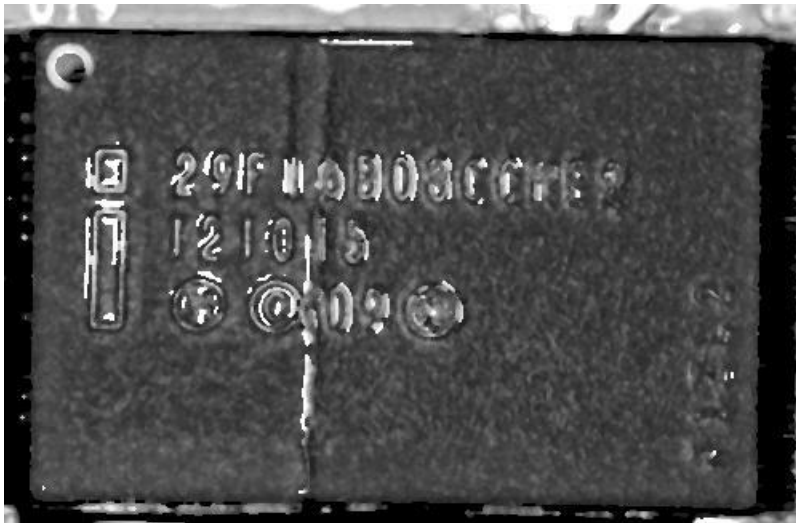
Module U19 C-SAMs

Given the flex of the module, the C-SAM anomaly is probably from a crack in the chip, not just a shadow of the crack in the overmold

Chip is badly damaged from the flexing

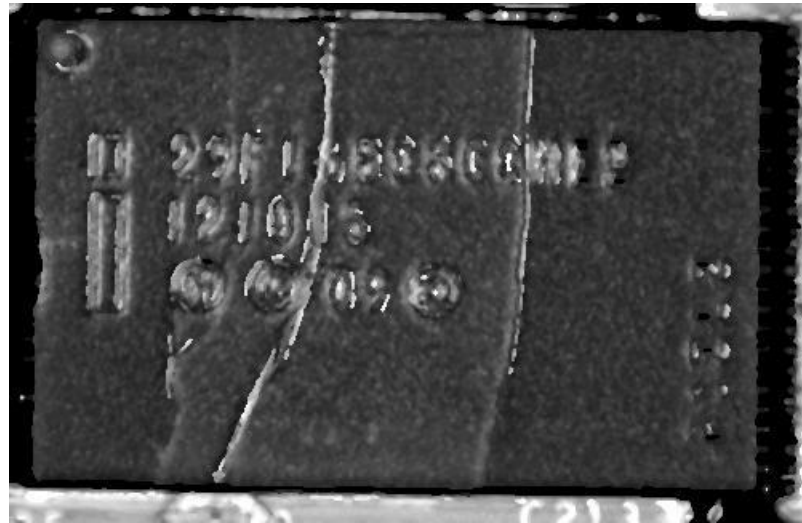
Module U20 C-SAMs

Chip is badly damaged from flexing

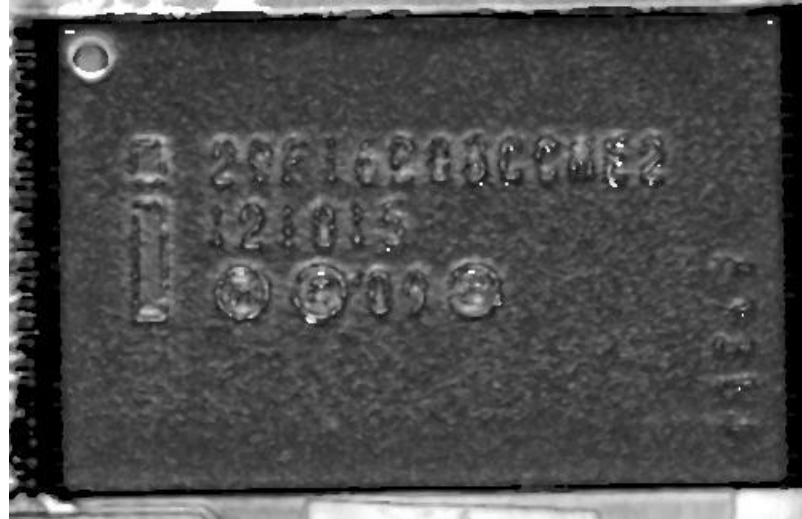
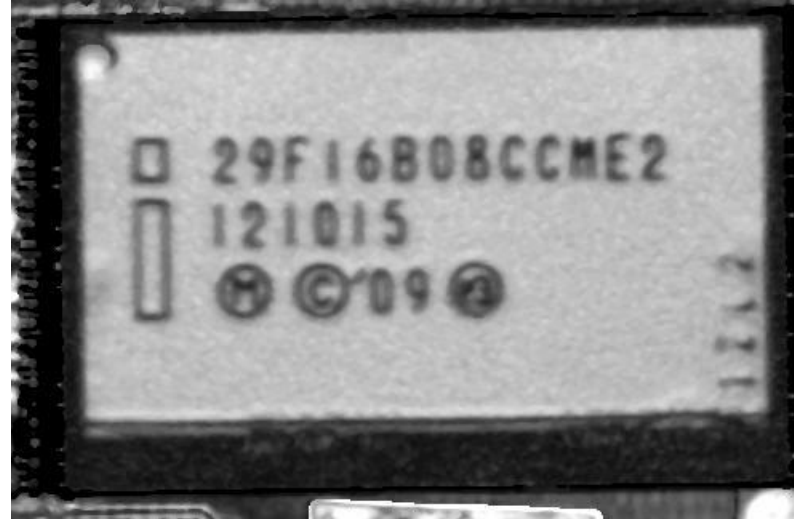
Module U21 C-SAMs

Chip appears to be in tact – no evidence of cracking or catastrophic delamination

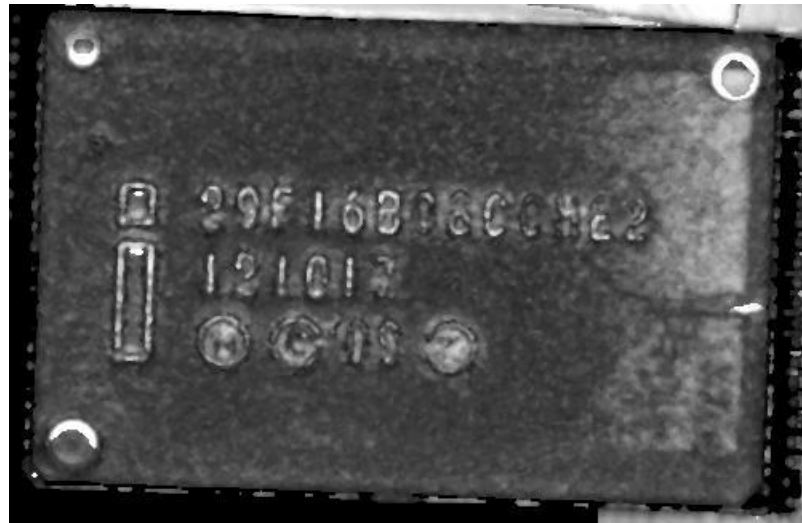
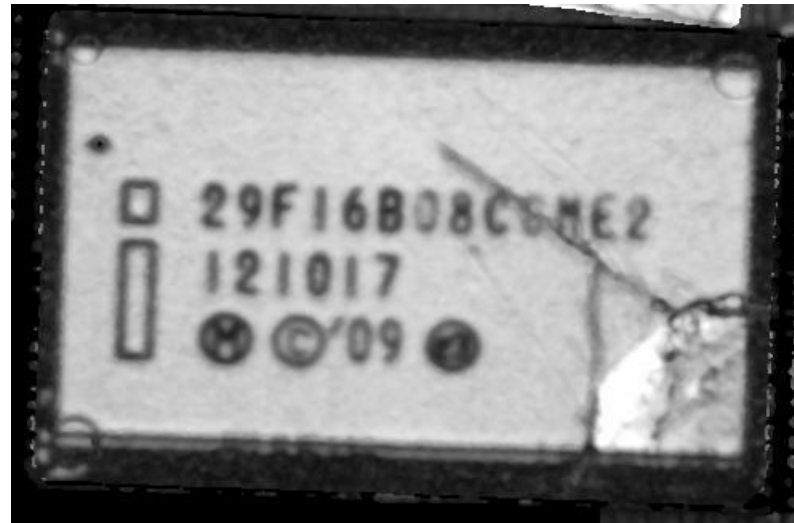
Module U25 C-SAMs

Corner of the chip is crushed from flexing

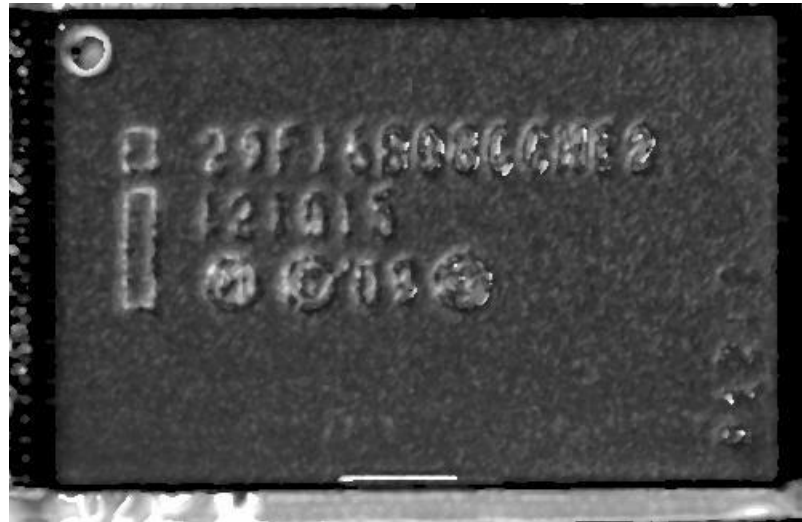
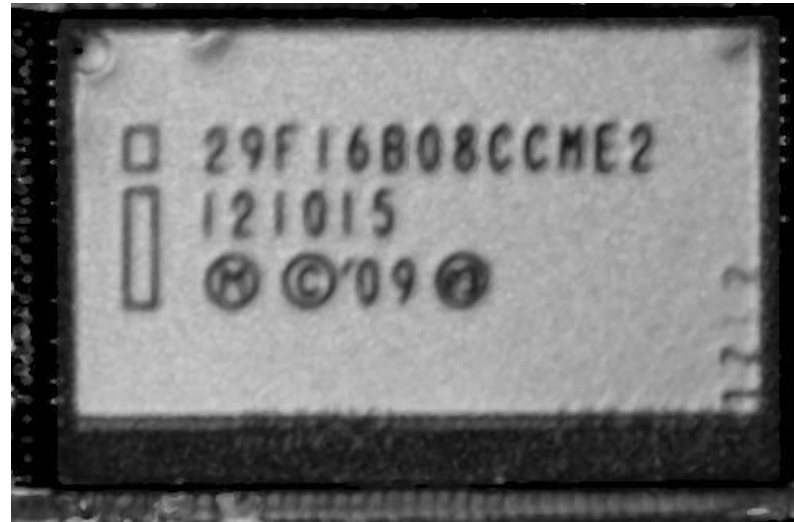
Module U22 C-SAMs

Chip appears to be in tact – no evidence of cracking or catastrophic delamination

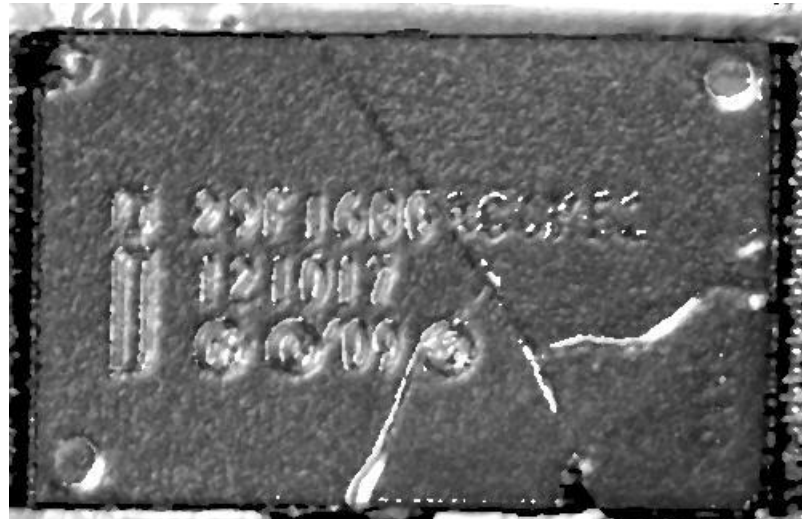
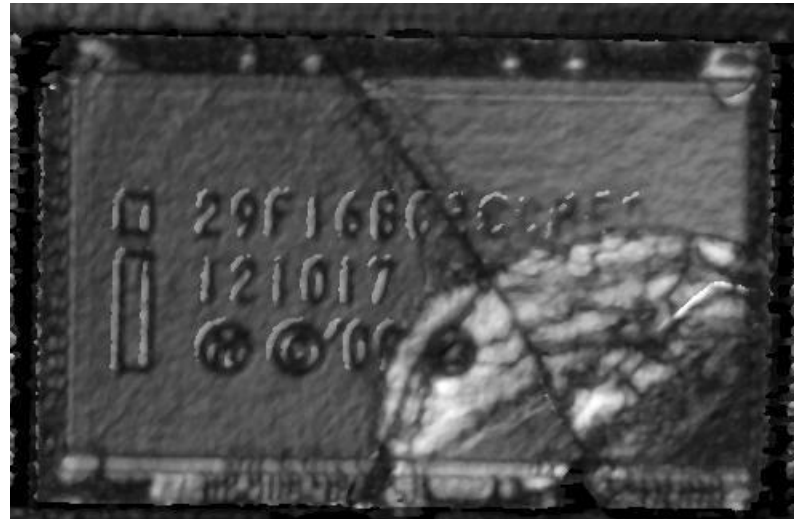
Module U26 C-SAMs

Chip is cracked, and the corner of the chip is crushed from flexing

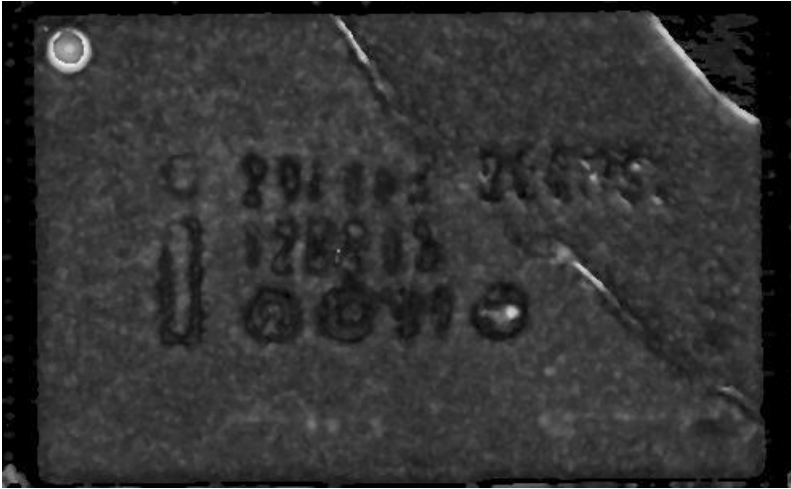
Module U27 C-SAMs

Given the flex of the module, the C-SAM anomalies are probably from cracks in the chip, not just a shadow of the cracks in the overmold

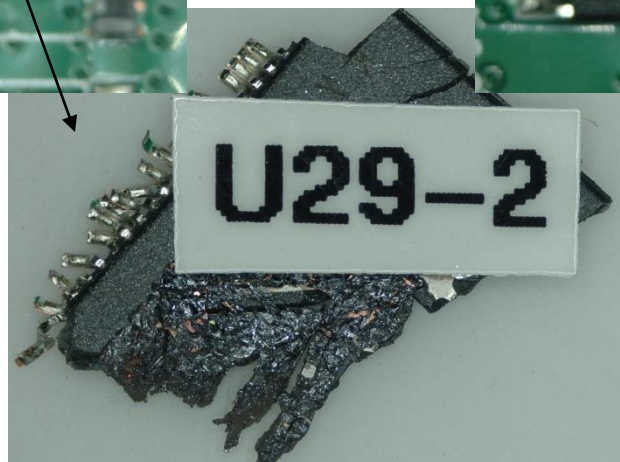
Module U29 / U33 Pair - Photos

U29 is broken into 2 parts
U33 is badly cracked, exposing
internal features

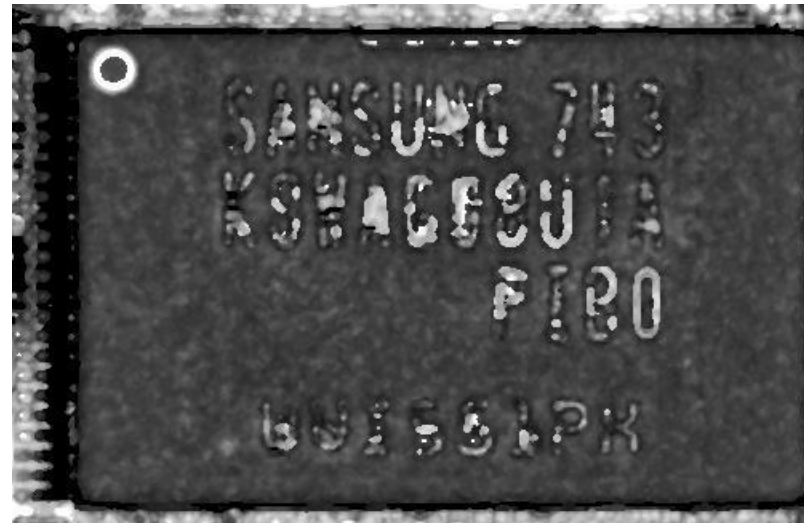
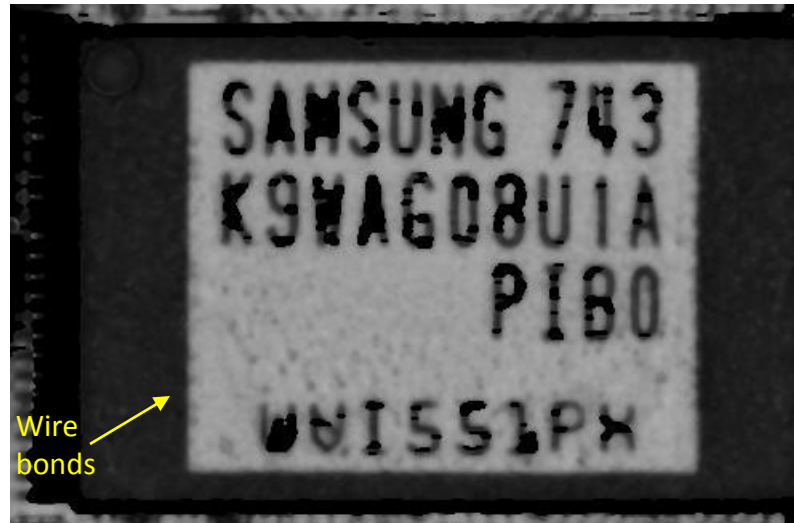
Module U3 C-SAMs

C-SAMs of deeper levels were taken, but gave no additional information

Overall, the top two chips appear to be intact (and very likely, the underlying ones as well)

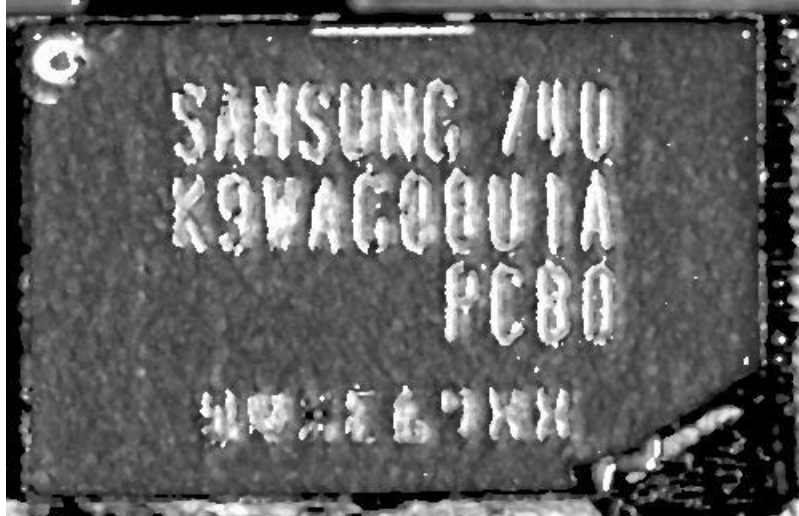
In overmold

The anomalies may be imaging artifacts, but it is more likely that they are cracks

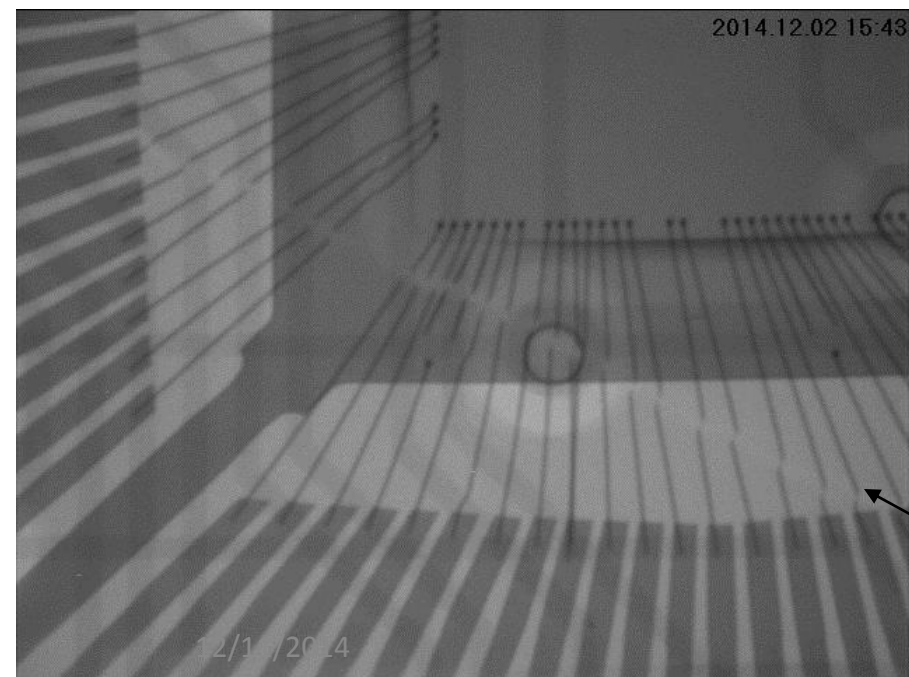
Broken wires found
