**Report of Preconstruction Condition
Survey Services**

**ADJACENT PROPERTIES TO
THE WHARF – PHASE I
WASHINGTON, DC**

ECS PROJECT NO. 37:1306

OCTOBER 6, 2014

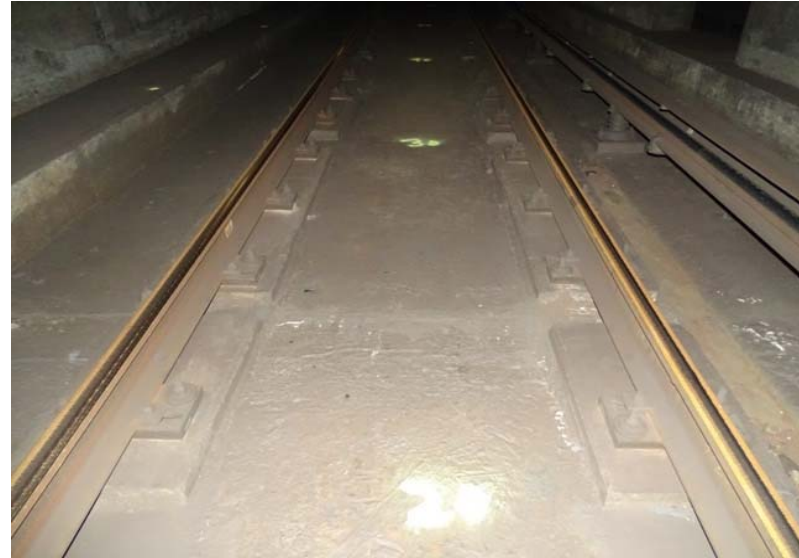
Photograph No. 89
Station 72+00 - cracks above west arch.

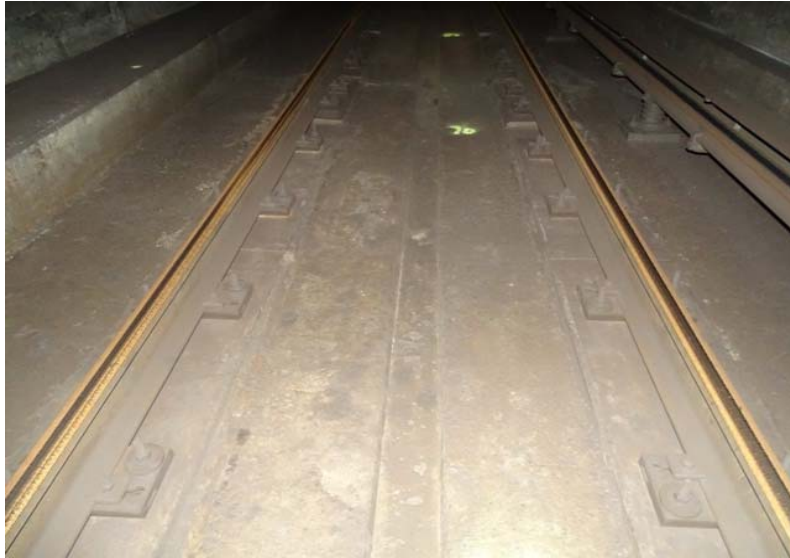
Photograph No. 108
Station 72+40 - cracks above west arch.

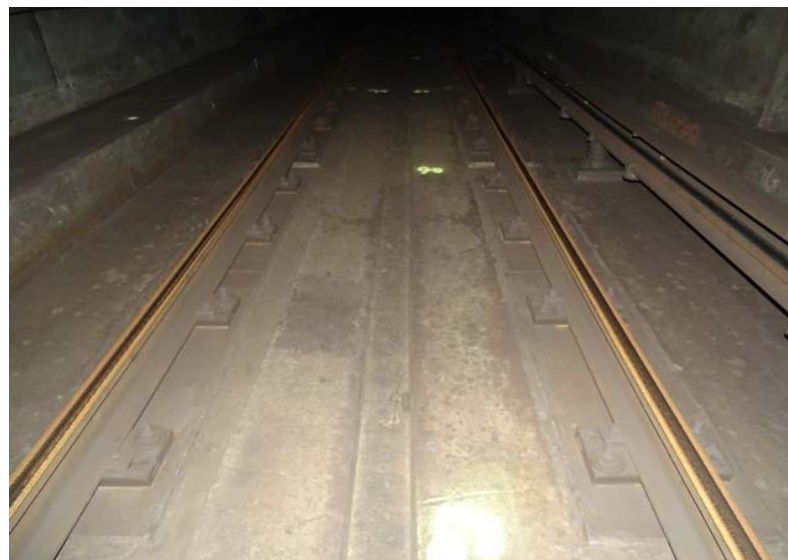
Photograph No. 119
Station 72+60 - crack on the west wall.

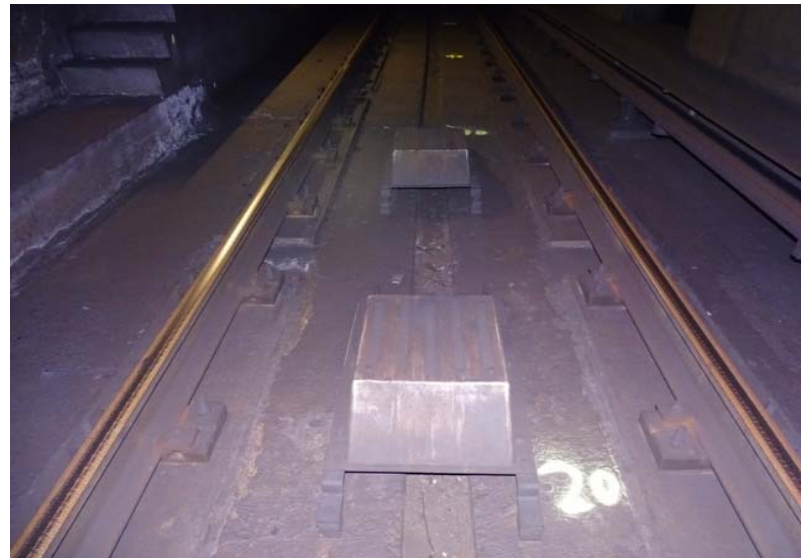
Photograph No. 172
Station 74+20, track bed.

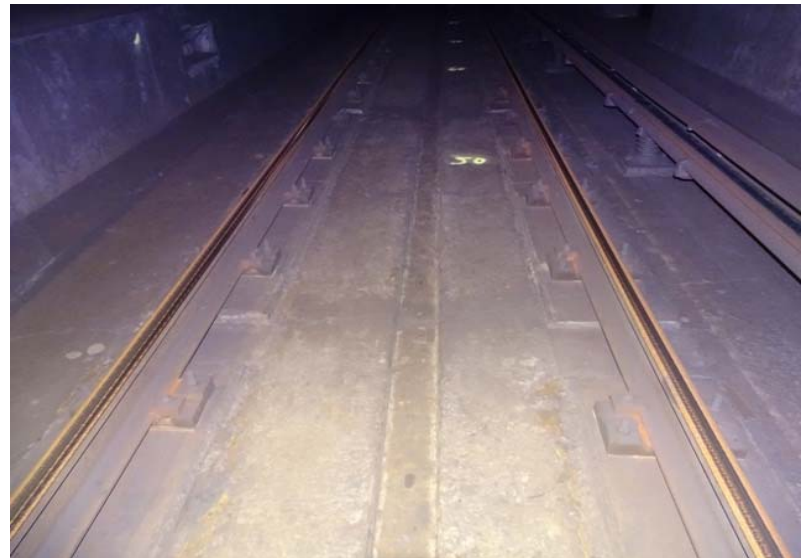
Photograph No. 180
Station 74+40, track bed.

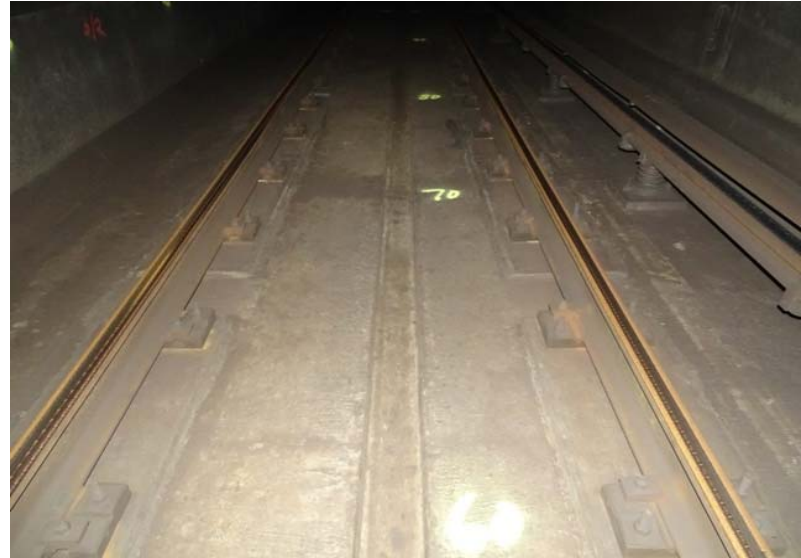
Photograph No. 190
Station 74+60, track bed.

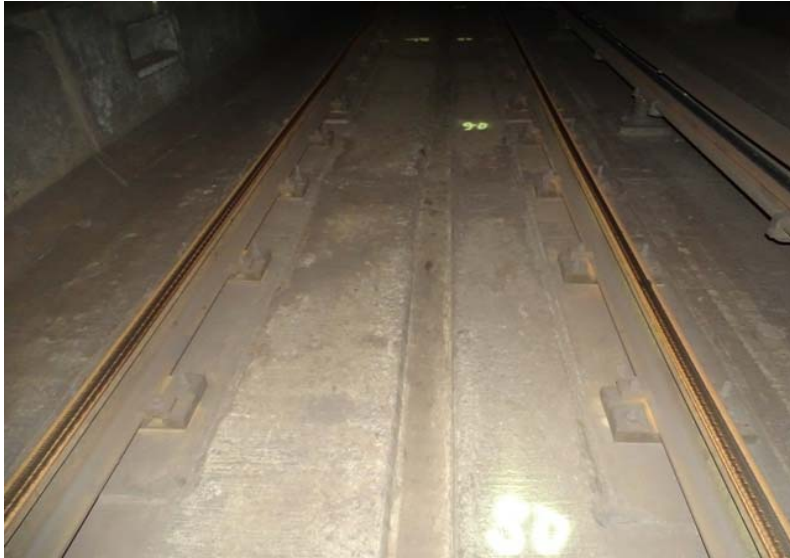
Photograph No. 197
Station 74+80, track bed.

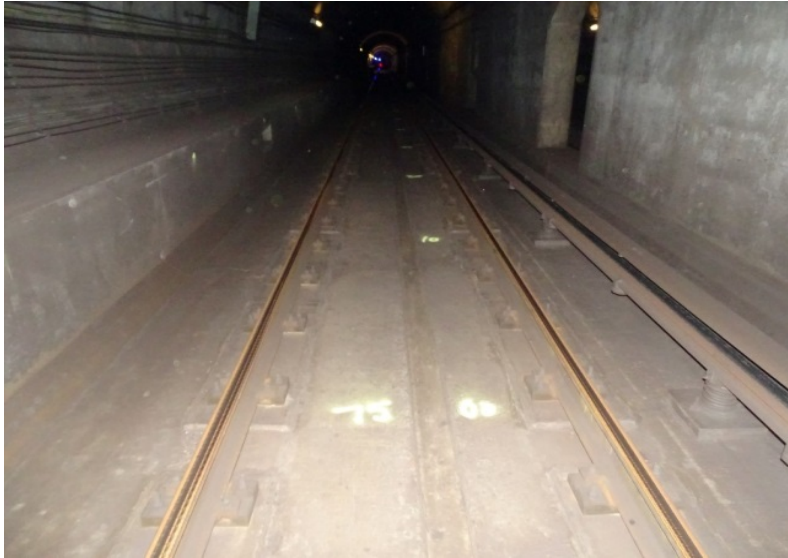
Photograph No. 205
Station 75+00, track bed.

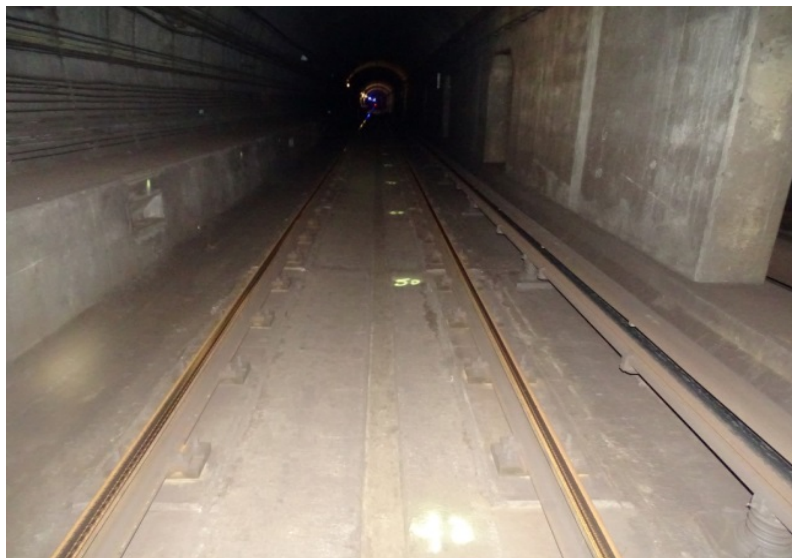
Photograph No. 220
Station 75+30 - crack in ceiling.

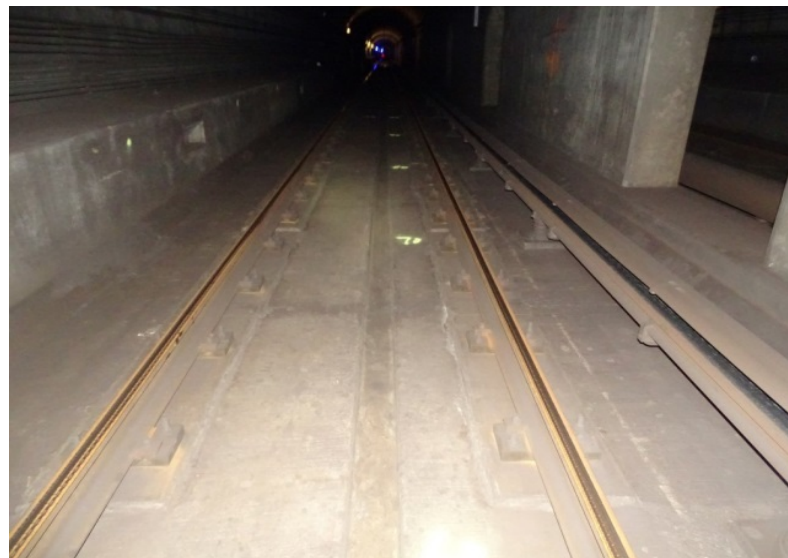
Photograph No. 229
Station 75+55 - transverse crack in ceiling.

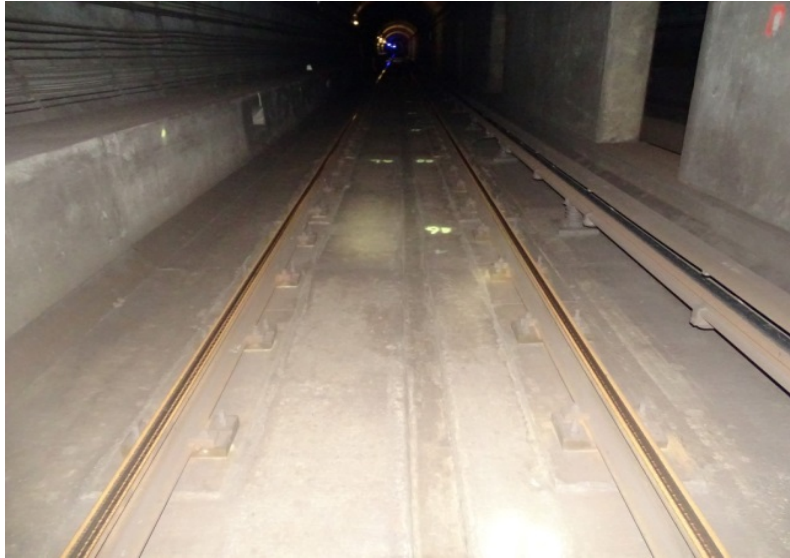
Photograph No. 236
Station 75+66 - vertical crack above west arch.

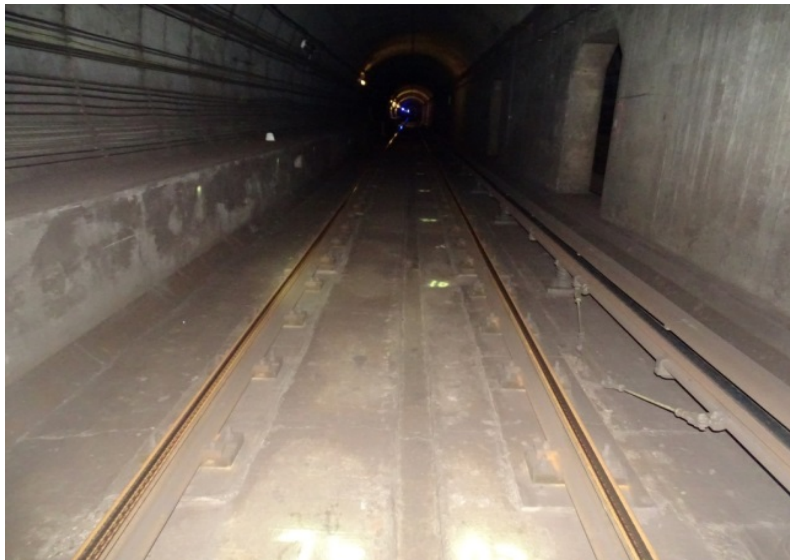
Photograph No. 246
Station 75+95 - vertical crack above west arch.

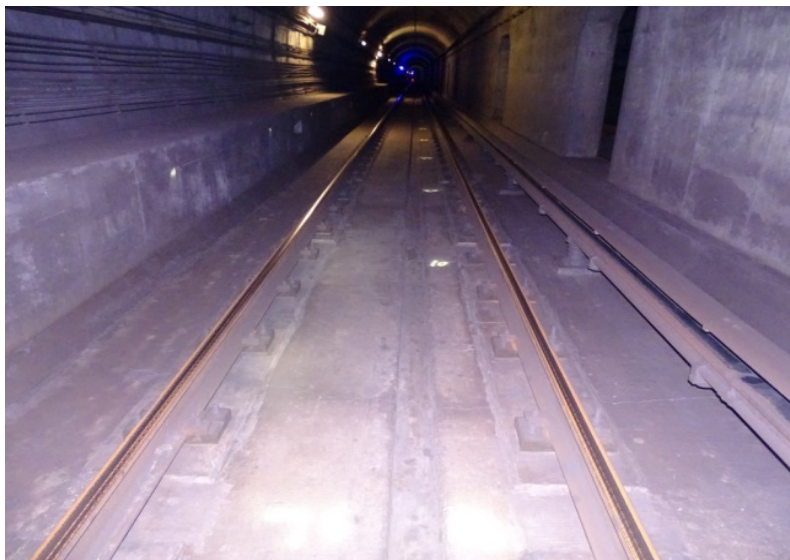
Photograph No. 335
Station 78+00, track bed.

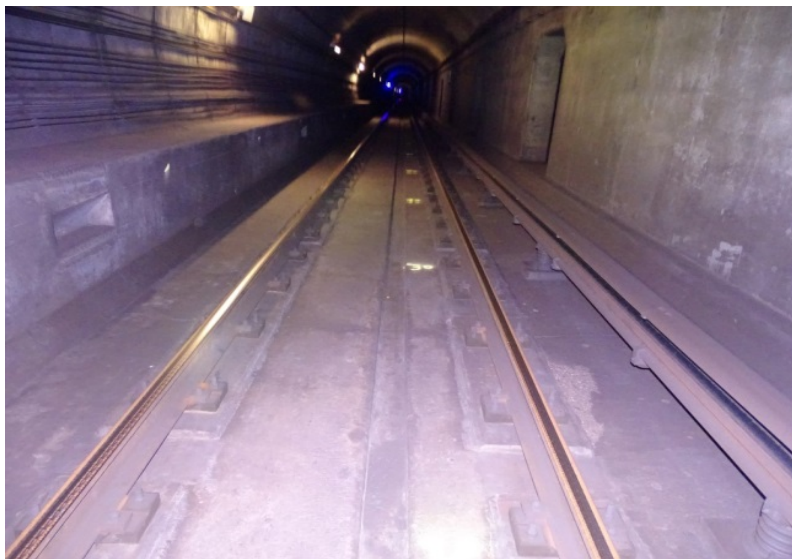
Photograph No. 341
Station 78+20, track bed.

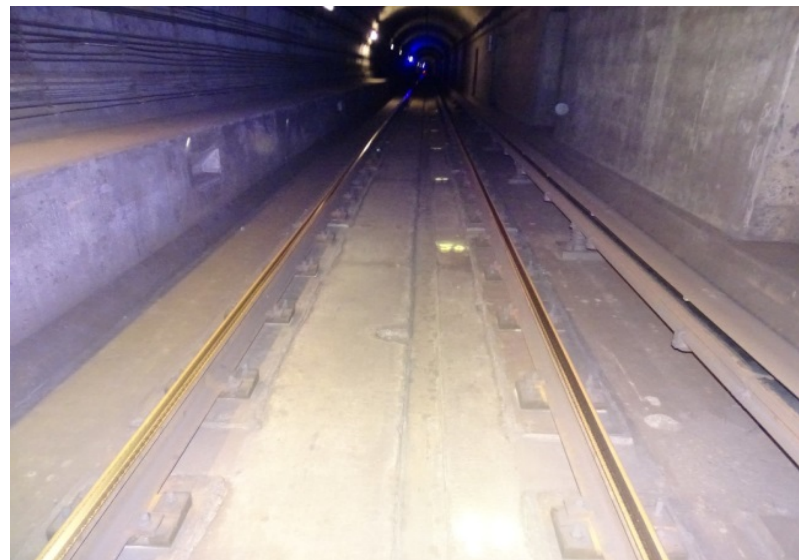
Photograph No. 348
Station 78+40, track bed.

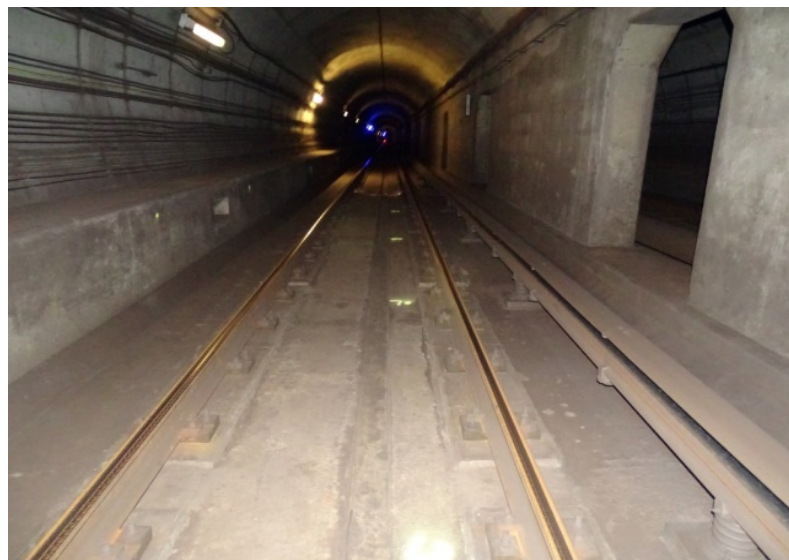
Photograph No. 356
Station 78+60, track bed.

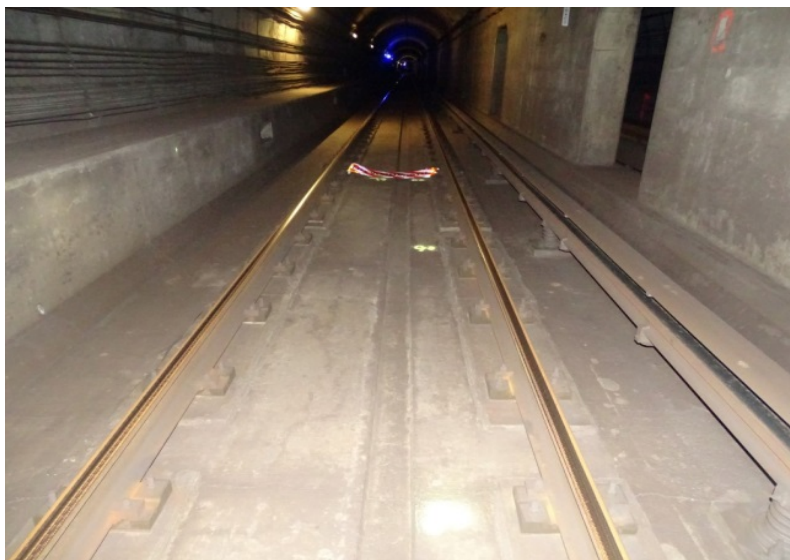
Photograph No. 363
Station 78+80, track bed.

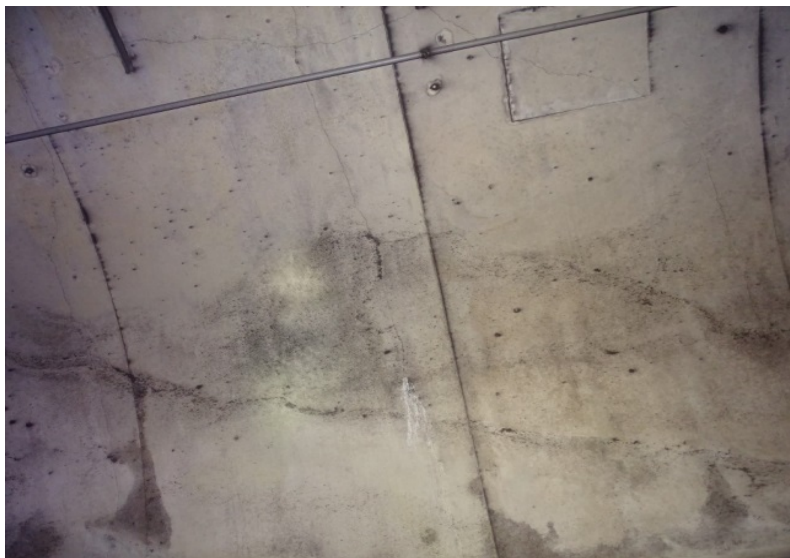
Photograph No. 369

Station 78+85 - crack in ceiling and efflorescence.

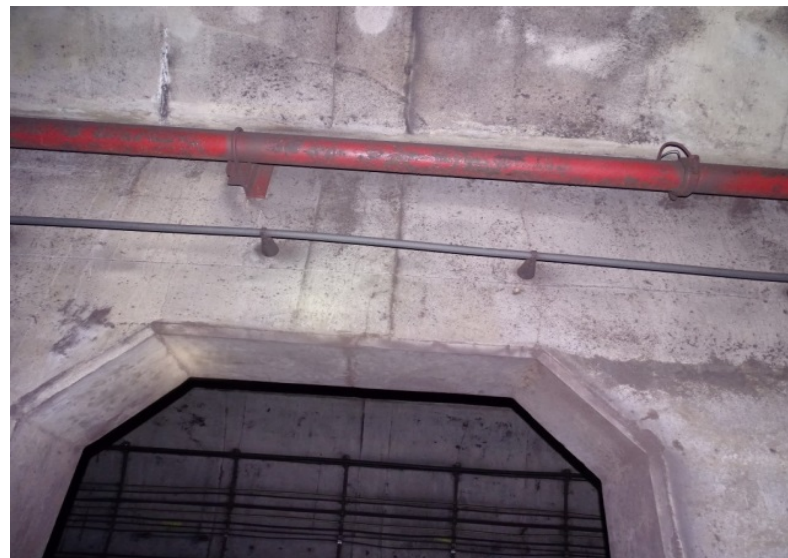
Photograph No. 370

Station 78+95 - vertical crack above west arch.

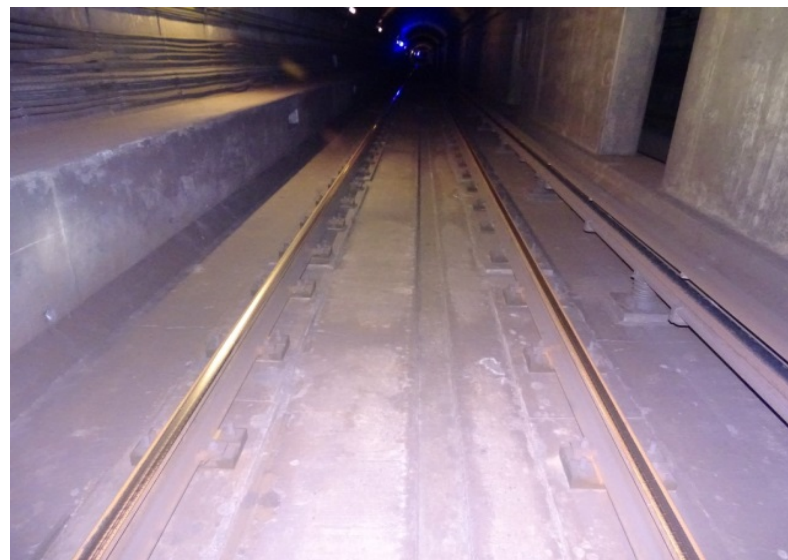
Photograph No. 372

Station 79+00, track bed.

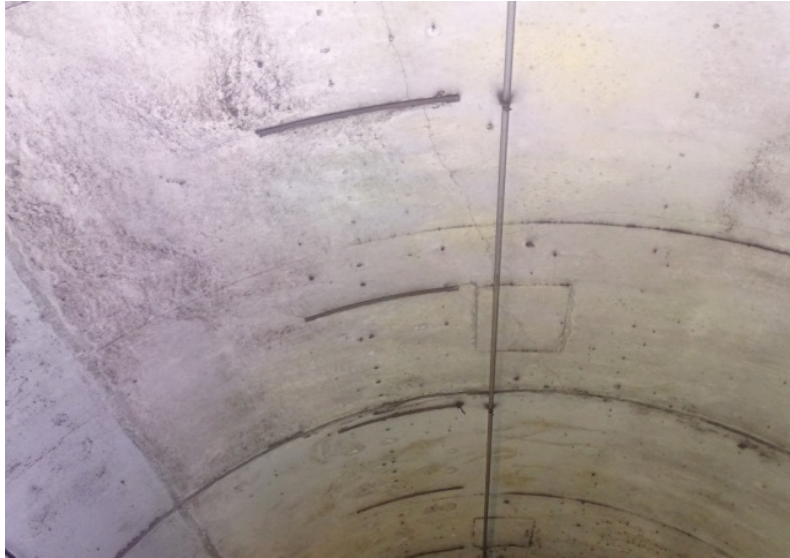
Photograph No. 376
Station 79+04 - vertical crack in east wall.

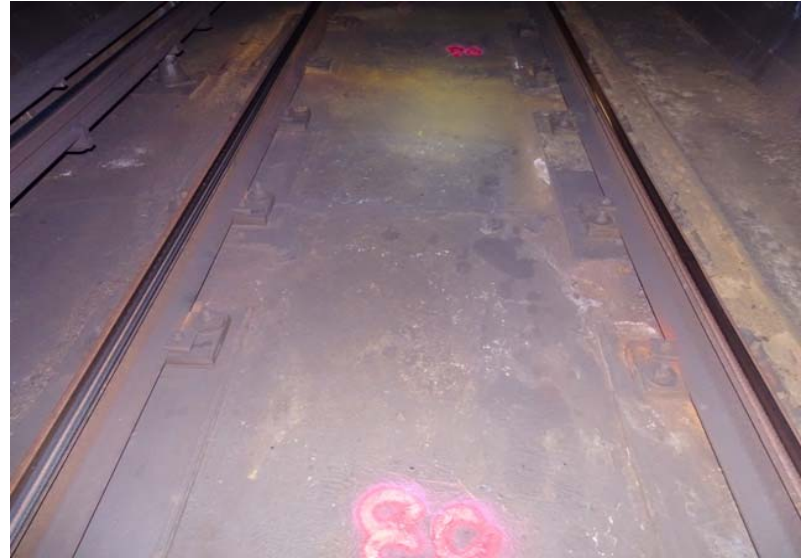
Photograph No. 6
Station 69+80, track bed.

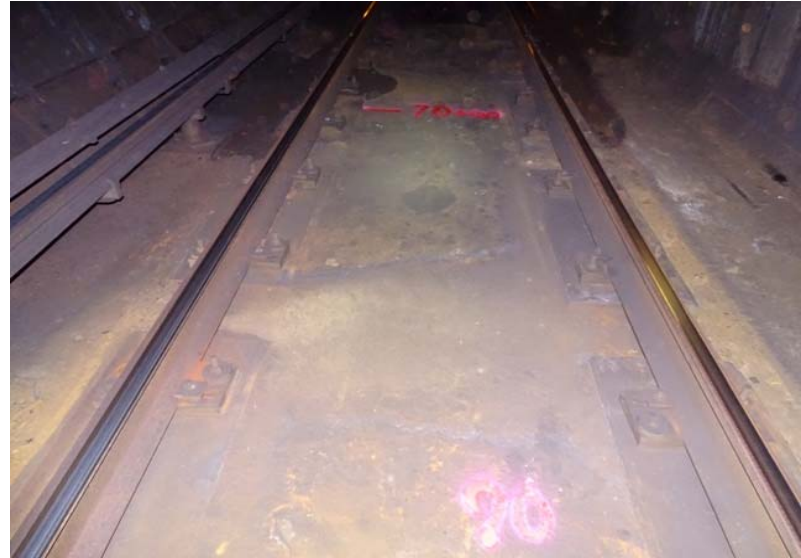
Photograph No. 10
Station 69+90, track bed.

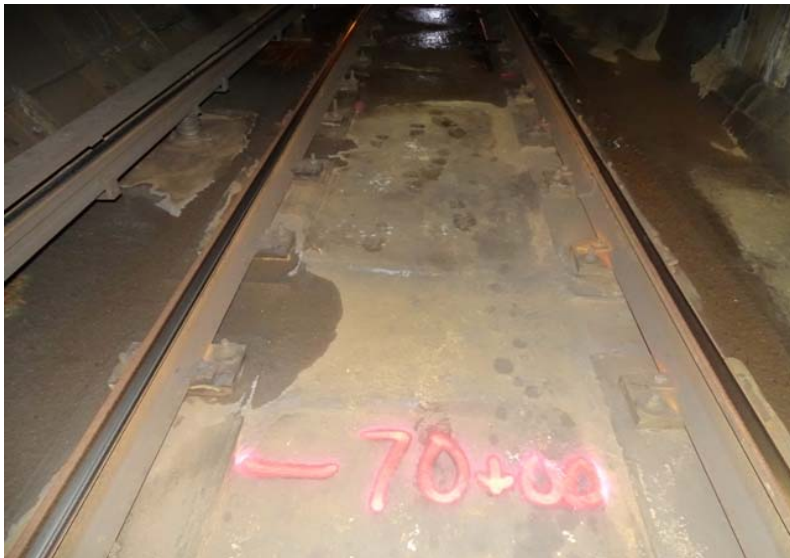
Photograph No. 15
Station 70+00, track bed.

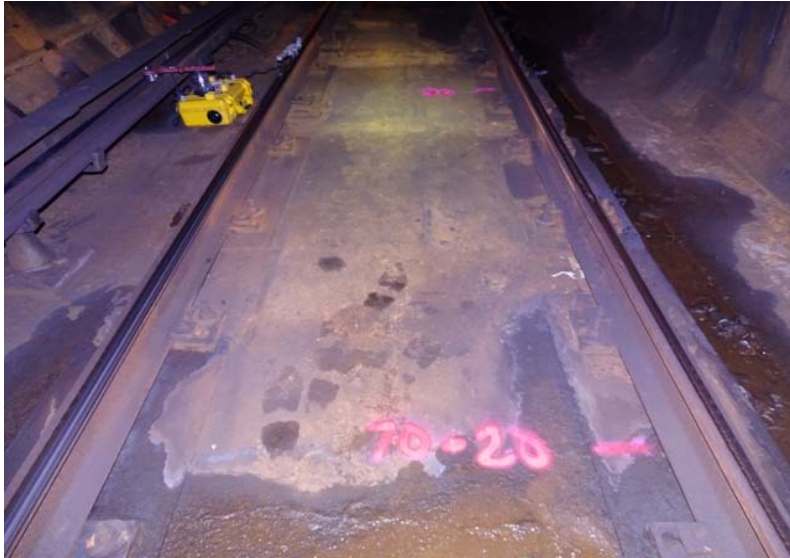
Photograph No. 25
Station 70+20, track bed.

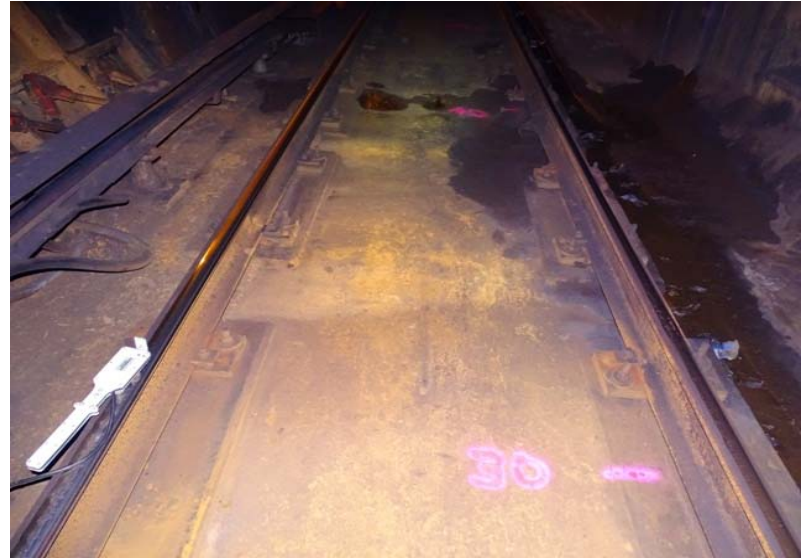
Photograph No. 30
Station 70+30, track bed.

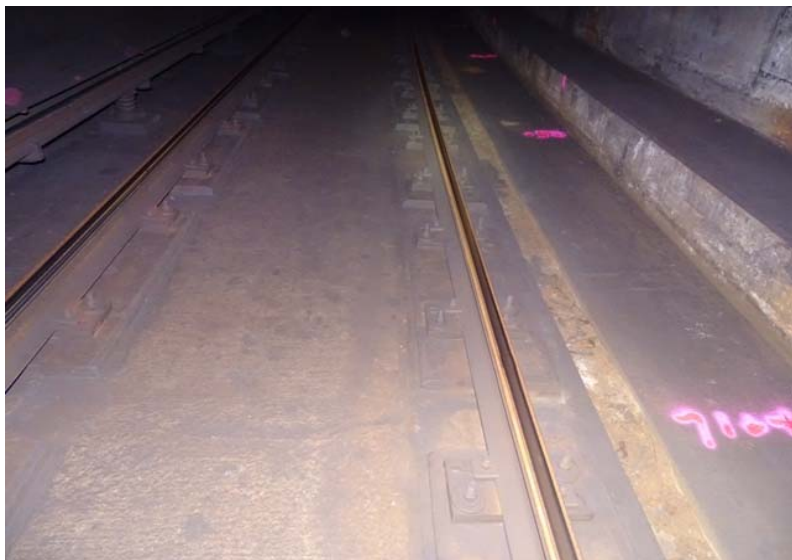
Photograph No. 99
Station 71+40, track bed.

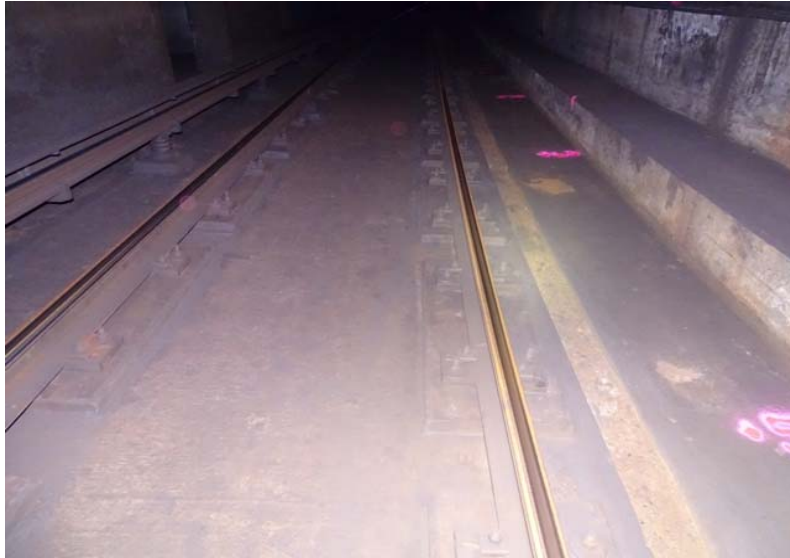
Photograph No. 105
Station 71+50, track bed.

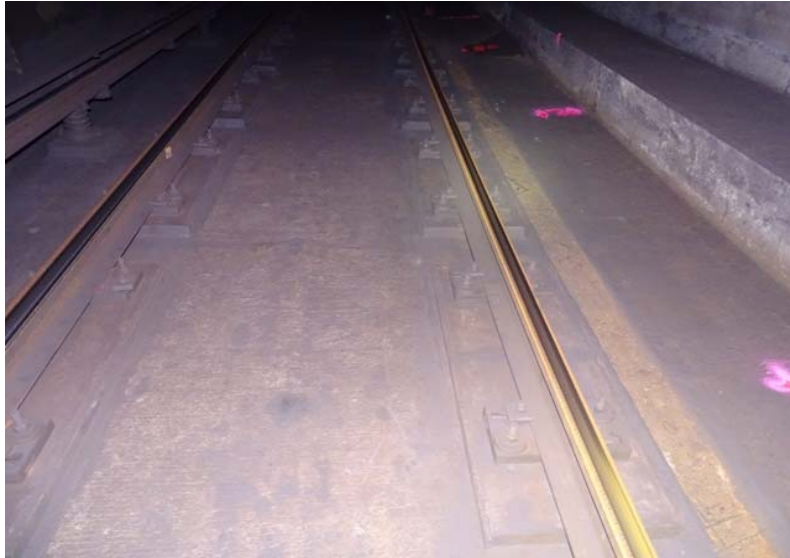
Photograph No. 113
Station 71+60, track bed.

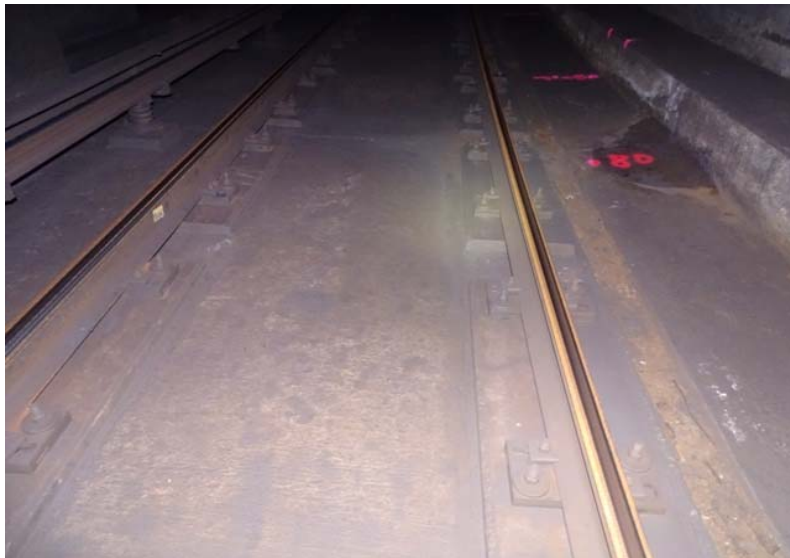
Photograph No. 119
Station 71+70, track bed.

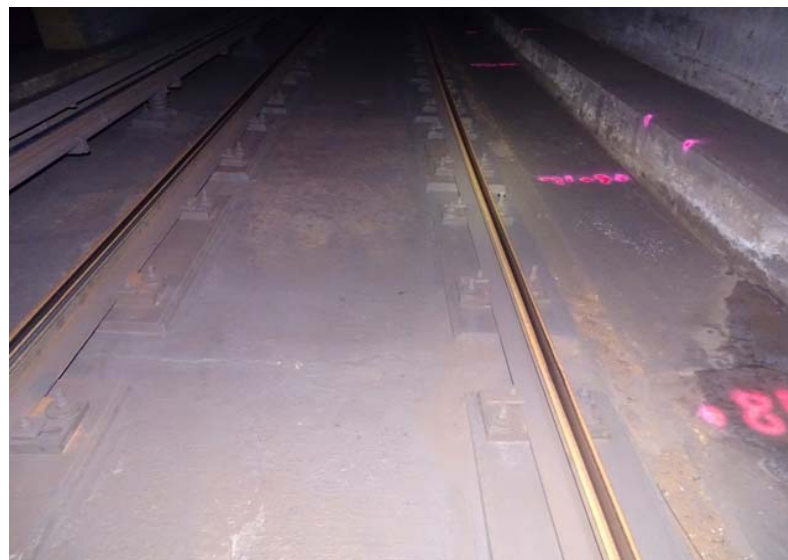
Photograph No. 123
Station 71+70, lower portion of west wall.

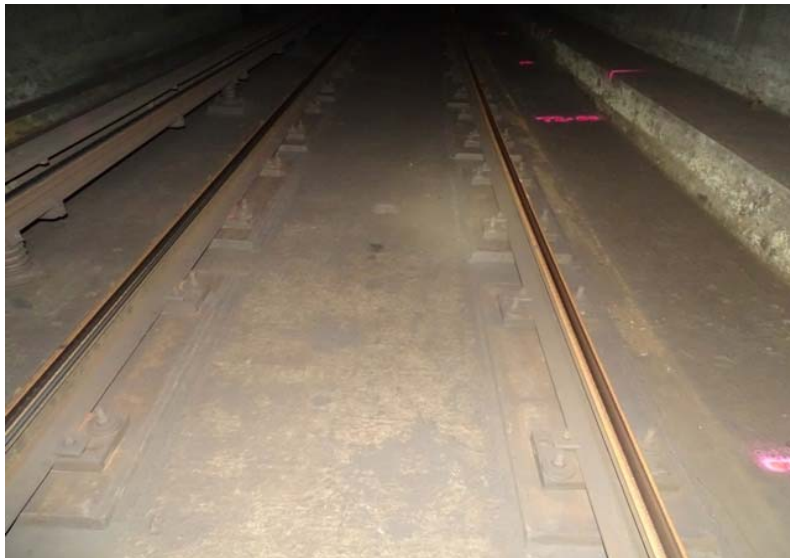
Photograph No. 130
Station 71+80, lower portion of west wall.

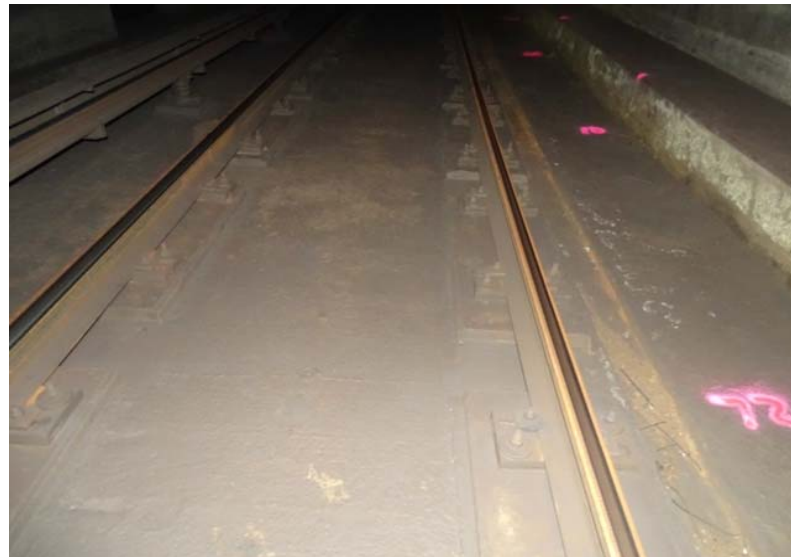
Photograph No. 137
Station 71+90, lower portion of west wall. Note the crack and efflorescence.

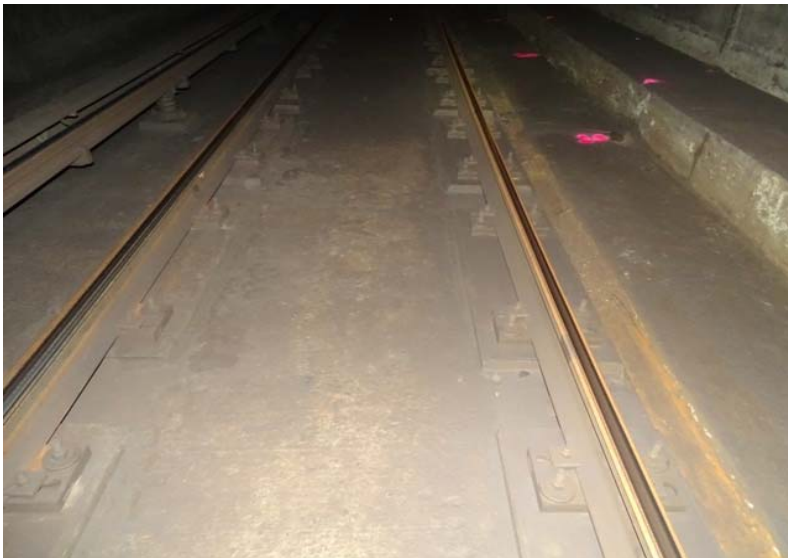
Photograph No. 146
Station 72+00 - crack and efflorescence on west wall.

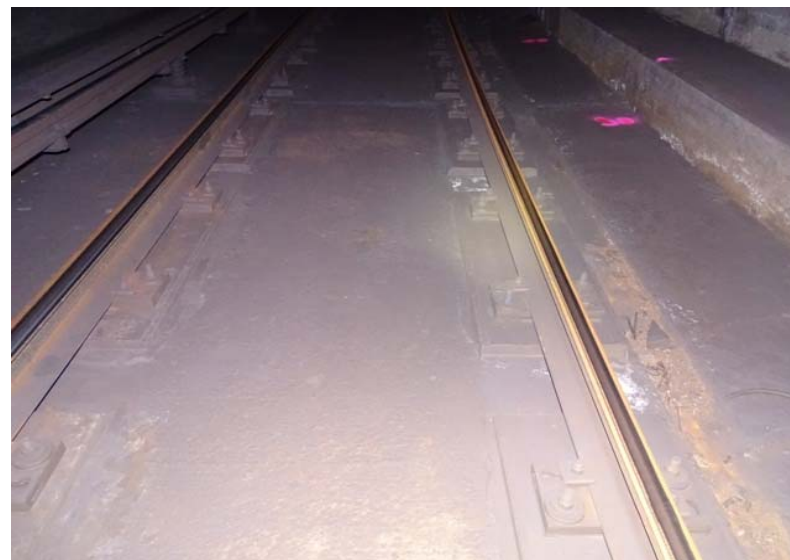
Photograph No. 155
Station 72+10 - crack and efflorescence on west wall.

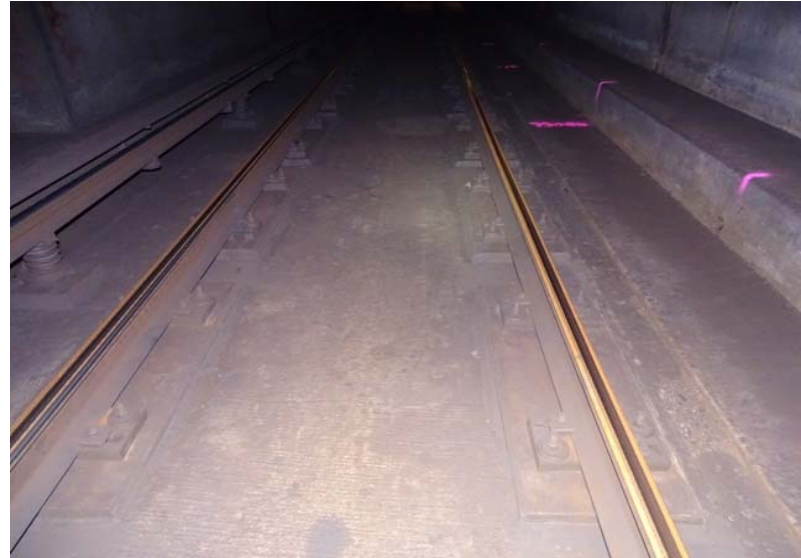
Photograph No. 202
Station 72+90, track bed.

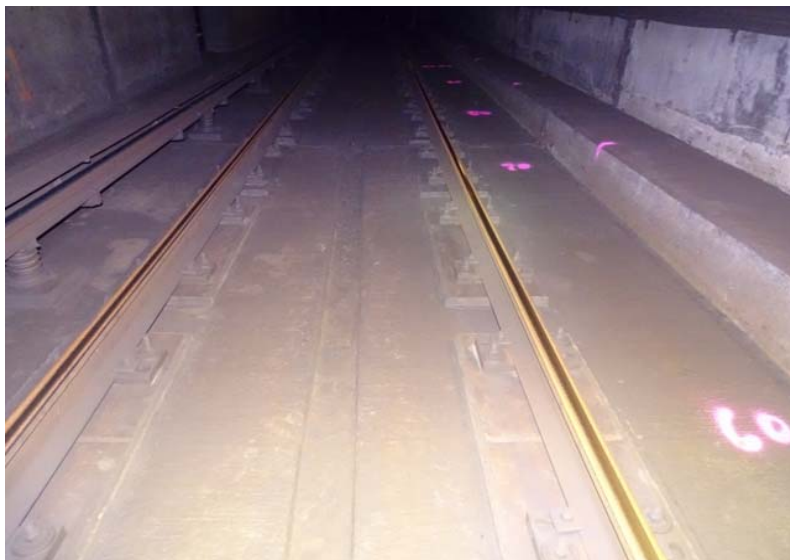
Photograph No. 250
Station 73+50 - efflorescence on west wall.

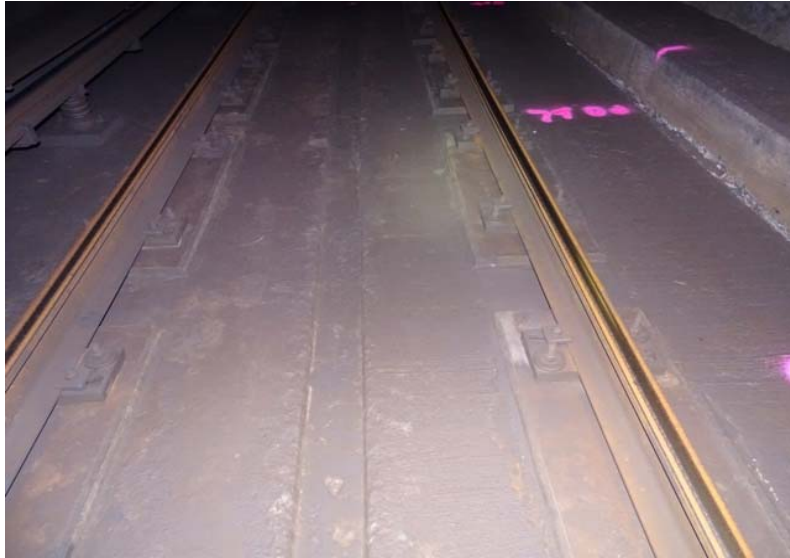
Photograph No. 268
Station 73+80 - efflorescence on the west wall.

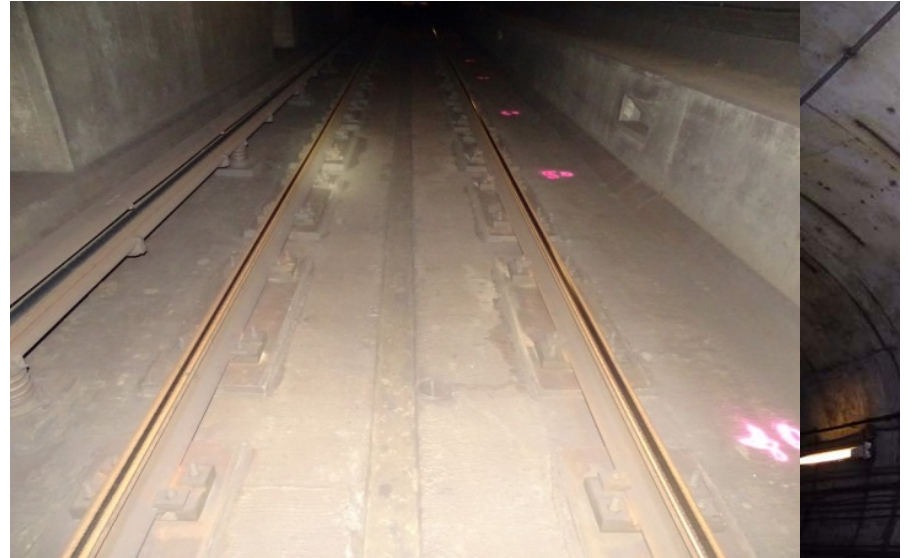
Photograph No. 377
Station 75+35 - vertical crack in east wall.

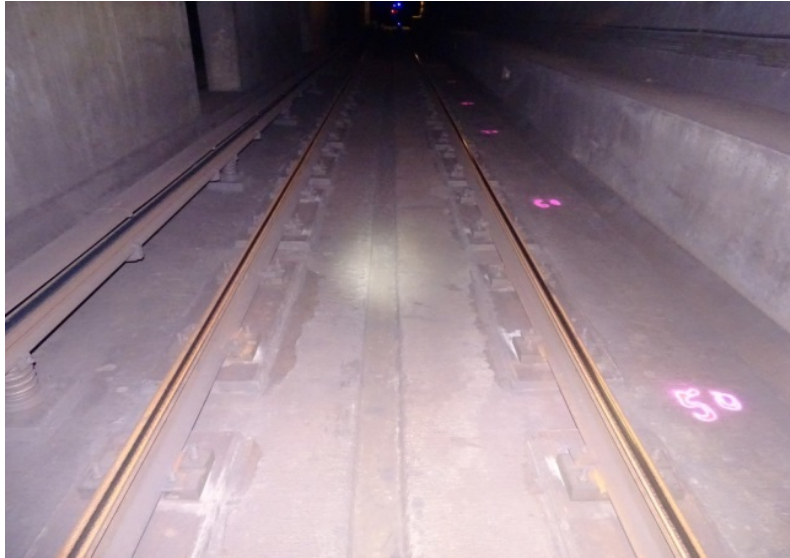
Photograph No. 384
Station 75+49 - crack in ceiling.

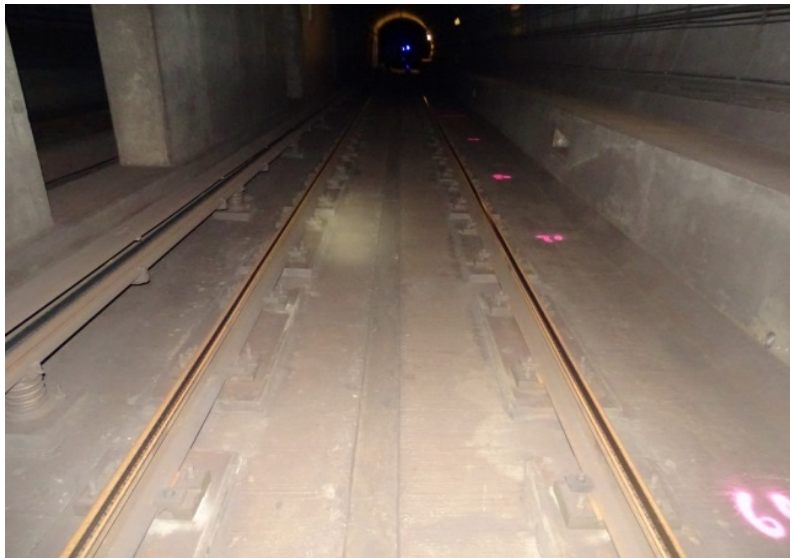
Photograph No. 390
Station 75+55 - crack in ceiling.

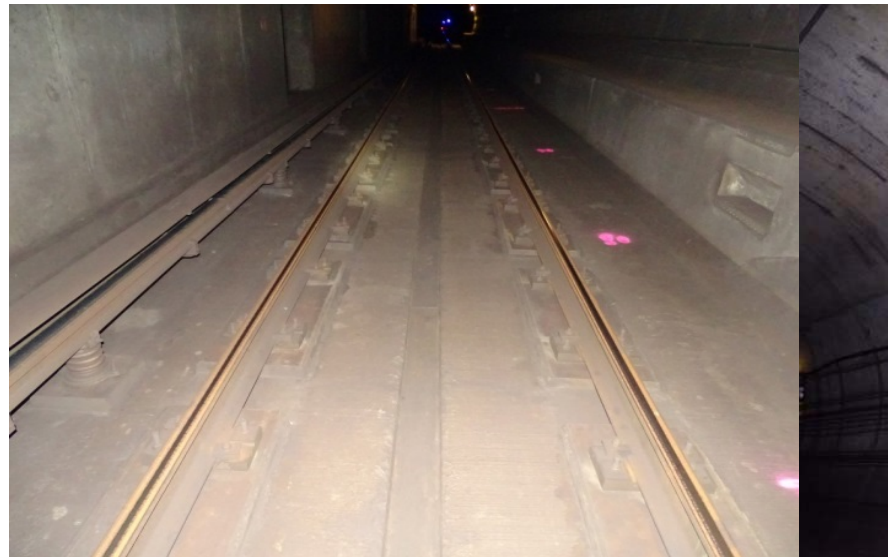
Photograph No. 397
Station 75+60 - crack in west portion of ceiling.

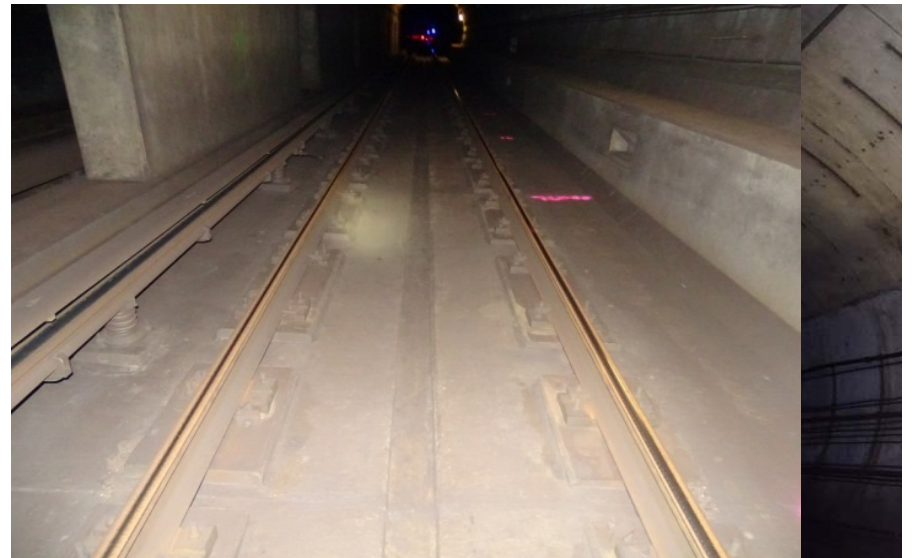
Photograph No. 411
Station 75+85 - cracks in ceiling.

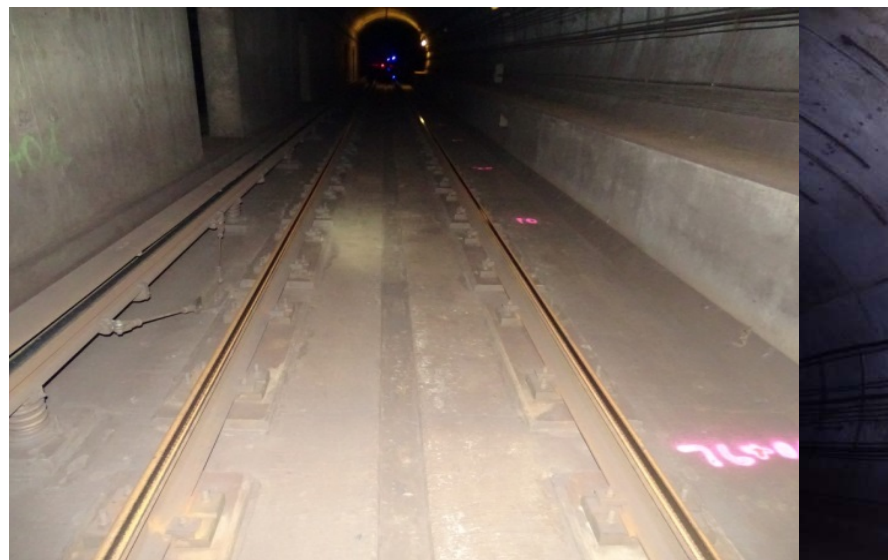
Photograph No. 419
Station 75+94 - crack in west portion of ceiling.

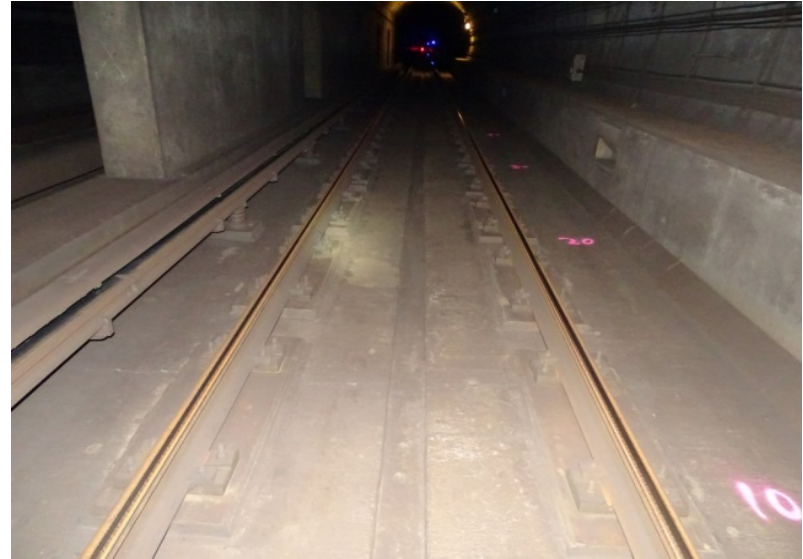
Photograph No. 429
Station 76+08 - crack in west safety walkway.

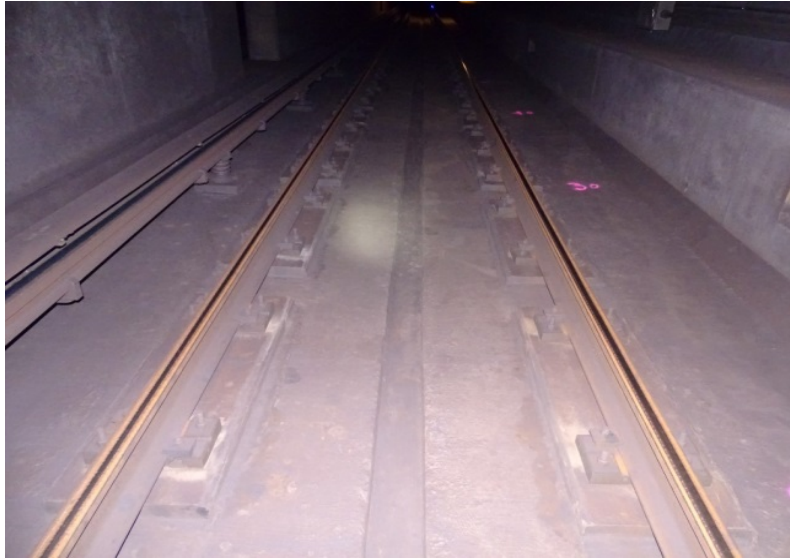
Photograph No. 436
Station 76+15 - three vertical cracks in east wall.

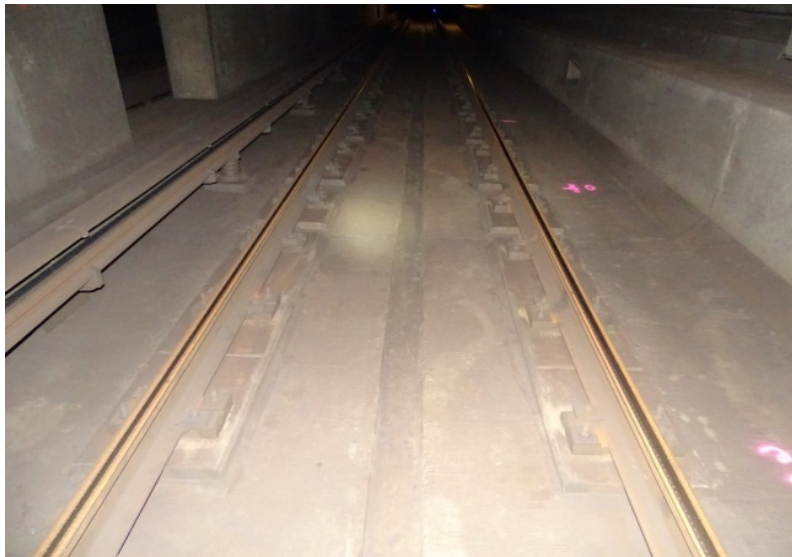
Photograph No. 444
Station 76+28 - crack in ceiling.

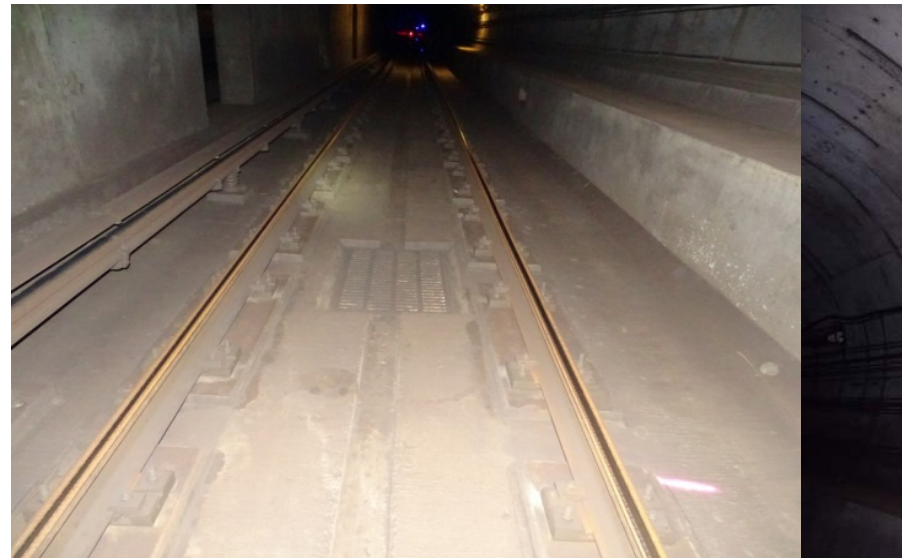
Photograph No. 455
Station 76+40 - vertical crack in east wall.

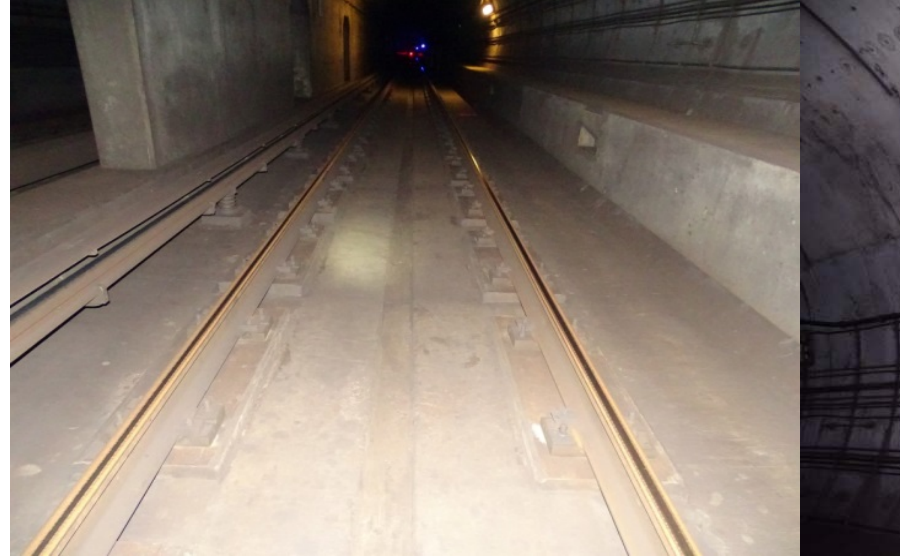
Photograph No. 461
Station 76+55 - longitudinal crack in ceiling.

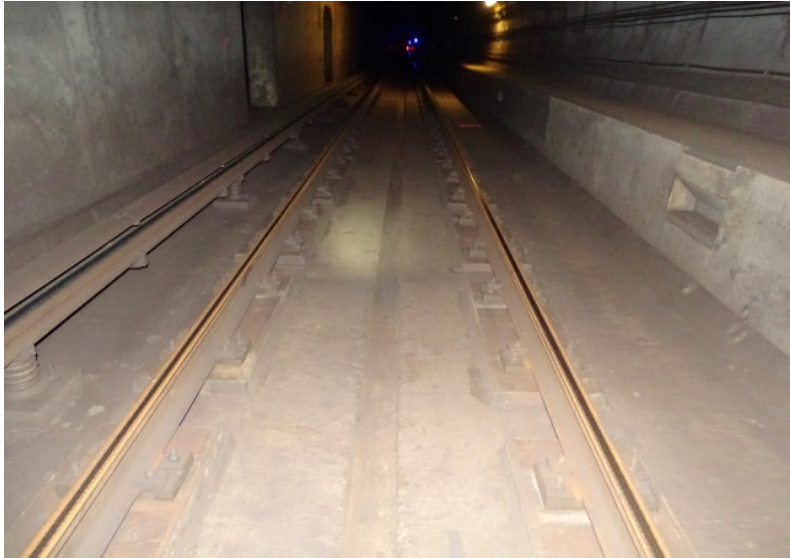
Photograph No. 468
Station 76+65 - crack in ceiling.
