**Report of Preconstruction Condition
Survey Services**

**ADJACENT PROPERTIES TO
THE WHARF – PHASE I
WASHINGTON, DC**

ECS PROJECT NO. 37:1306

OCTOBER 6, 2014

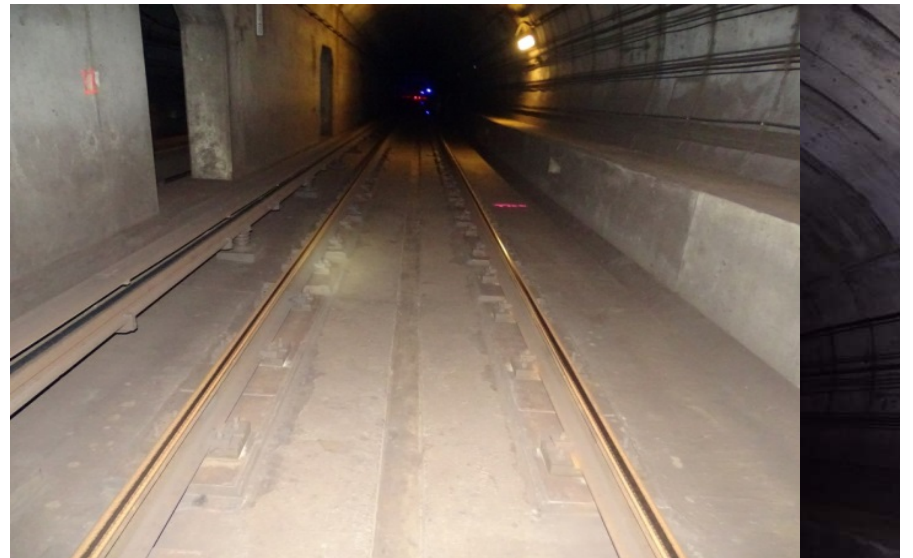
Photograph No. 475
Station 76+75 - vertical crack in upper portion of east wall.

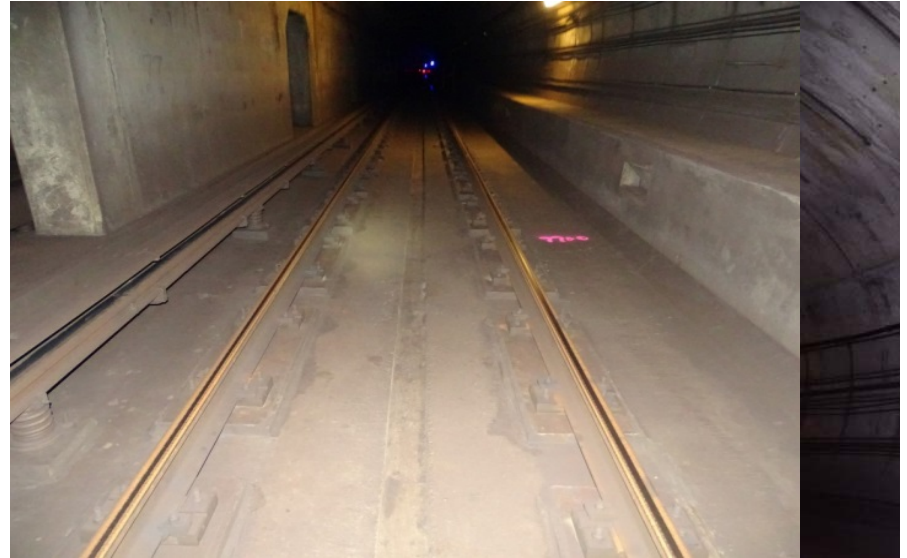
Photograph No. 481
Station 76+85 - vertical crack in upper portion of west wall.

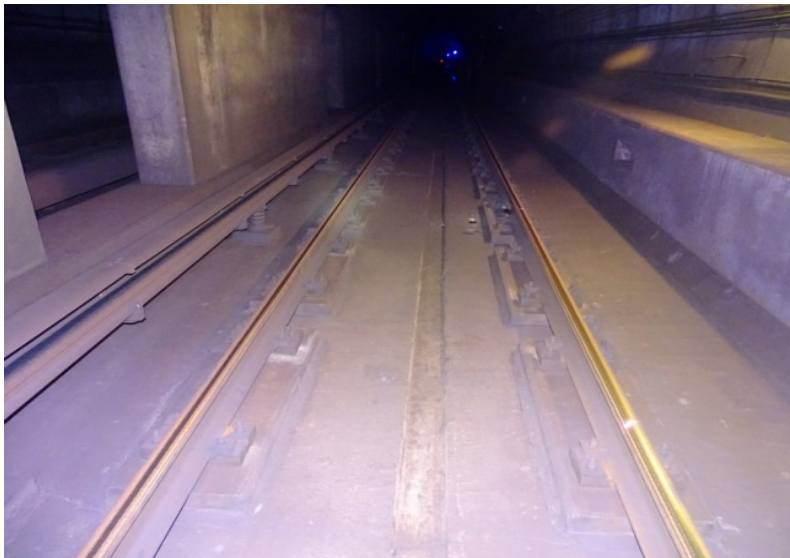
Photograph No. 494
Station 77+00 - diagonal crack in upper portion of east wall.

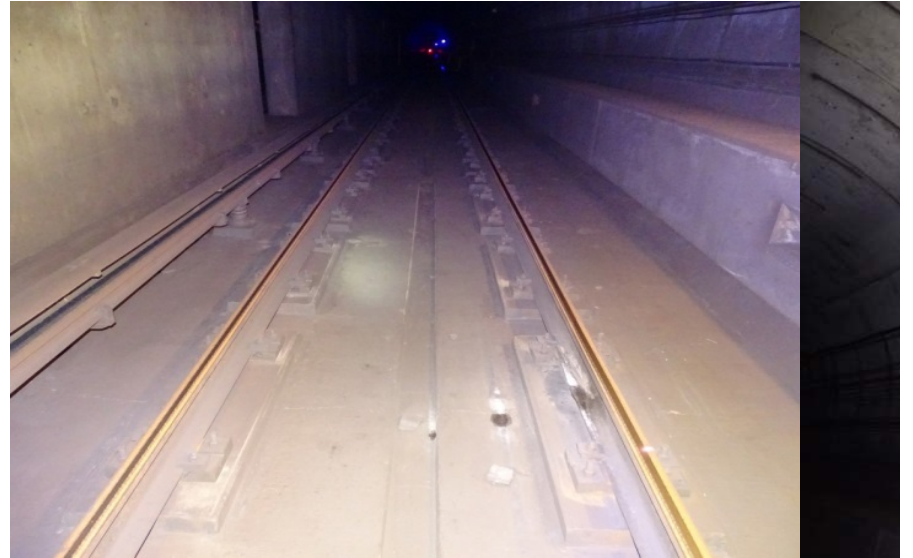
Photograph No. 501
Station 77+12 - crack in ceiling.

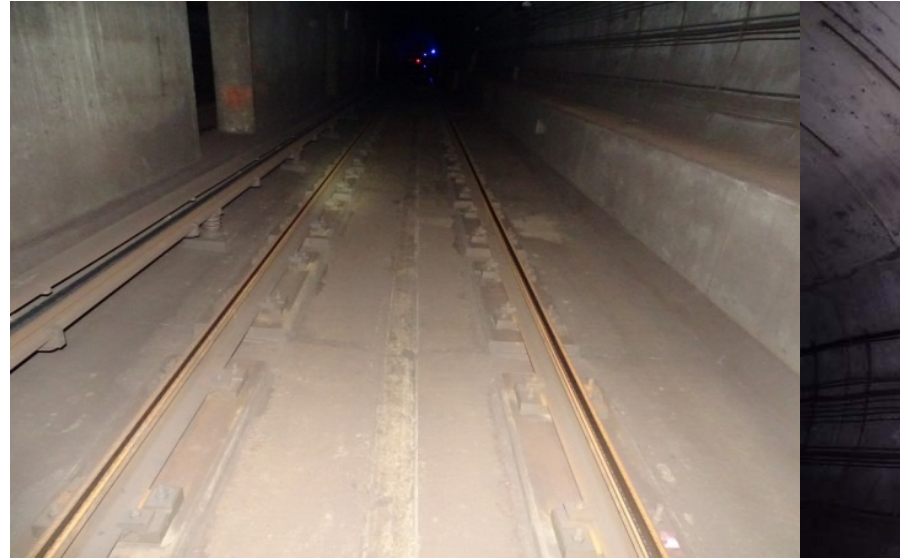
Photograph No. 517
Station 77+40 - vertical crack above east arch.

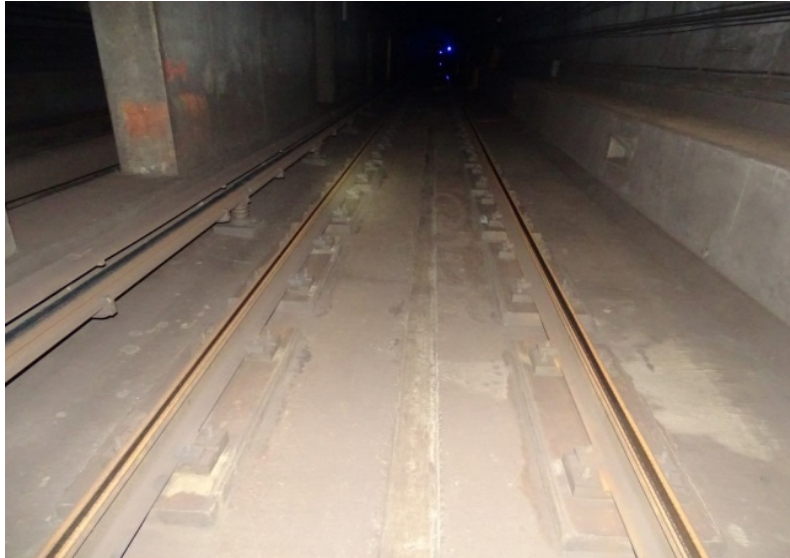
Photograph No. 524
Station 77+53 - crack in ceiling.

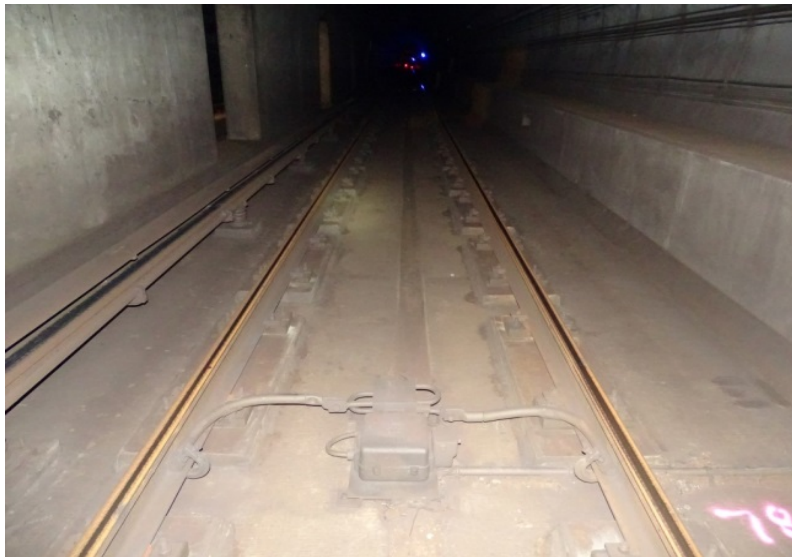
Photograph No. 544
Station 77+90 - transverse crack in ceiling.

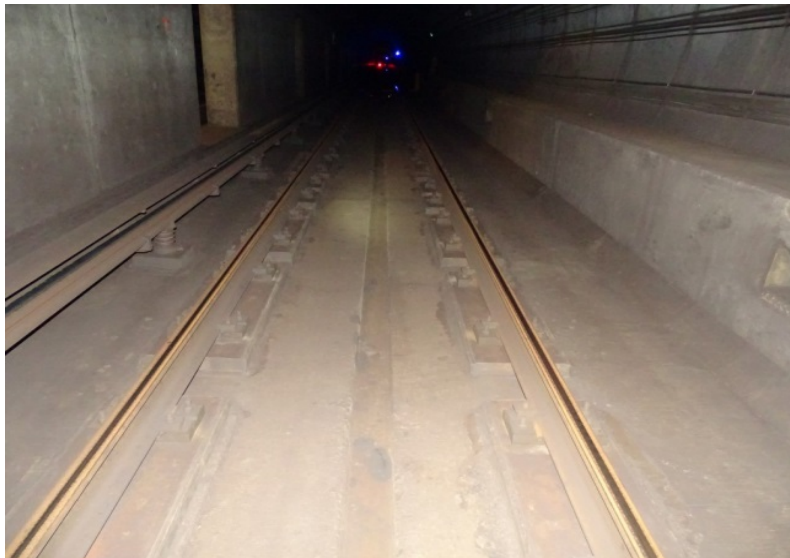
Photograph No. 550
Station 78+20 - vertical crack above east arch.

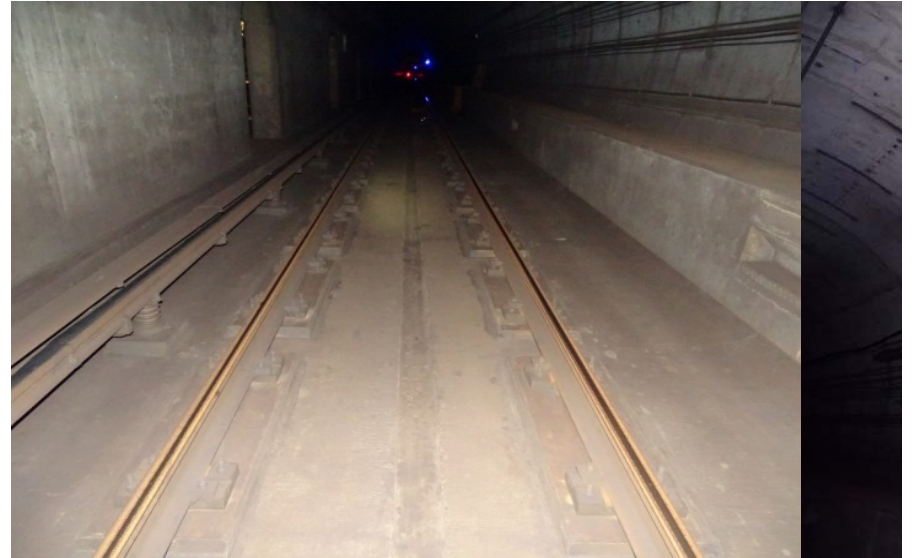
Photograph No. 557
Station 78+40 - vertical crack in east wall.

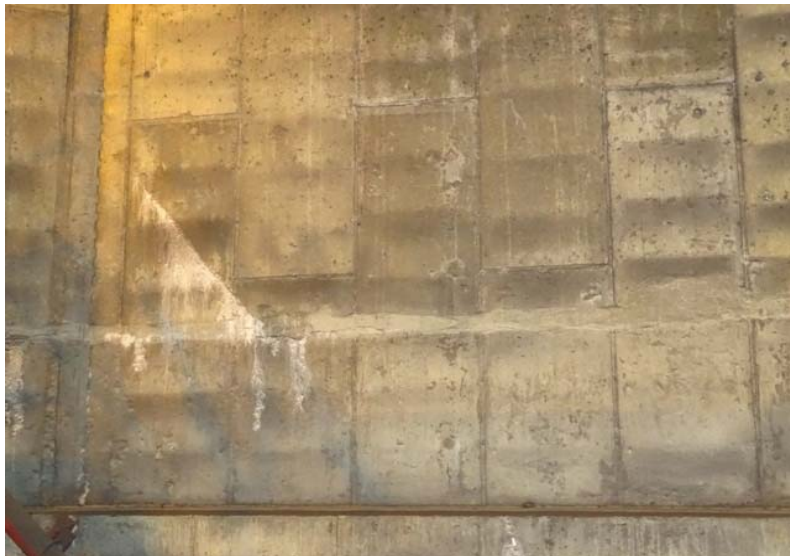
Photograph No. 85

Main room, upper portion, close up of crack and efflorescence.

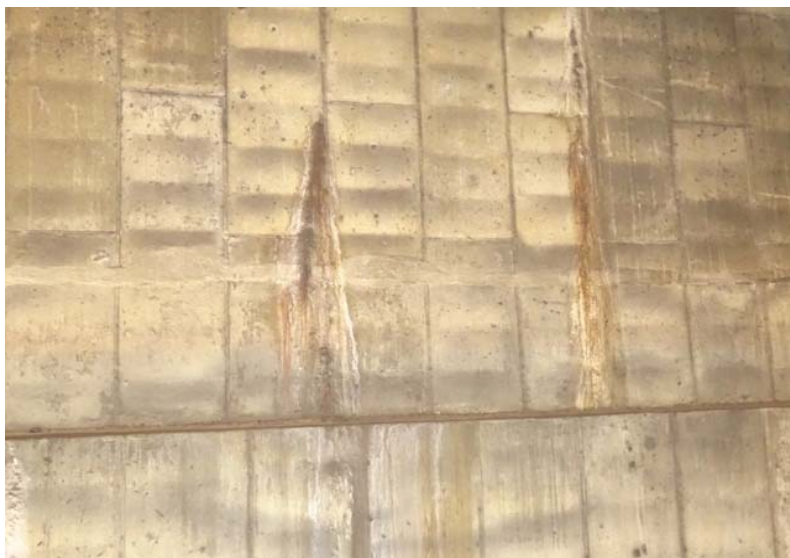
Photograph No. 87

Main room, upper portion, close up of stains and efflorescence.

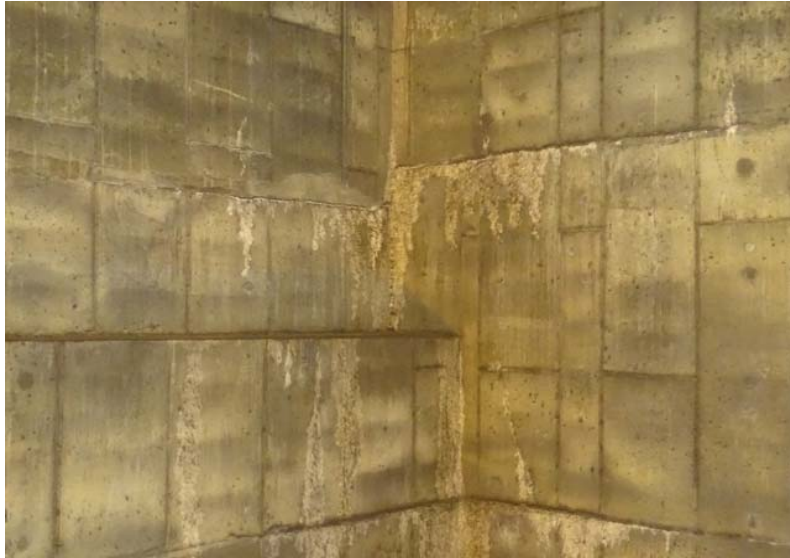
Photograph No. 89

Main room, upper portion, northeast corner, close up of efflorescence.

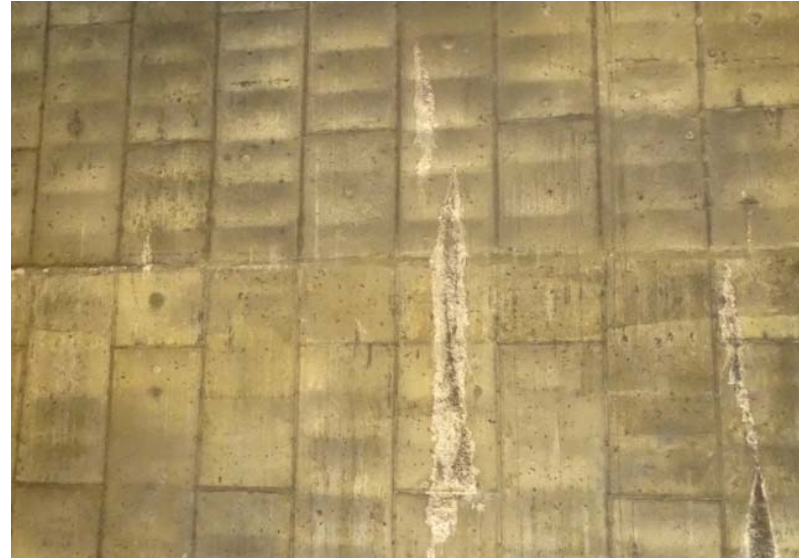
Photograph No. 90

Main room, upper portion, east wall, close up of efflorescence.

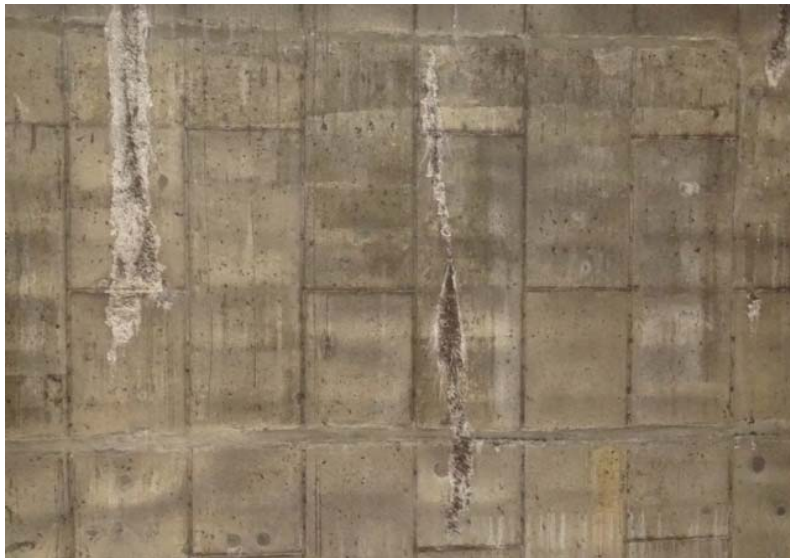
Photograph No. 91

Main room, upper portion, east wall, close up of stains and efflorescence.

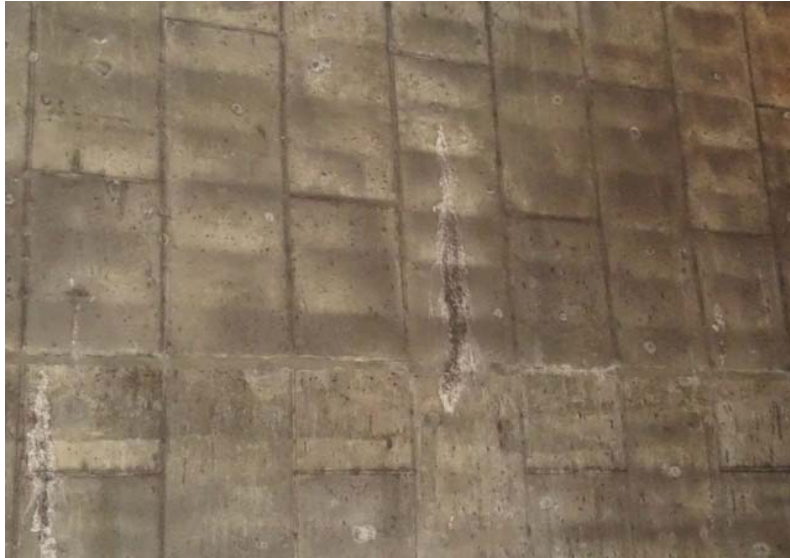
Photograph No. 93

Main room, upper portion, close up of stains and efflorescence.

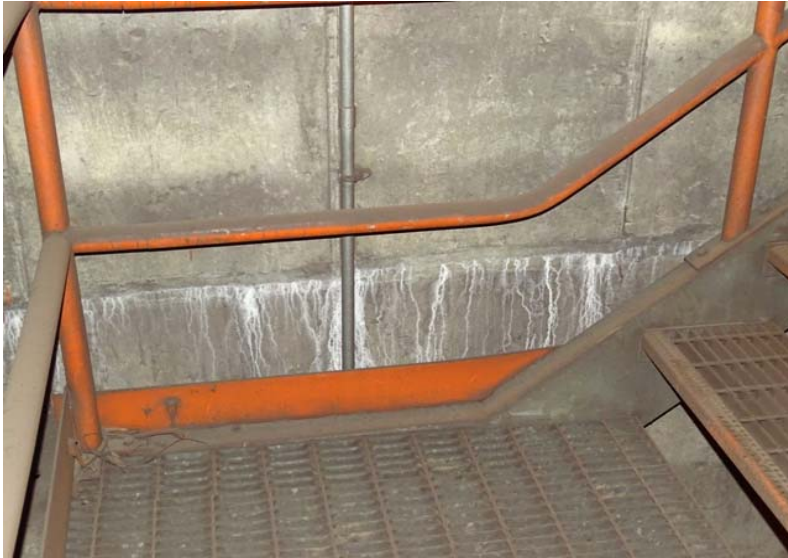
Photograph No. 101

Main room, upper portion, west wall at the stair, close up of efflorescence.

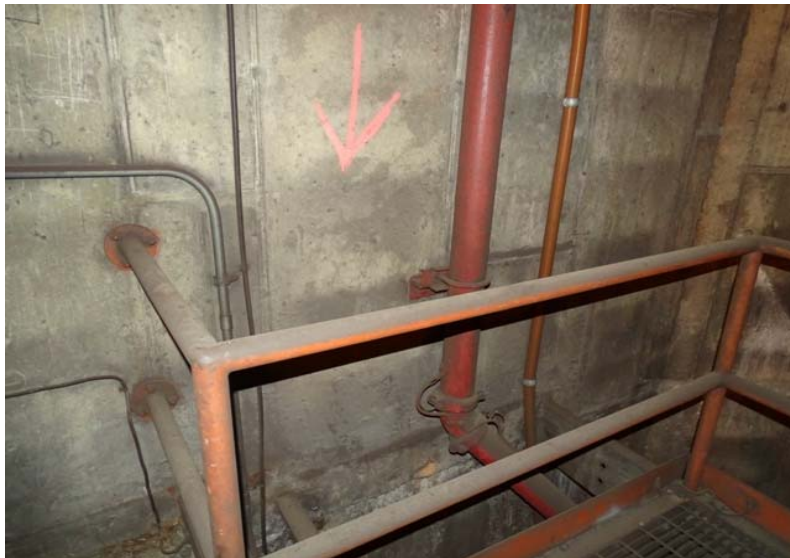
Photograph No. 114
Main room, upper level, north wall.

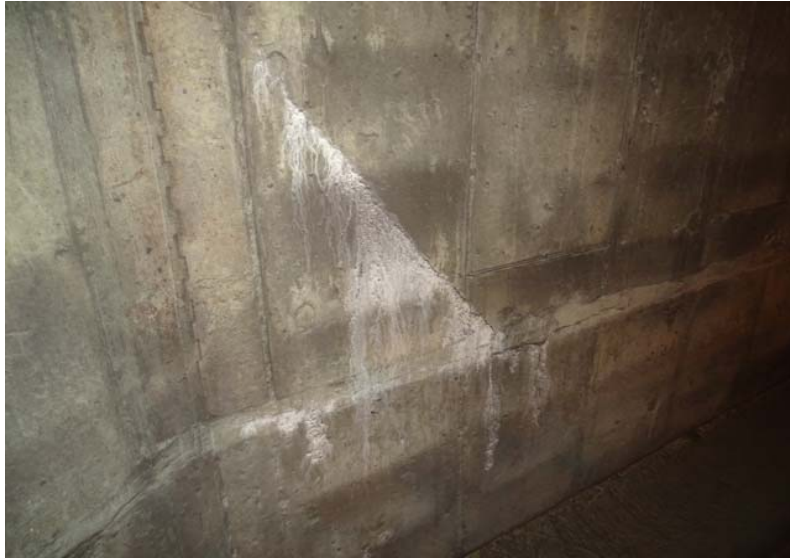
Photograph No. 116
Main room, upper level, north wall, looking down at crack and efflorescence.

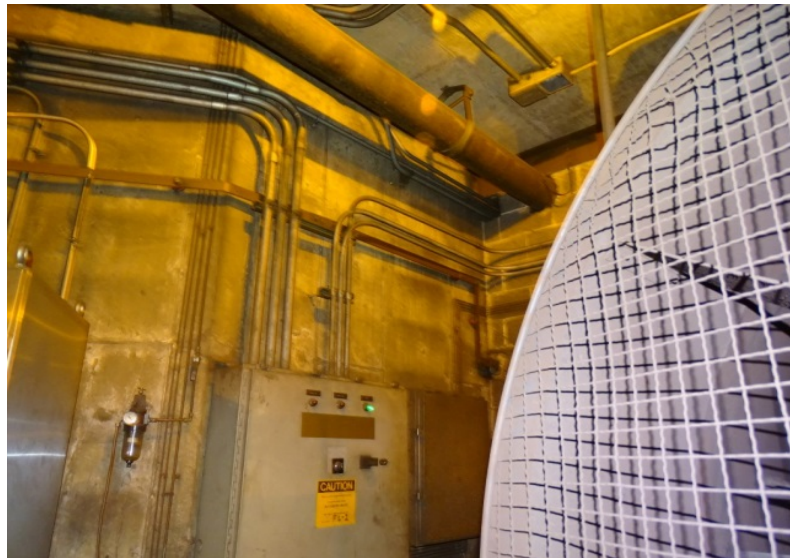
Photograph No. 118

Main room, upper level, south wall, east portion.

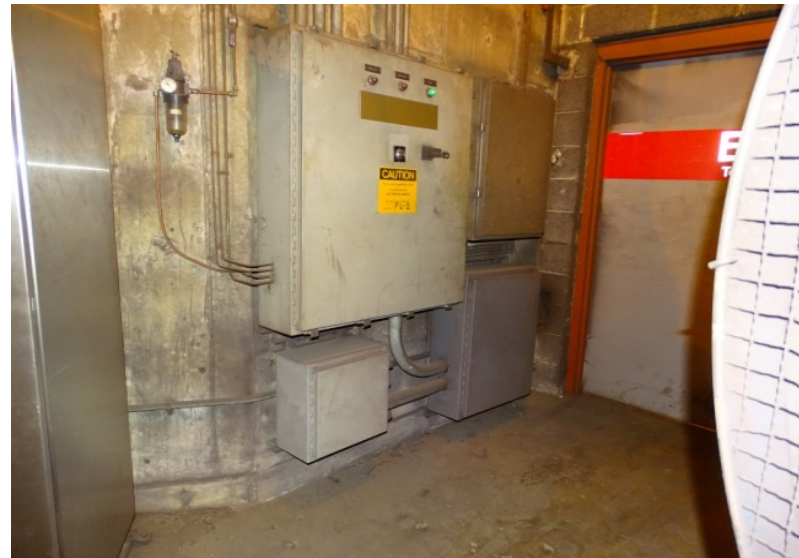
Photograph No. 119

Main room, upper level, south wall, upper west portion.

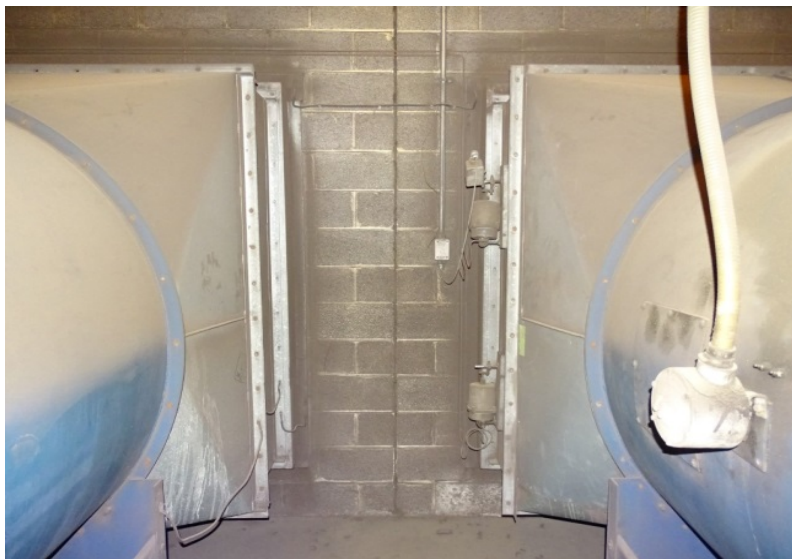
Photograph No. 124
Main room, upper level, west wall, above south-center fan unit.

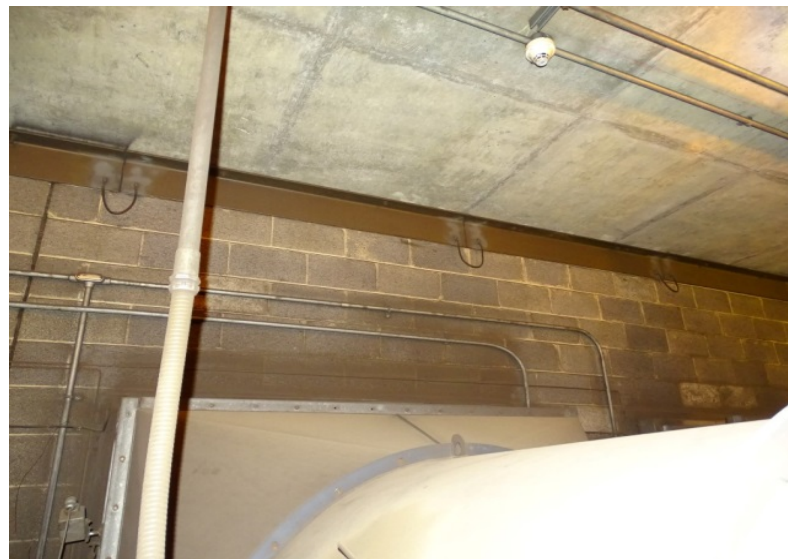
Photograph No. 125

Main room, upper level, west wall, between south-center and north-center fan units.

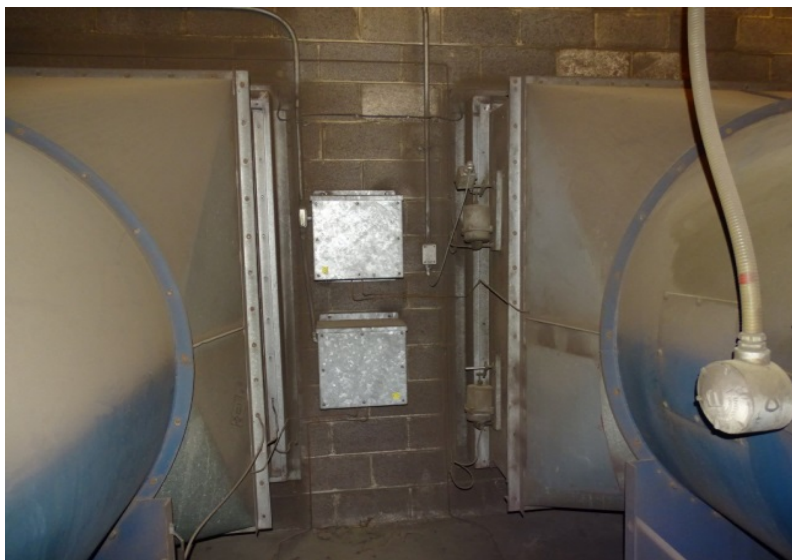
Photograph No. 126

Main room, upper level, west wall, above north-center fan unit.

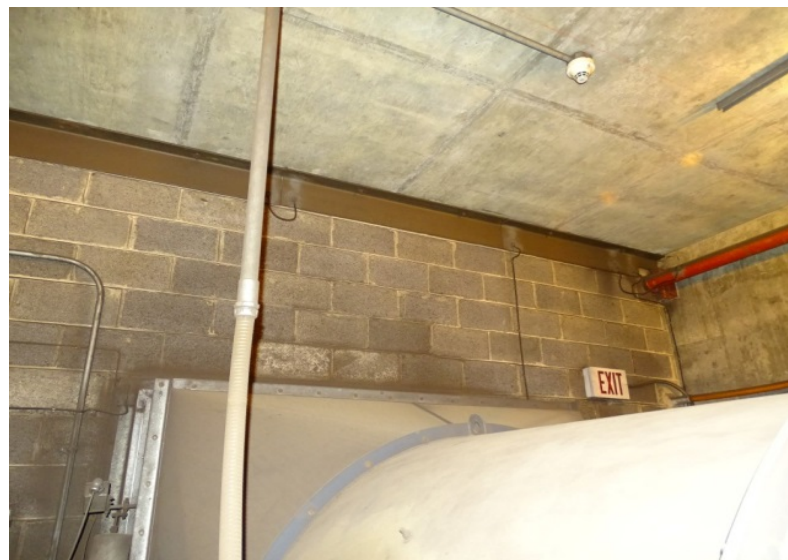
Photograph No. 127

Main room, upper level, west wall, between north-center and north fan units.

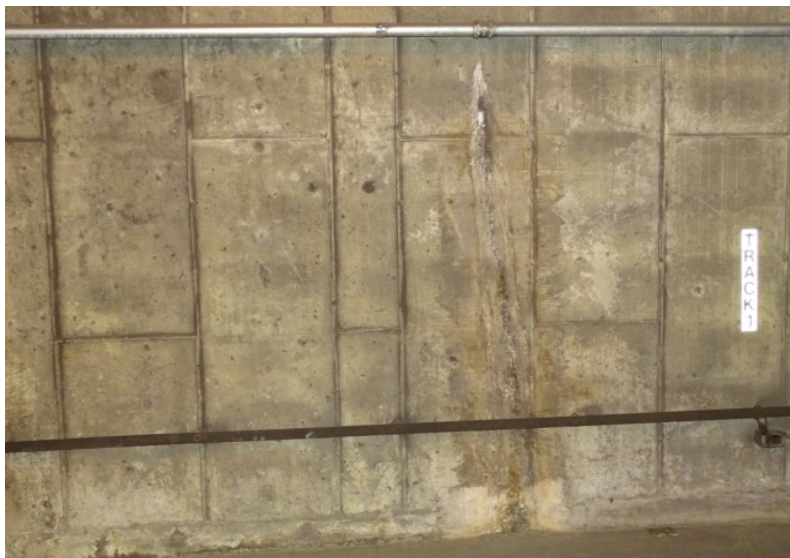
Photograph No. 136
Upper fan room, north wall, lower-east portion.

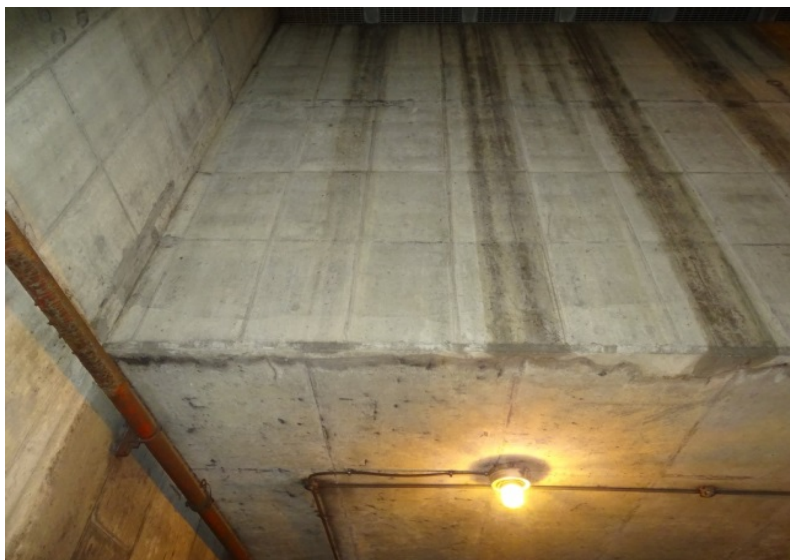
Photograph No. 138

Upper fan room, east wall, north end, upper portion.

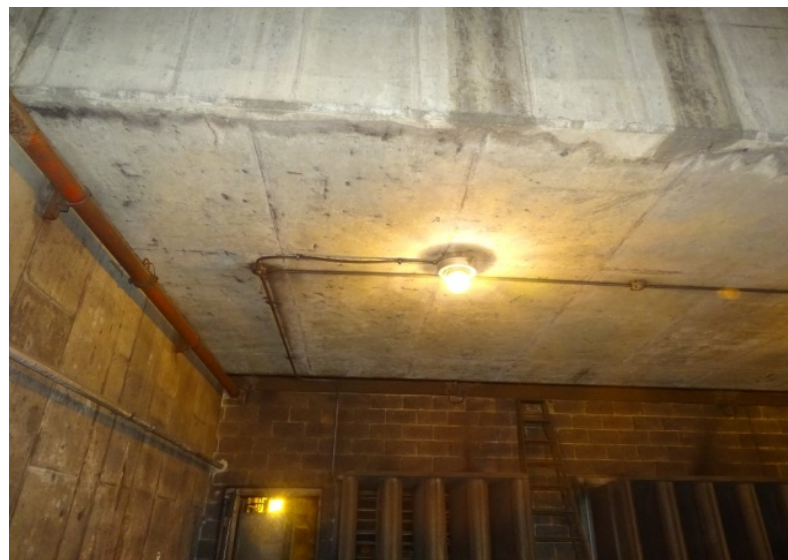
Photograph No. 139

Upper fan room, east wall, north end, middle-upper portion.

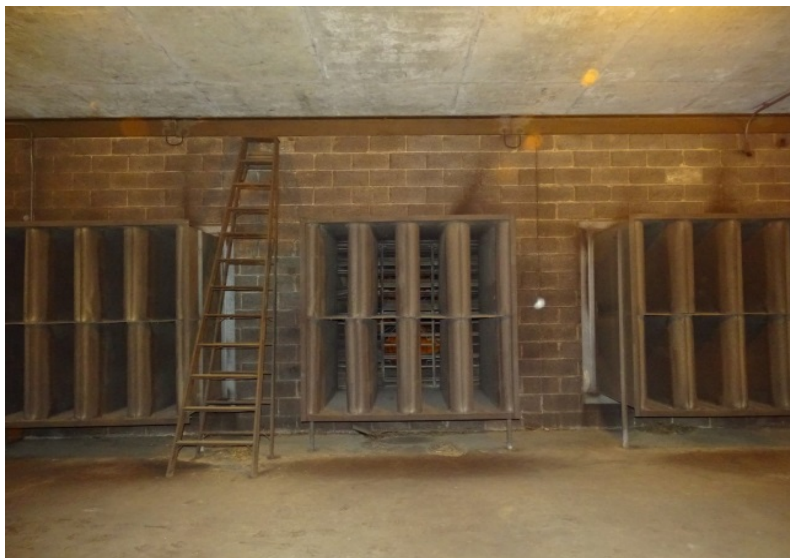
Photograph No. 144
Upper fan room, east wall, north-center section, middle-lower portion.

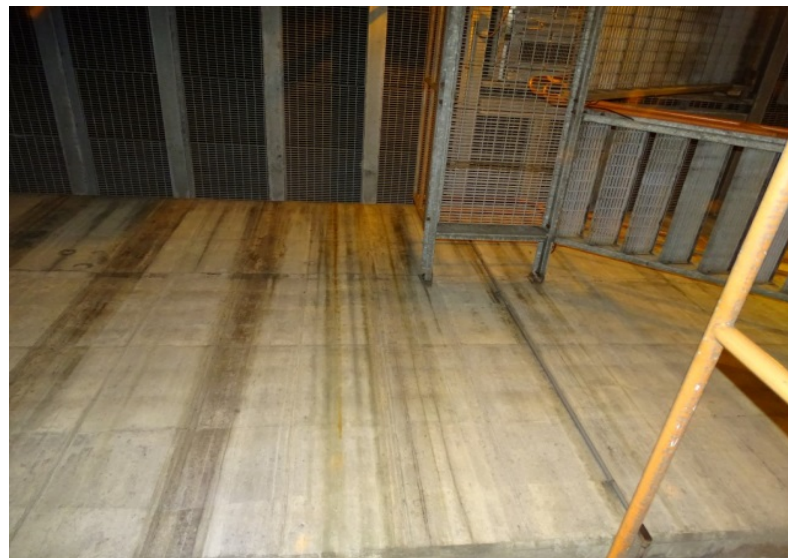
Photograph No. 145

Upper fan room, east wall, north-center section, lower portion.

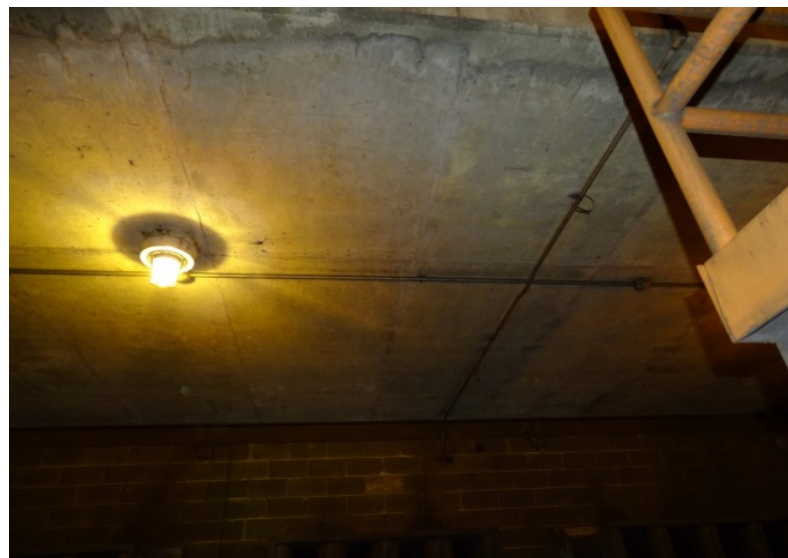
Photograph No. 147

Upper fan room, east wall, south-center section, middle-upper portion.

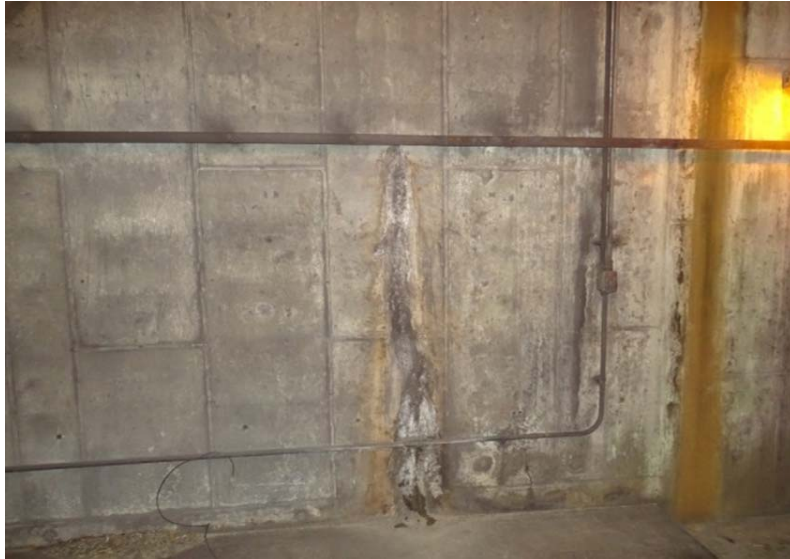
Photograph No. 156
Upper fan room, south wall, lower-east portion - vertical crack and efflorescence.

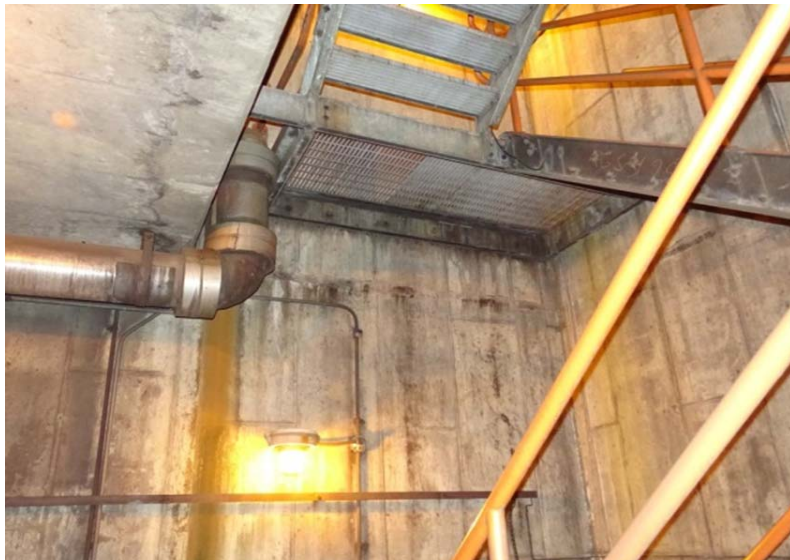
Photograph No. 158

Upper fan room, west wall, south section, upper portion.

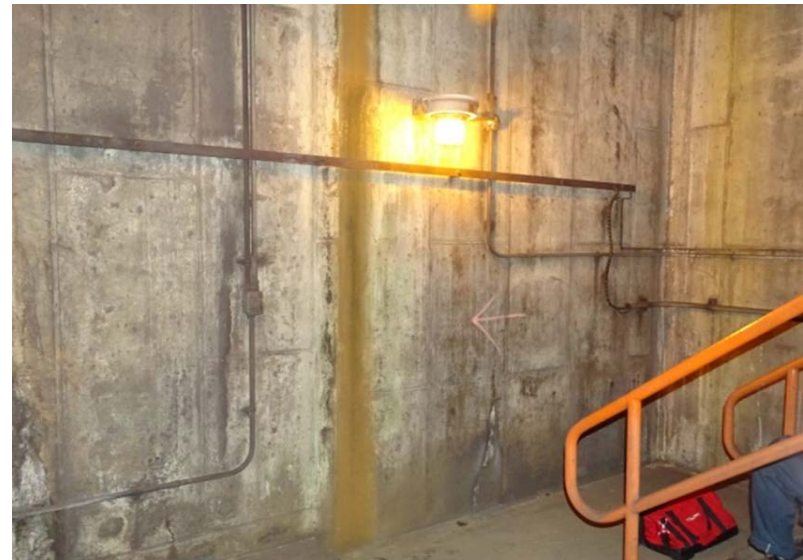
Photograph No. 159

Upper fan room, west wall, south section, middle portion.

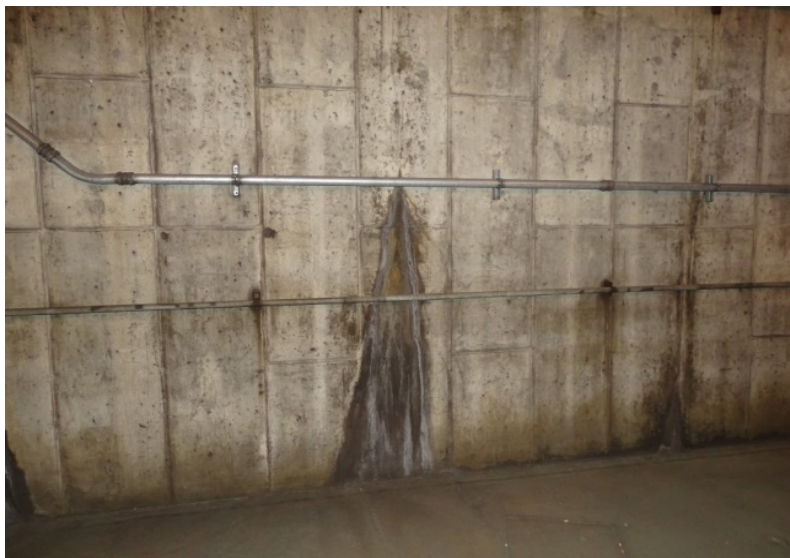
Photograph No. 168
Upper fan room, west wall, middle-south section, middle portion.

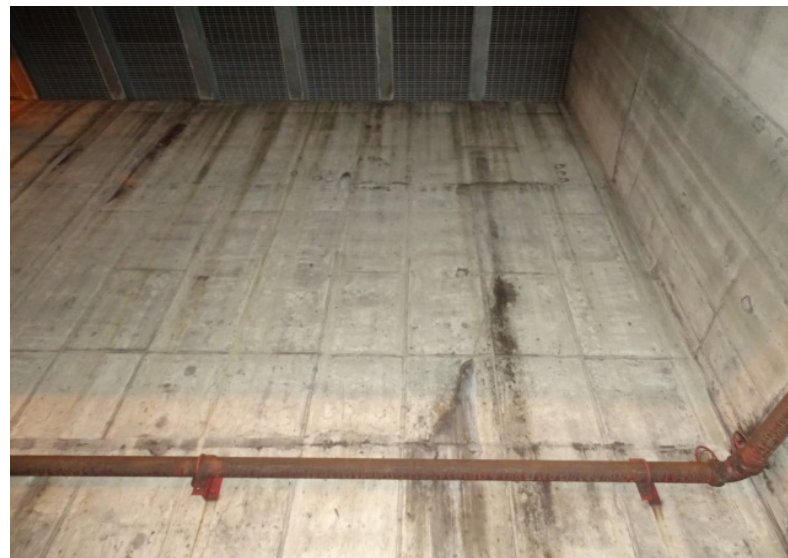
Photograph No. 169

Upper fan room, west wall, middle-south section, lower portion. Note efflorescence.

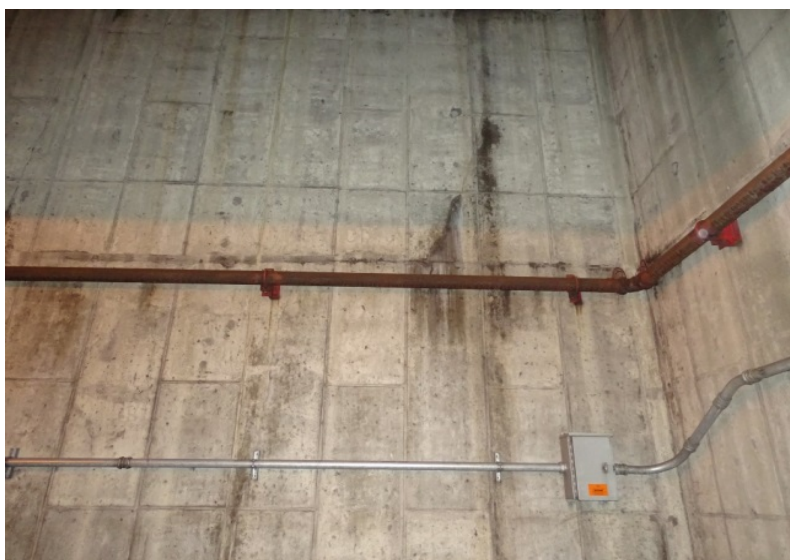
Photograph No. 170

Upper fan room, west wall, south end, upper portion.

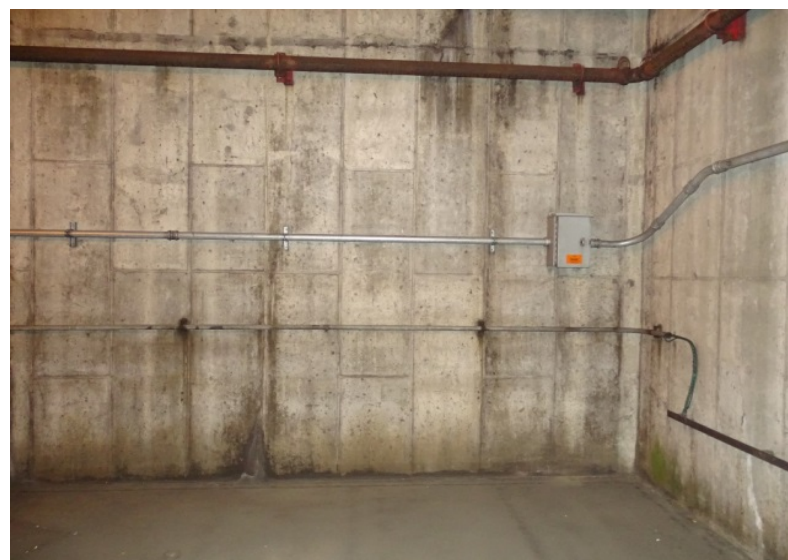
Photograph No. 171

Upper fan room, west wall, south end, middle portion.

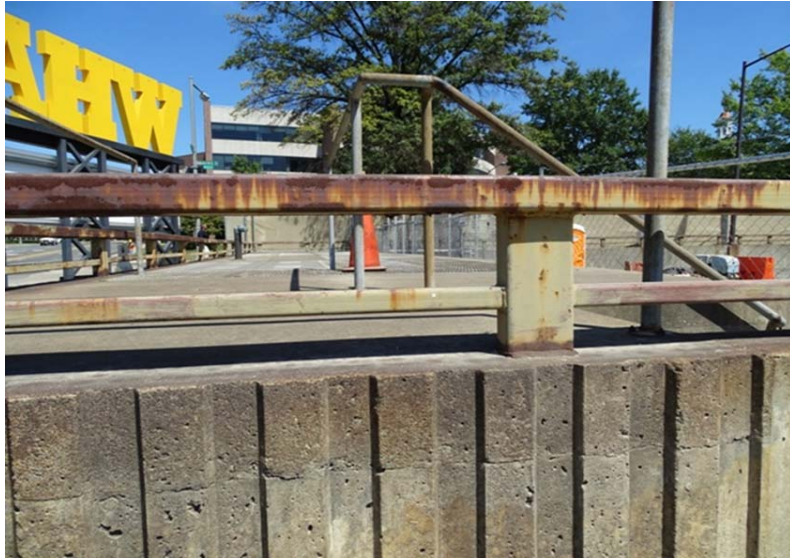
Photograph No. 180
Exterior of main vent shaft, south wall, close up of rust stains.

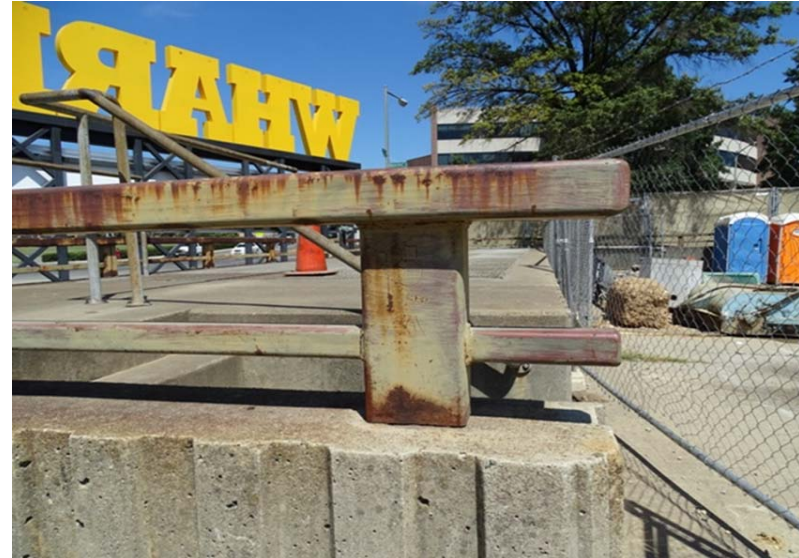
Photograph No. 181

Exterior of main vent shaft, south wall, close up of rust stains.

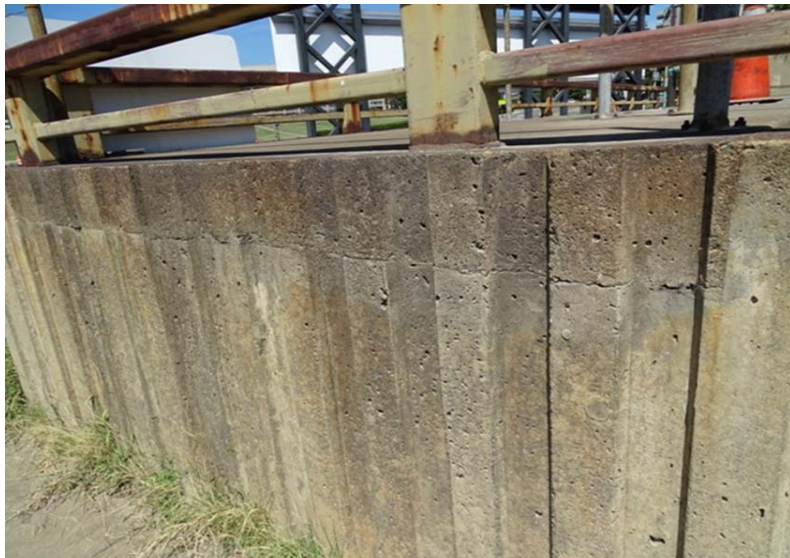
Photograph No. 182

Exterior of main vent shaft, south wall, close up of rust stains.

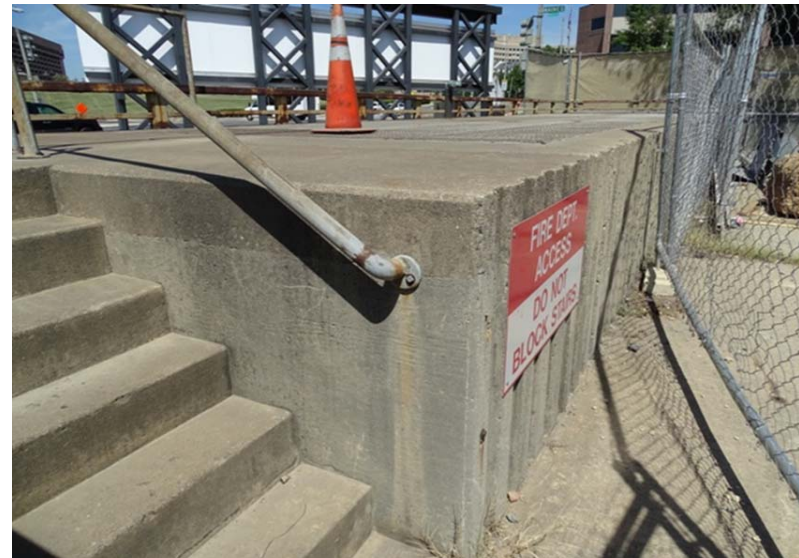
Photograph No. 183

Exterior of main vent shaft, south wall, construction joint in concrete.

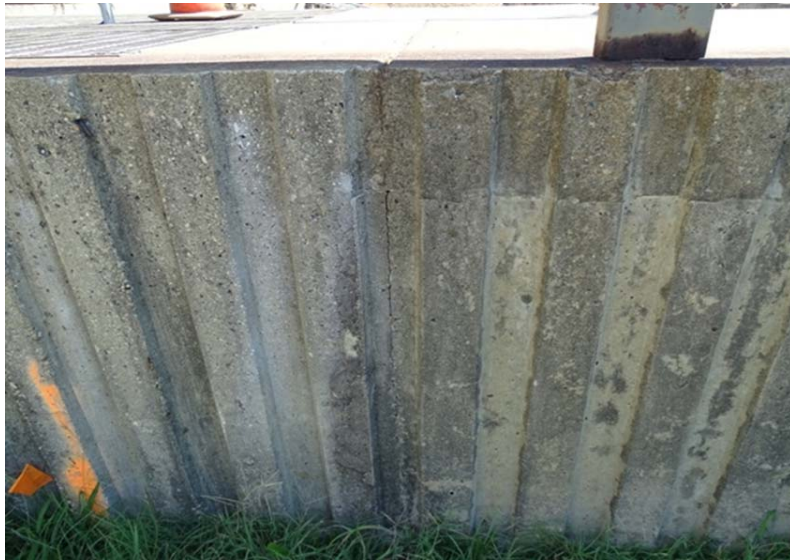
Photograph No. 196
Vent shaft exterior, northwest side, close up of separation.

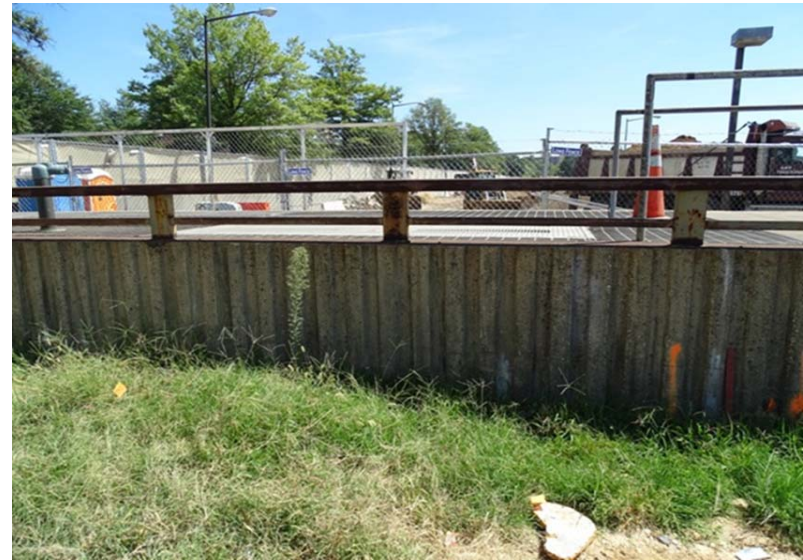
Photograph No. 197

Vent shaft exterior, northwest side, close up of separation.

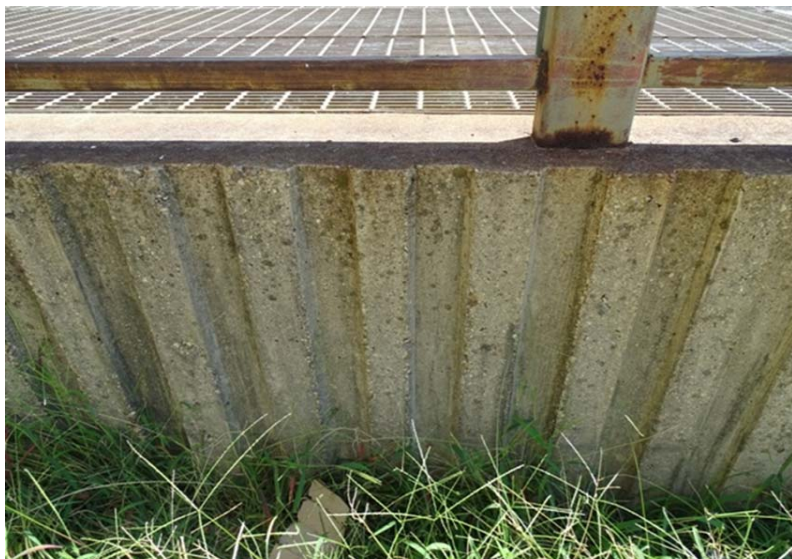
Photograph No. 200

Vent shaft exterior, northwest side, close up of crack.

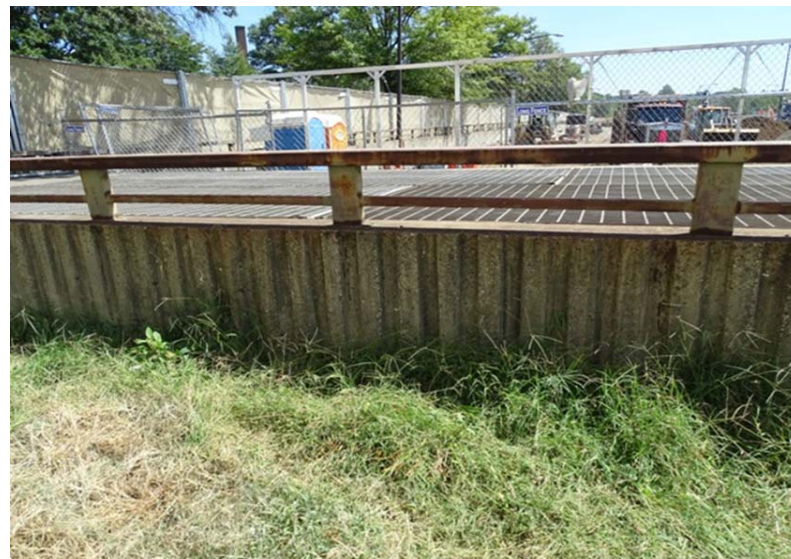
Photograph No. 201

Vent shaft exterior, northwest side, close up of crack.
