I ANALYSIS

1.0 Accident Synopsis

- 1.1 The subject engine was removed from an Agusta A119 Aircraft Registration No.N403CF following an aircraft mishap.
- 1.2 It was reported that the aircraft was found substantially damaged when it impacted terrain while approaching to land to a remote landing zone (LZ) approximately 8 miles northeast of Mancos, Colorado. The pilot, nurse, and paramedic were fatally injured.

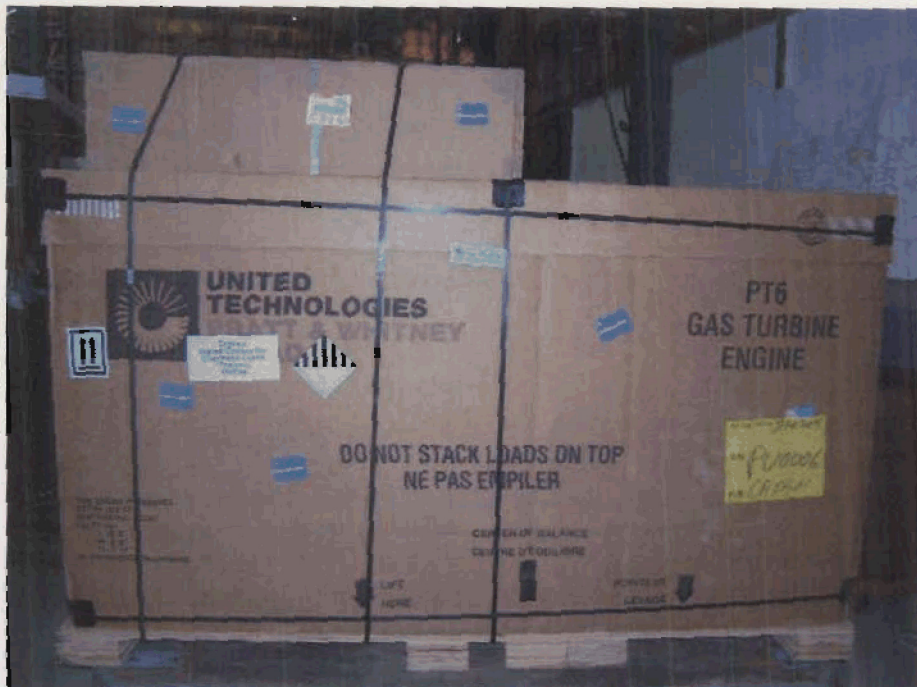
Photo no. 1

As received, engine S/N PU0006 container with a cardboard box attached above the container.

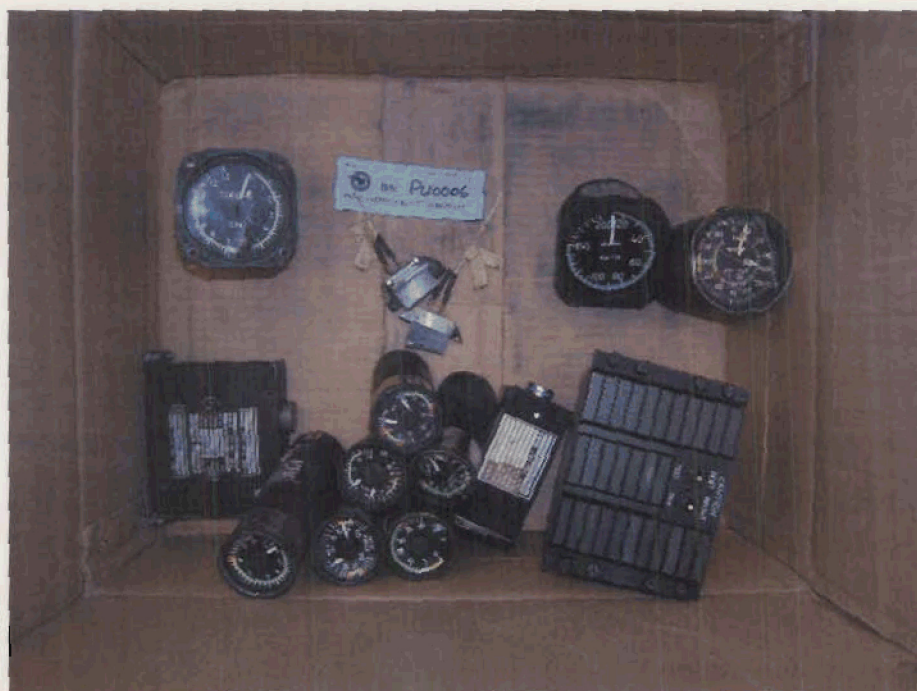
Photo no. 2

As received, various aircraft instruments

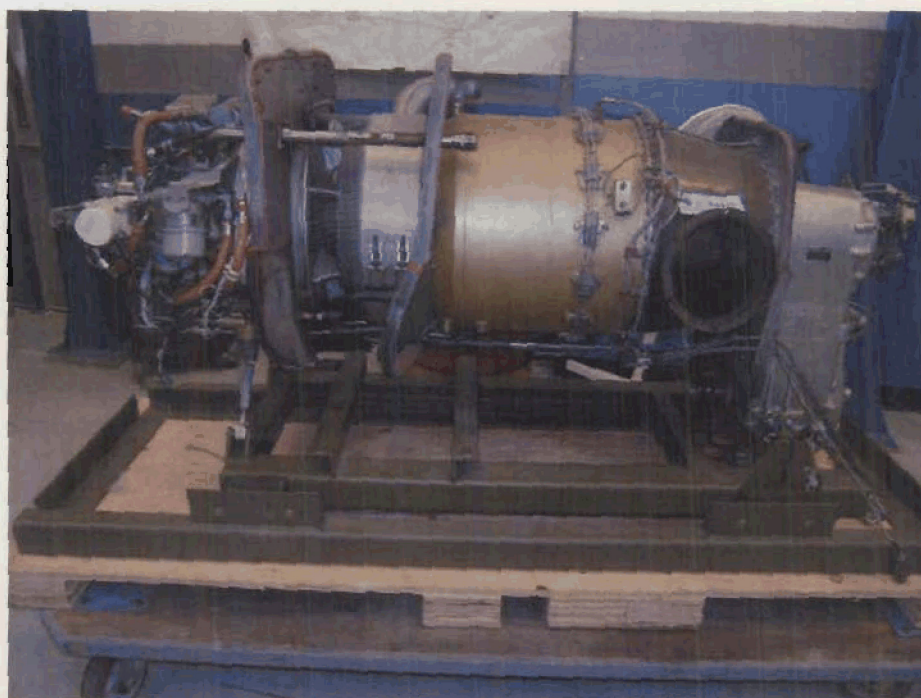
Photo no. 4
As received, the engine left hand (LH) view

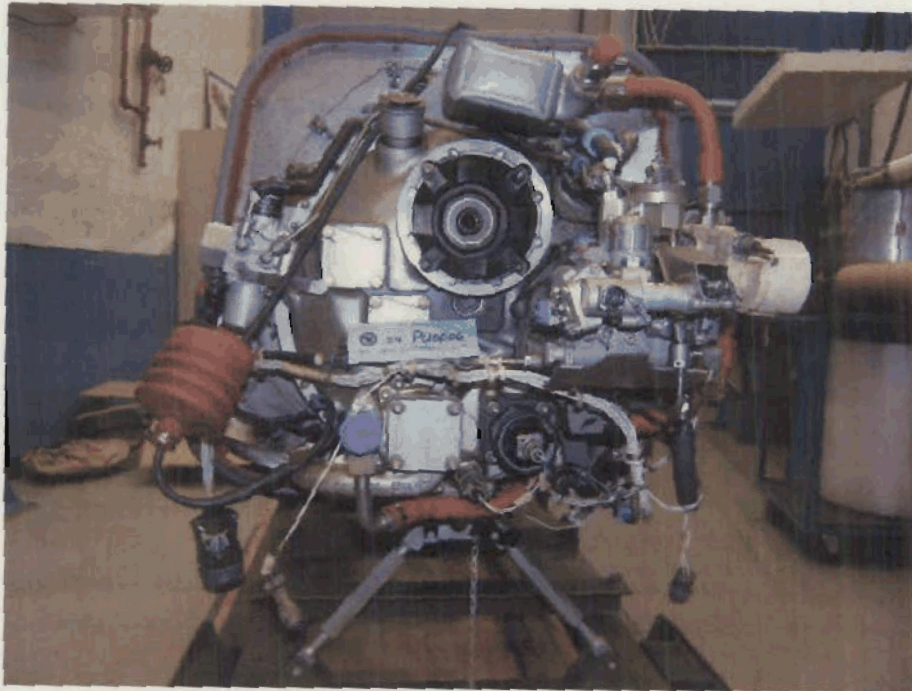
Photo no. 7

As received, the engine front view (accessory gearbox side)

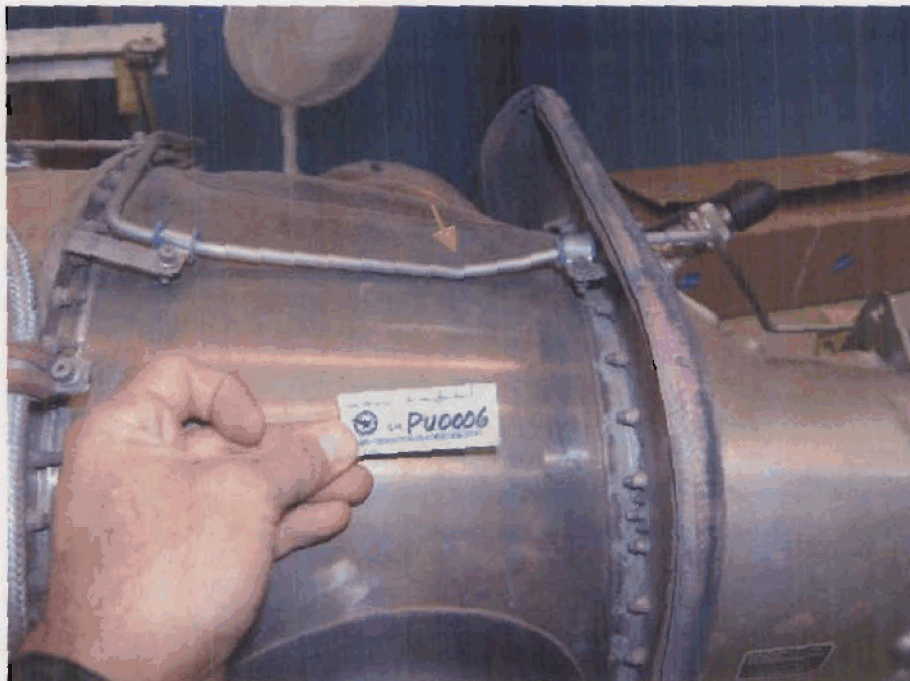
Photo no. 24

Engine top view at the exhaust case area shows the dented pneumatic line (arrow).

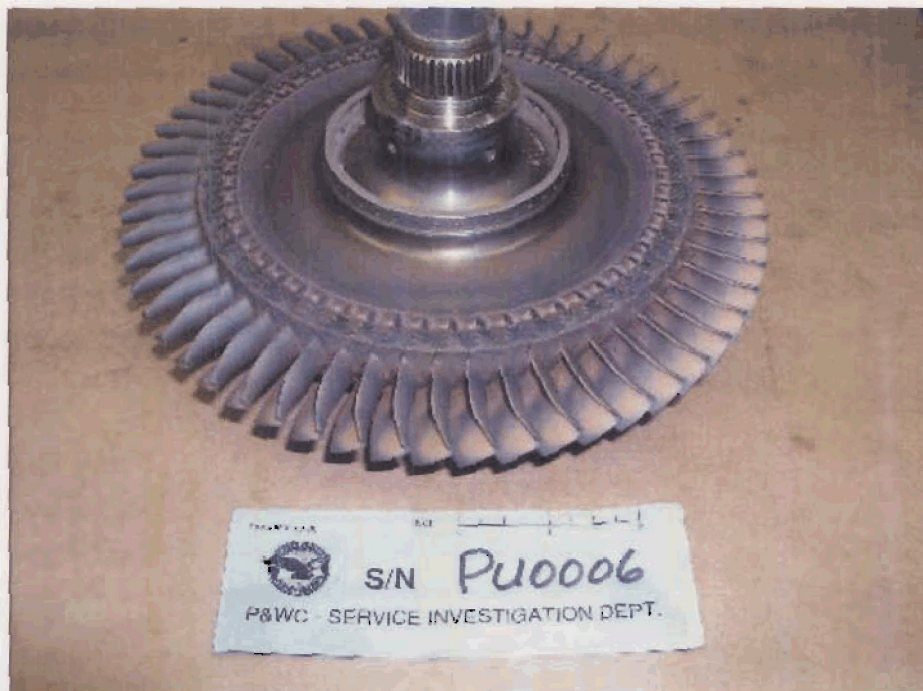
Photo no. 32
Leading edge view of the CT disc assembly

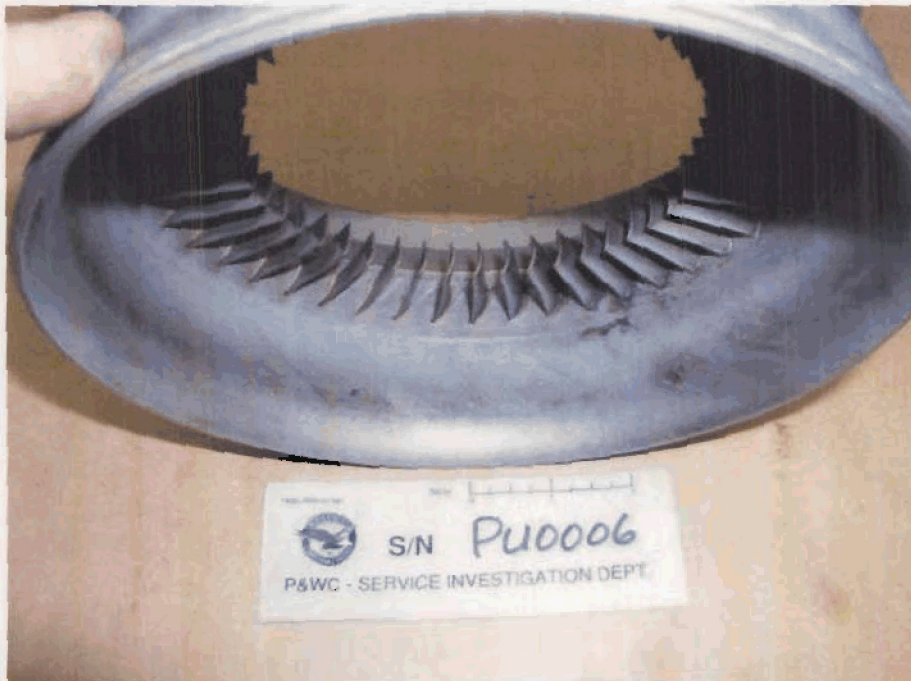
Photo no. 34

1st stage compressor stator shows no evidence of rubbing damage to the shroud.

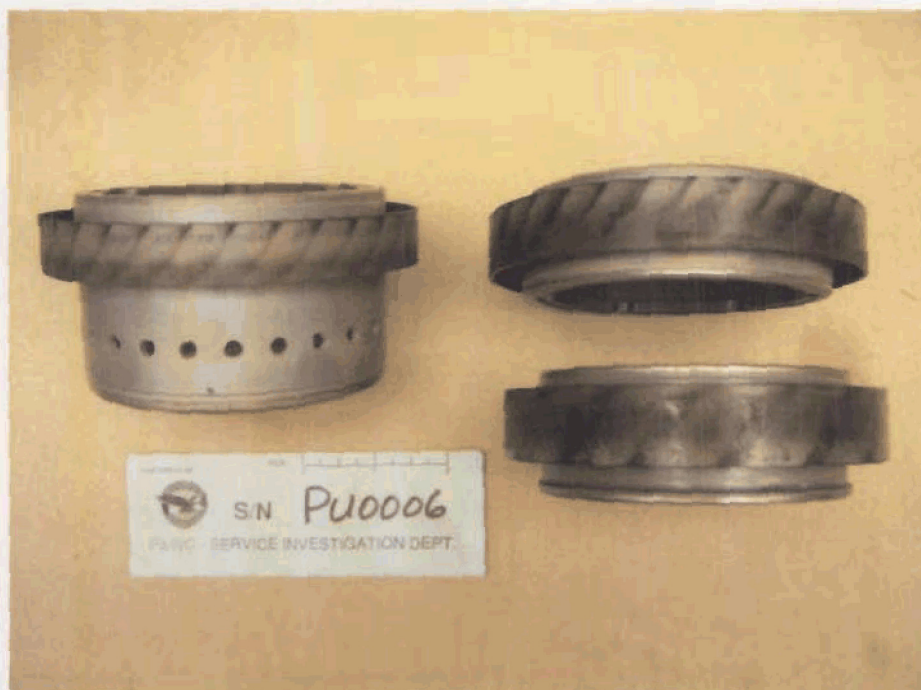
Photo no. 38

View of the compressor rotor spacers shows no impact and rubbing damage to their OD's
Note that the wetness seen on the spacers (O.D) was introduced during the disassembly handling.

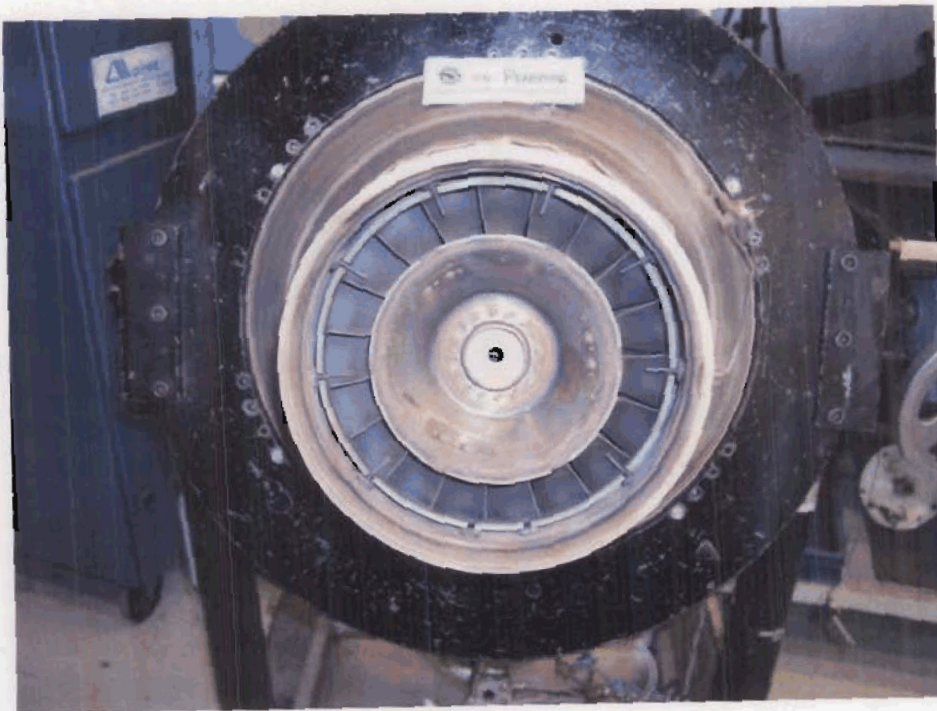
Photo no. 40
Leading edge view of the intact PT stator assembly

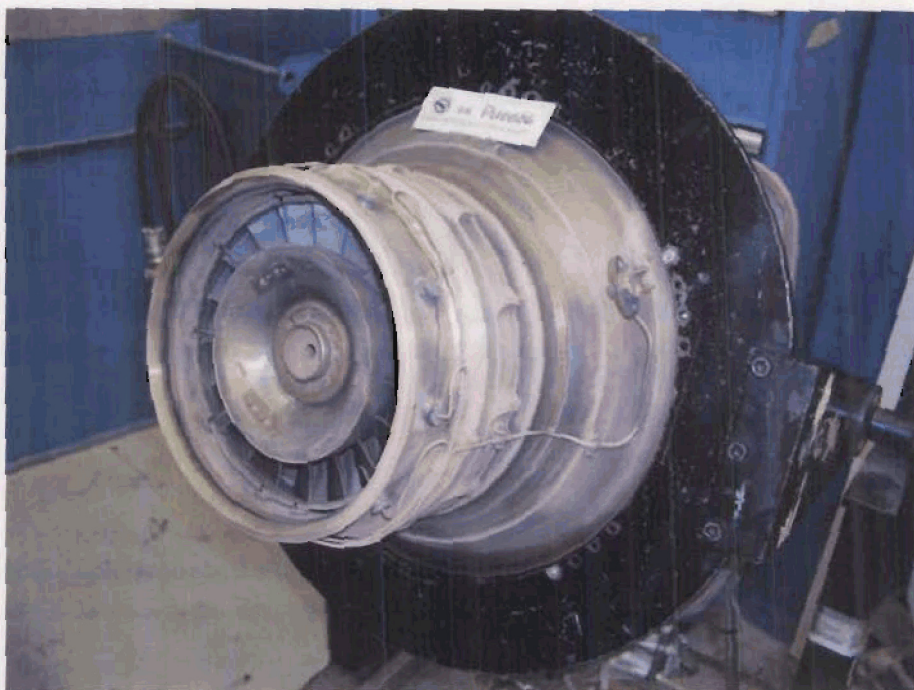
Photo no. 41

PS module LH view of the intact PT stator & housing, the temperature harness (T5) & the TED

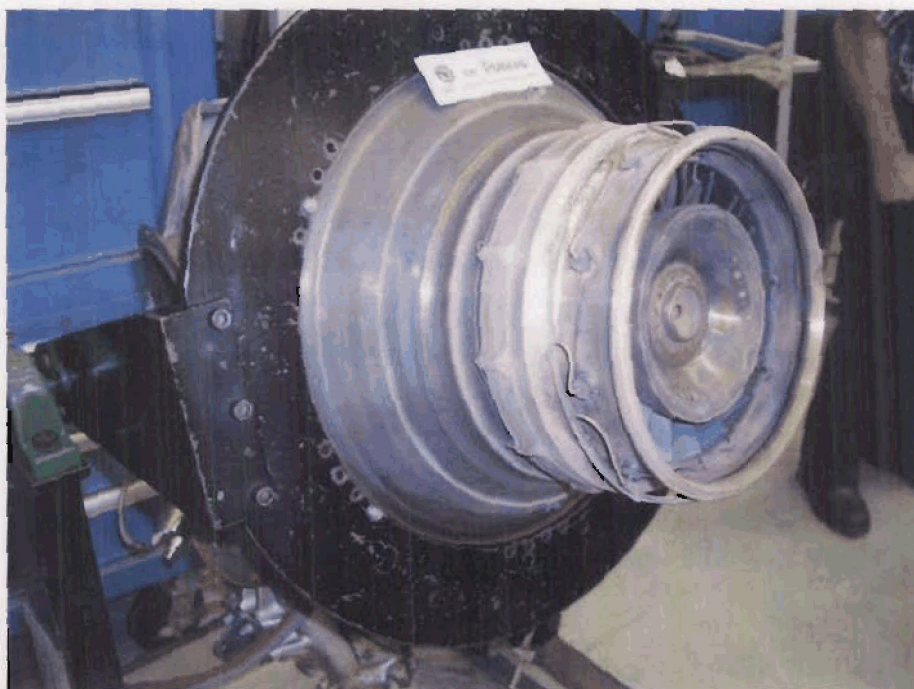
Photo no. 42

PS module RH view of the intact PT stator & housing, the temperature harness (T5) & the TED

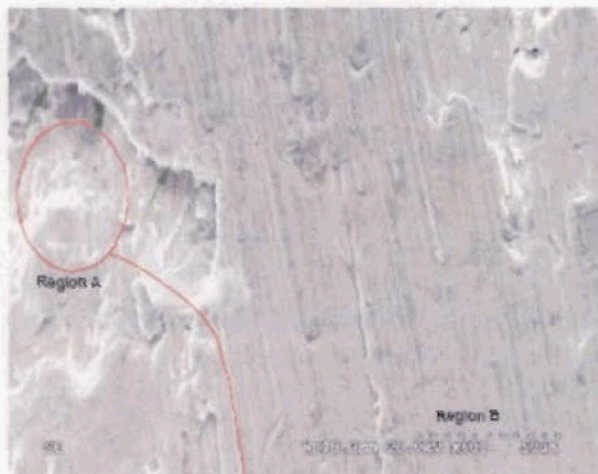
Figure 16

General aspect in a region where surfaces A and B are visible. The orientation of the sample is the same as in Figures 14 and 15. Dimples are visible (red circled area) in region of type A. The orientation of the dimples is consistent with a shear moment resulting from a relative motion between the bolt and the flow body with the bolt moving out of the flow body (see Figure 16b).

Areas of type B are not consistent with a fracture surface and exhibit evidence of smearing over regions of type A (green arrows). The lines in area B are consistent with rubbing. Regions of type B are consequently subsequent to the shear fracture. The lines are also clearly defined and no evidence of fretting was observed indicating that the rubbing damage was produced in a single event.

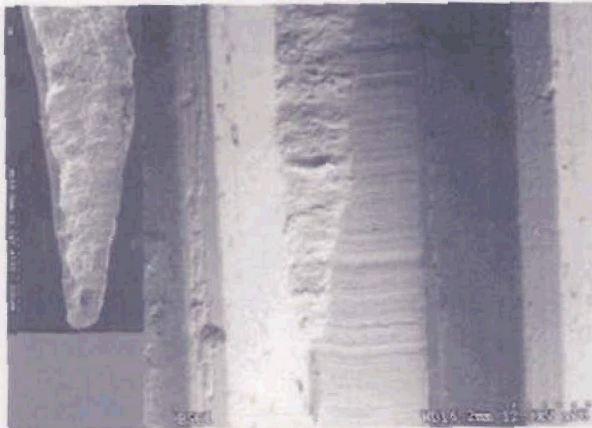
Figure 28

Tip of the fragment of stripped material matching the location of the replica in Figure 27. No features on the fracture surface matching the replica were found. The fact that the lines on the crest are in the axial direction of the bolt hole indicates that the damage resulted from a rubbing in the axial direction. The lines are also well defined indicating that there was no wear and consequently no subsequent rubbing between the fracture surface and the crest of the thread in the bolt hole.

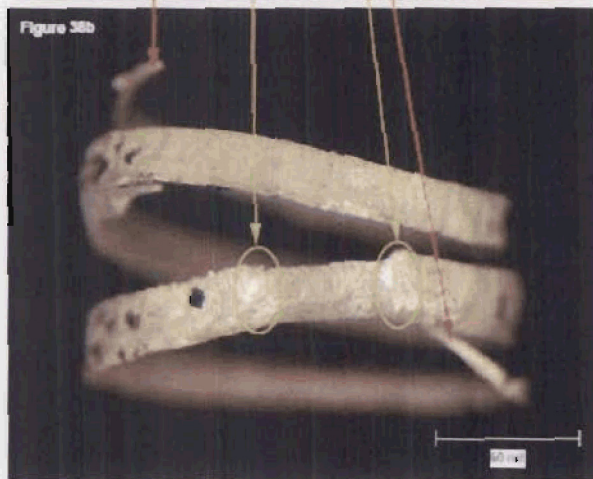
Figure 38

Figure 38a) Figure 9B from Honeywell's South Bend Materials Technology Center report No. AA05358 and titled "Investigation of B-37 fuel Control, S/N 69008", dated 11/11/05, showing the presence of a crack on the fragment of stripped material when it was still attached to bolt No. 3 (blue arrow heads)

Figure 38b) Area of the stripped material matching the area where evidence of fatigue crack propagation was observed on the as removed bolt No. 3. The details of the fracture surface are provided in photographs 29 to 37. This shows that there was a pre-existing crack at the time of the final fracture. The fragment containing the matching fracture surface was not submitted to the lab for examination.
