**NATIONAL TRANSPORTATION SAFETY BOARD
OFFICE OF AVIATION SAFETY
WASHINGTON, D.C. 20594**

POWERPLANTS GROUP CHAIRMAN'S FACTUAL REPORT

NTSB ID No.: ERA15FA221

Location: West Columbia, South Carolina
Date: May 23, 2015
Time: 0921 Eastern Daylight Time
Aircraft: BR Legend LLC, Turbine Legend, N42BR

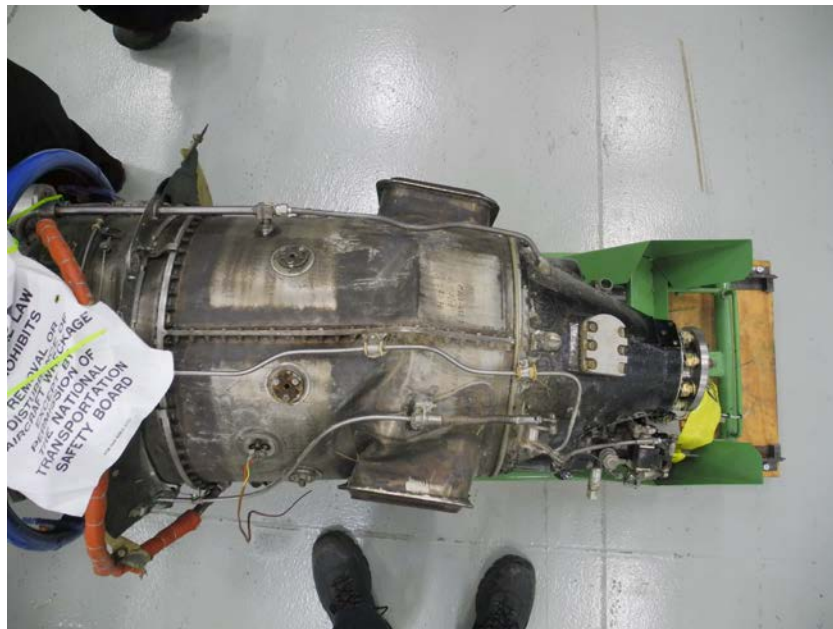
The 2-segment compressor/combustor or gas generator (GG) case was intact; however, it was buckled in the section between 11 and 1 o'clock (Figure 9), near the upper engine mount location. The inlet screen was present and undamaged.

Figure 9 – Gas Generator (GG) Case - Buckled

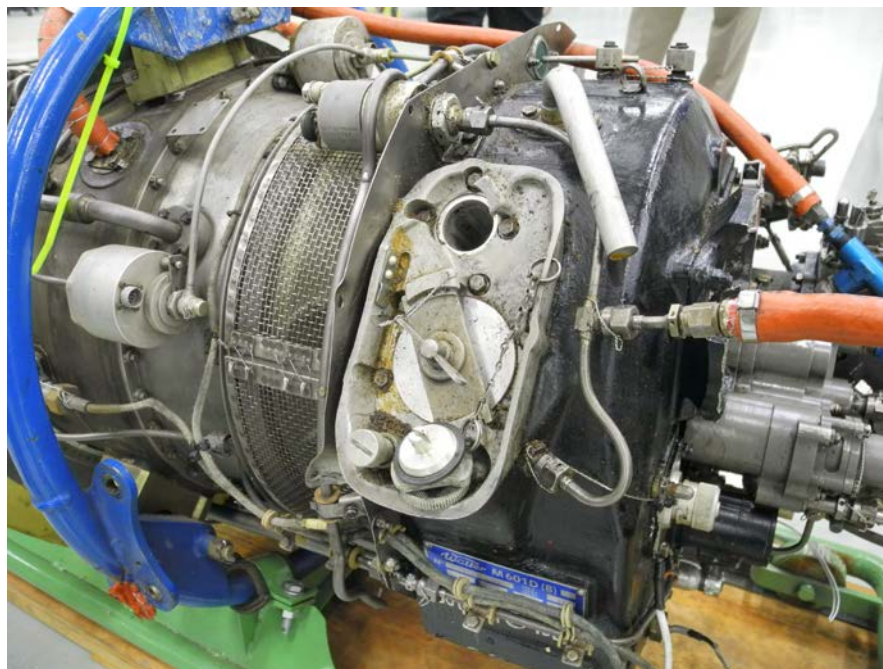
Figure 11 – Fuel Pump & Fuel Control Unit (FCU) – As Received

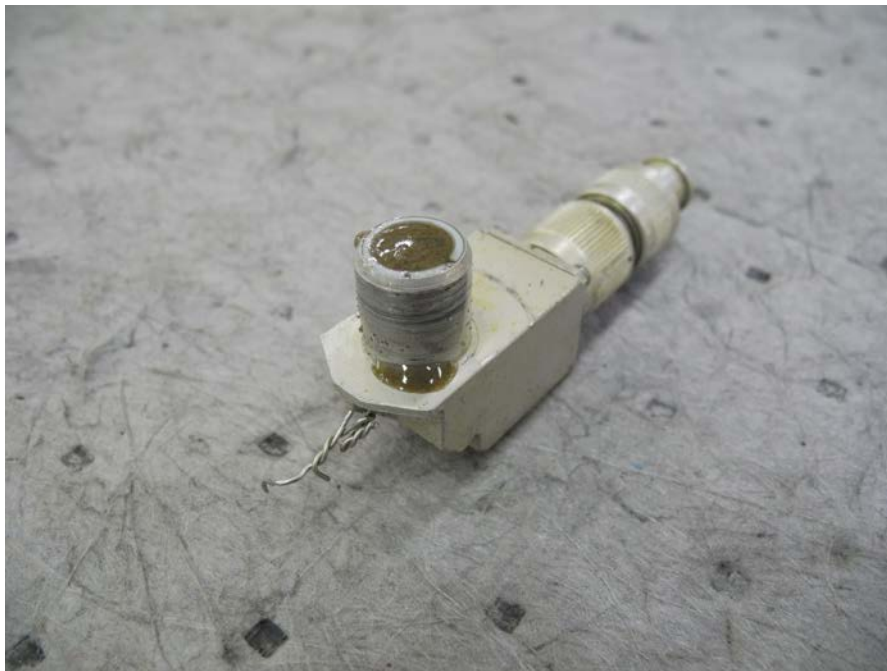
The AGB/oil tank contained approximately 1½ gallons of an oil-water mixture, consistent with immersion in water. The magnetic drain plug contained a small number of fine particles (Figure 15) and was oil wetted while the chip detector (Figure 16) was water wetted and clear of particles. The AGB contained approximately 1 gallon of oil-water mixture.

Figure 15 – AGB/Oil Tank Magnetic Drain Plug

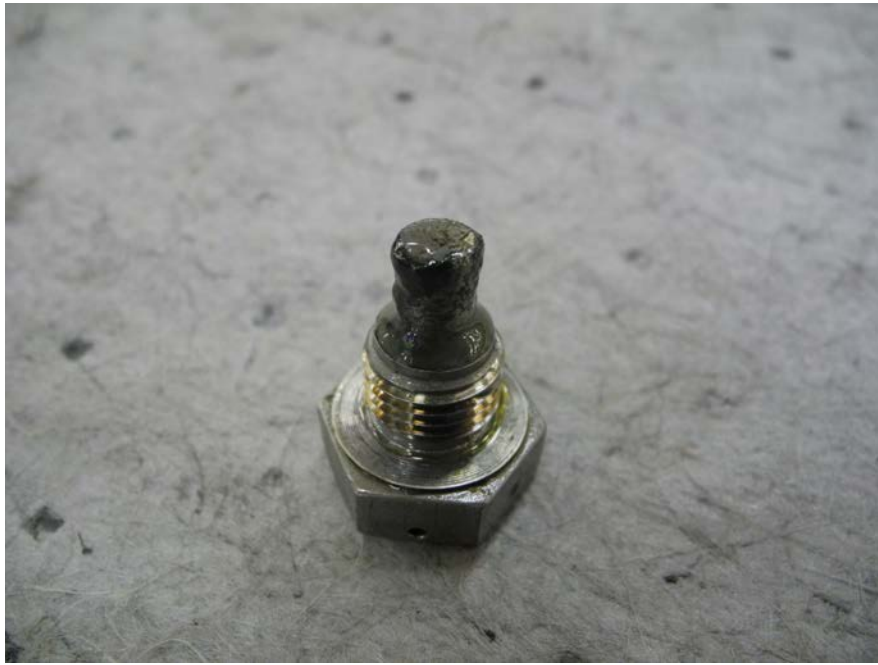
Figure 16 – AGB/Oil Tank Chip Detector

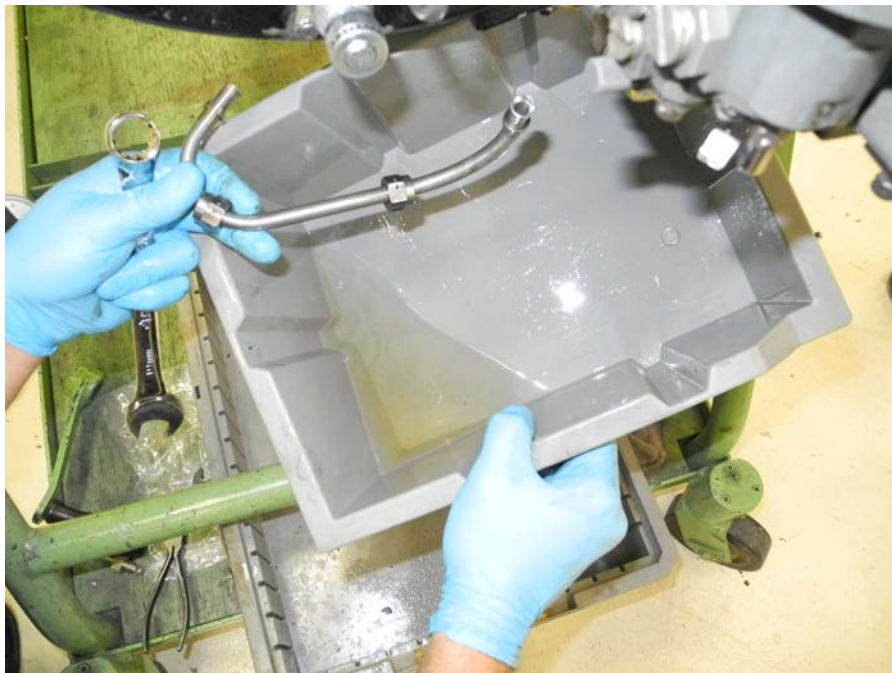
The RGB was disassembled as far as practically possible and the internal components examined. The power turbine (PT) support cone (Figure 23) was intact; however, it had an 8-inch long internal, arc shaped impact mark consistent with contact against the front cast feature of planetary gearcase diaphragm, consistent with an axial impact. The reduction gear support diaphragm was intact (Figure 24) and the 1st and 2nd

Figure 23 – Power Turbine (PT) Support Cone

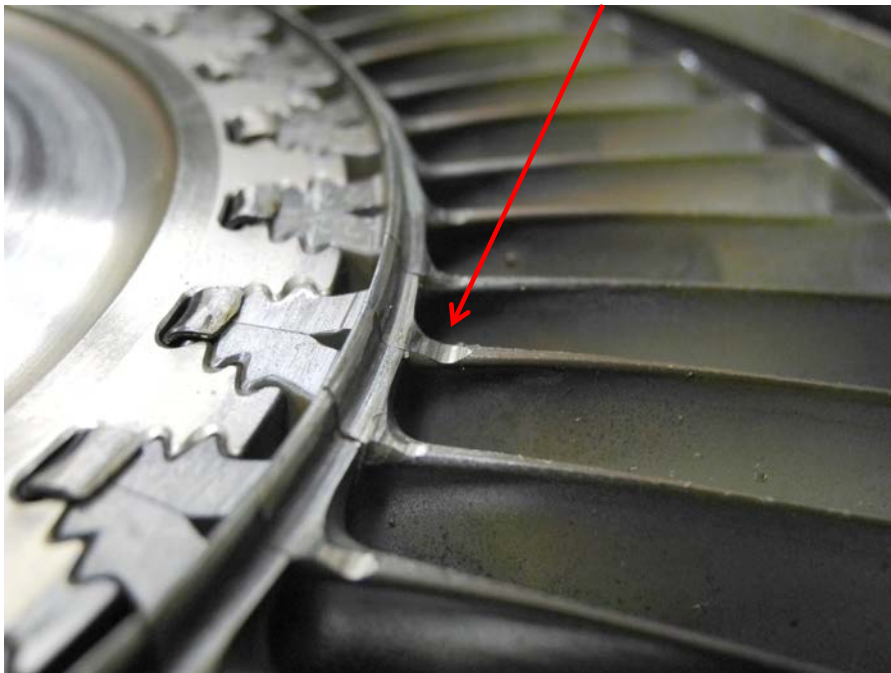
The PTNGVR was intact, and generally undamaged (Figure 31); however, the aft (with respect to the airflow direction) surface of the PT stator inner vane platform and the shroud support face were rotationally scored, consistent with contact against the rotating PT hub.

Figure 31 - Power Turbine Nozzle Guide Vane Ring

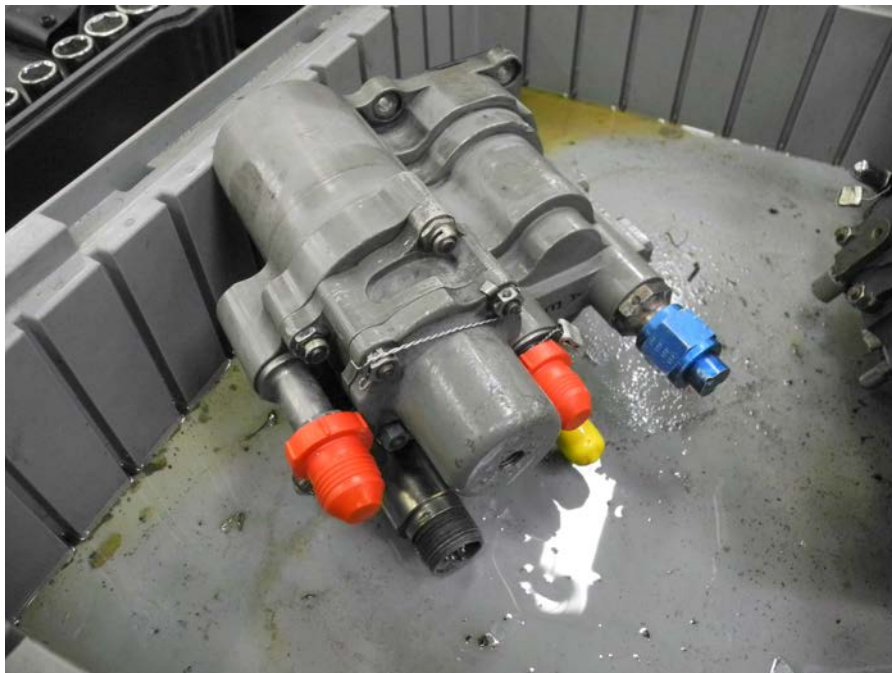
Figure 45 - Fuel Pump Input Drive Spline - Undamaged

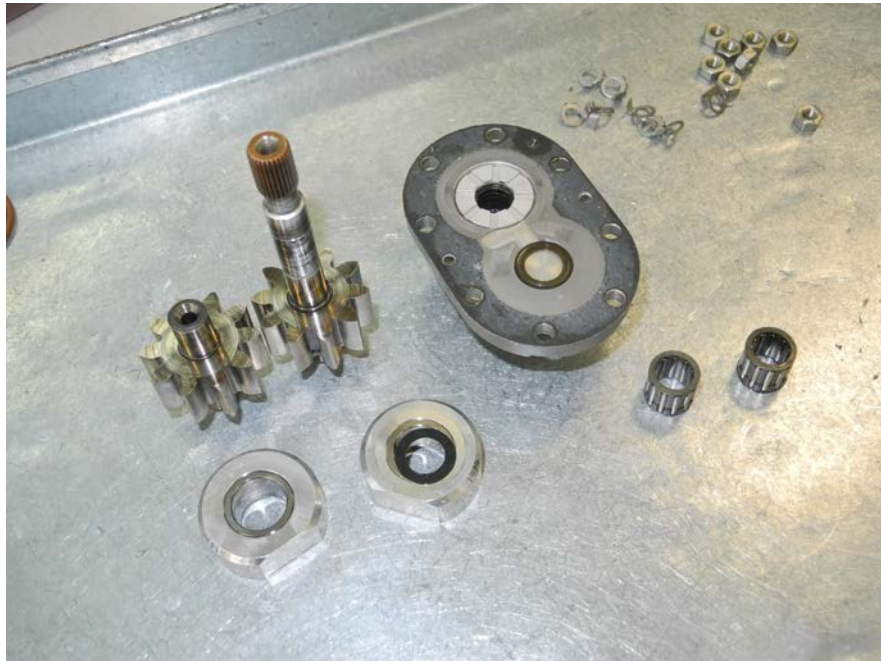
Figure 47 - Brass Gear Side-Sealing Plates

Rotational Scoring

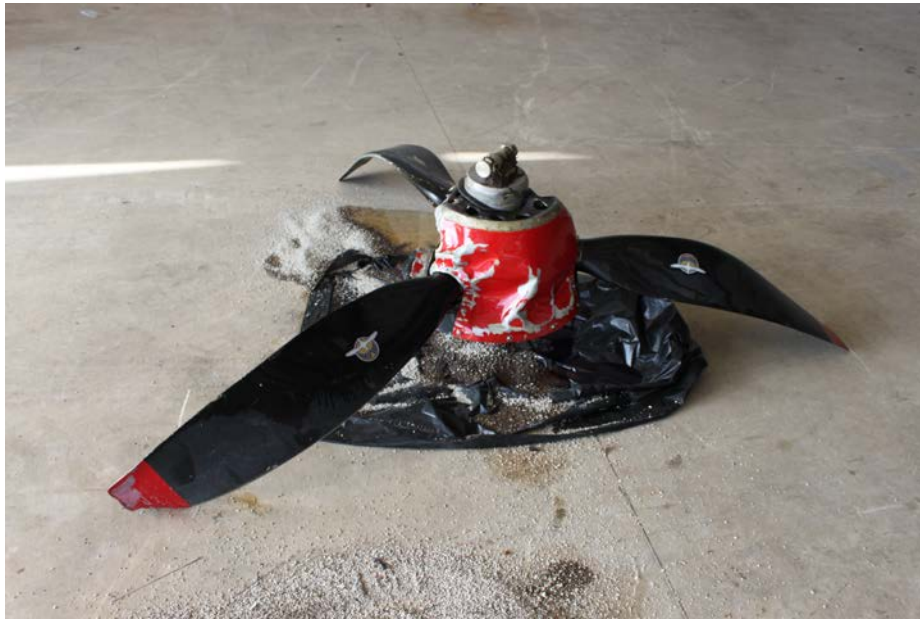
The propeller was retained until January 17, 2017, when it was transported to the Turbine Power Tech facility in Deland, Florida where it was dis-assembled and examined. The propeller was intact (Figure 63); however, the overspeed governor cover was missing. The spinner was present, however, it was battered, torn and crushed over the hub and counterweights. All 3 blades were bent aftwards in the form of a large radius and with only a minor amount of twist. The leading edges were all undamaged and the front, low pressure surfaces, exhibited no rotation score marks (Figure 64). The counterweights were all in their forward position, which is associated with a flat or fine blade pitch (Figure 65). The counterweight clamp locating keys were all in location and undamaged (Figure 66), confirming that the clamps were in their original location and had not rotated from their indexing position. All the blades were unscrewed from the blade bushings with normal effort and all threads were undamaged (Figure 67).

Figure 64 – Blade – No Impact or Scoring Damage

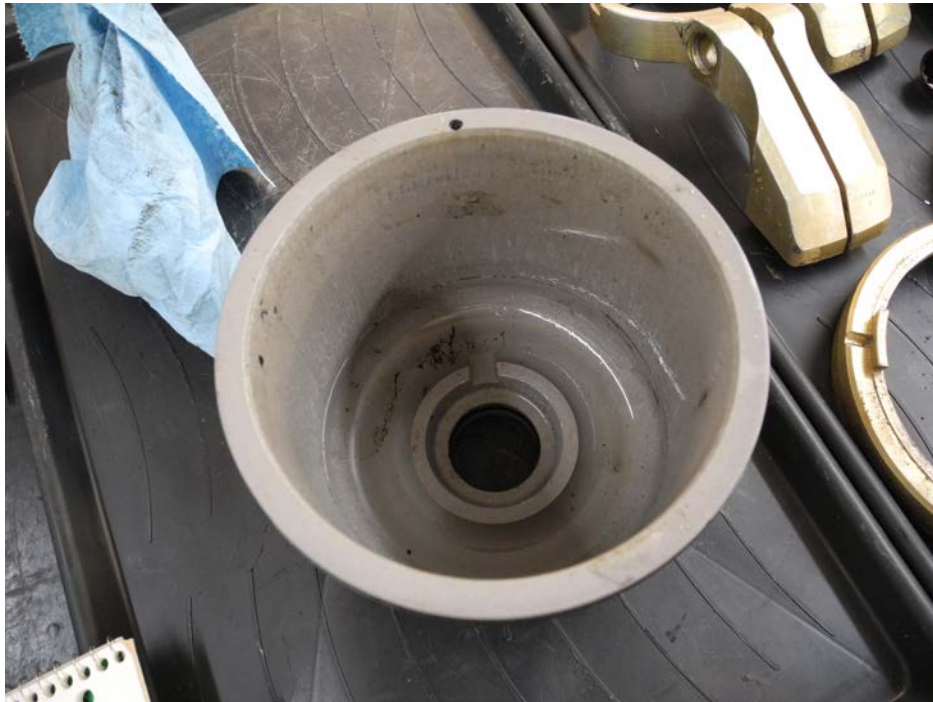
The cylinder was removed with normal effort and the internal bore was found undamaged (Figure 68). The piston and elastomer piston ring were also undamaged (Figure 69). The sliding fork and tube assembly operated smoothly (Figure 70); however, each of the three lower fork flanges exhibited one impact mark, consistent with contact against the crank flange of the blade bushings (Figure 71) during a propeller strike or impact.

Figure 69 – Piston and Ring - Undamaged

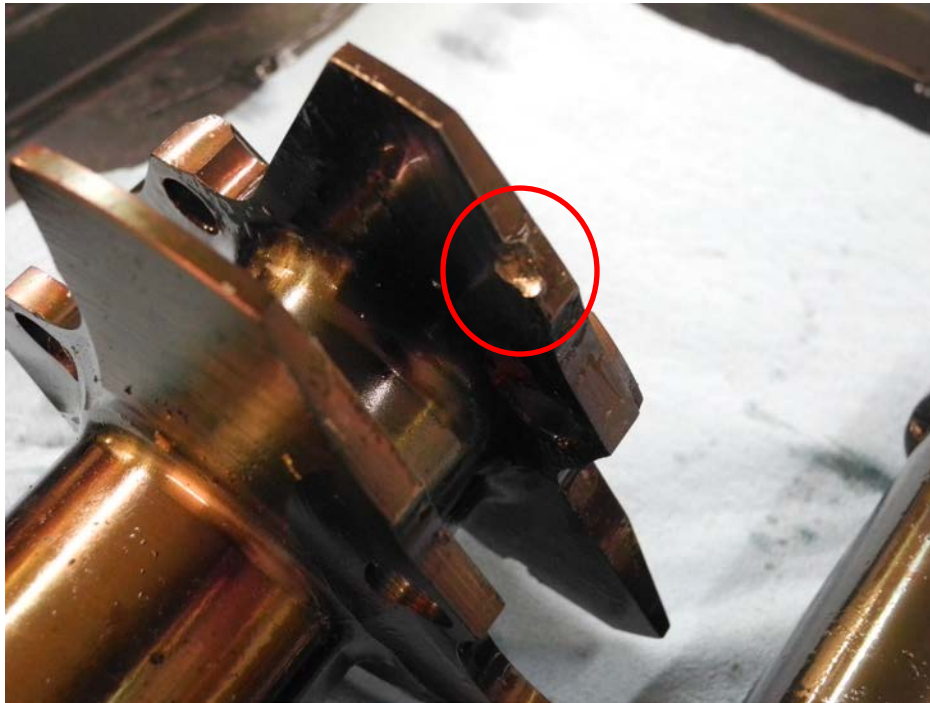
The blade bushings and pitch change blocks were all intact (Figure 72); however, there was mild corrosion on the inner race surface of one bushing, consistent with post-accident contact with water. All the ball bearings and their elastomeric spacers were present and undamaged (Figure 73), except for several that exhibited mild post-accident corrosion. The hub was intact; however, the blade bushing sleeves were fractured at the outer aft lips, consistent with a large axially aftward levered loading of the propeller blades (Figure 74). Additionally, spherical indentations from ball bearing, consistent with static overload were observed on the aft side of outer races (Figure 75).

Figure 72 – Blade Bushings & Pitch Change Blocks

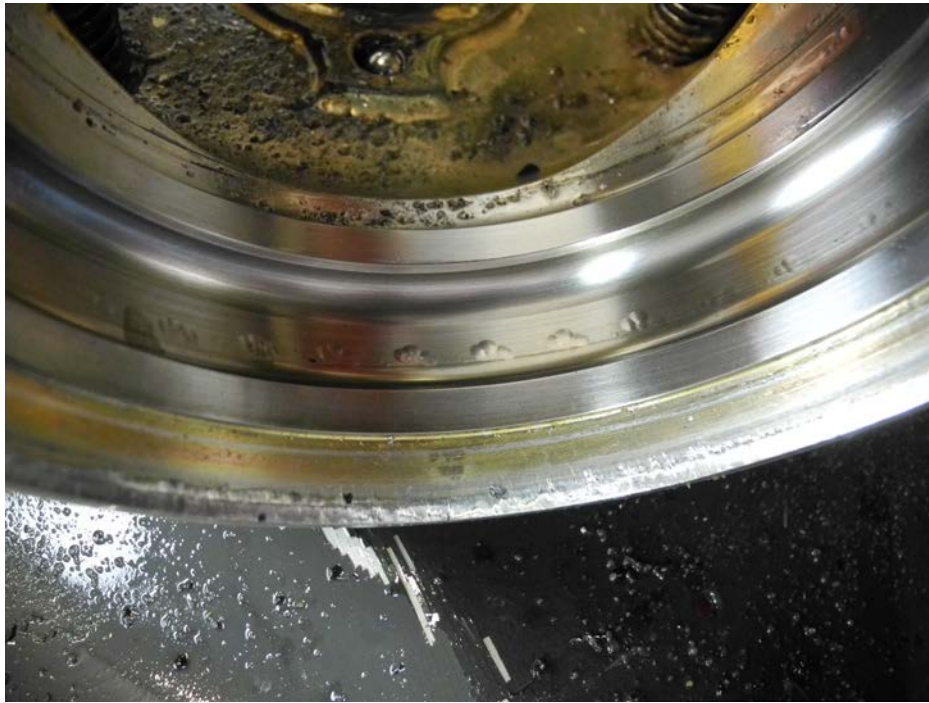
Figure 75 – Indentations on Aft Side of Outer Race from Ball Bearing
