Attachment A Figures & Photographs

American Airlines Flt. 587 - Radar Based Flight Path & Debris Field

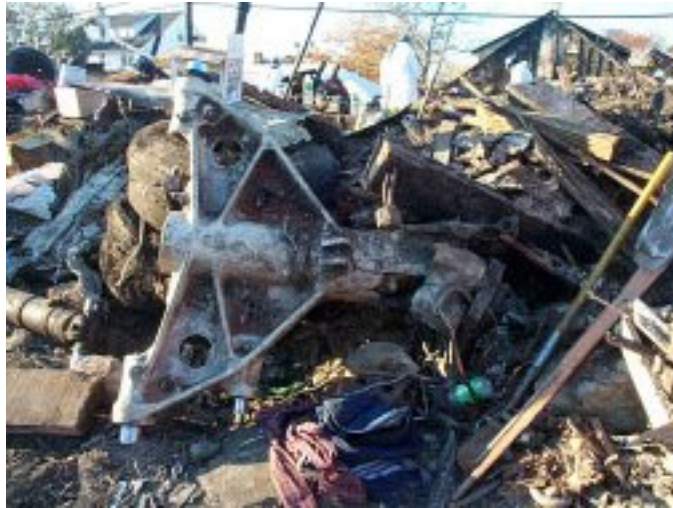
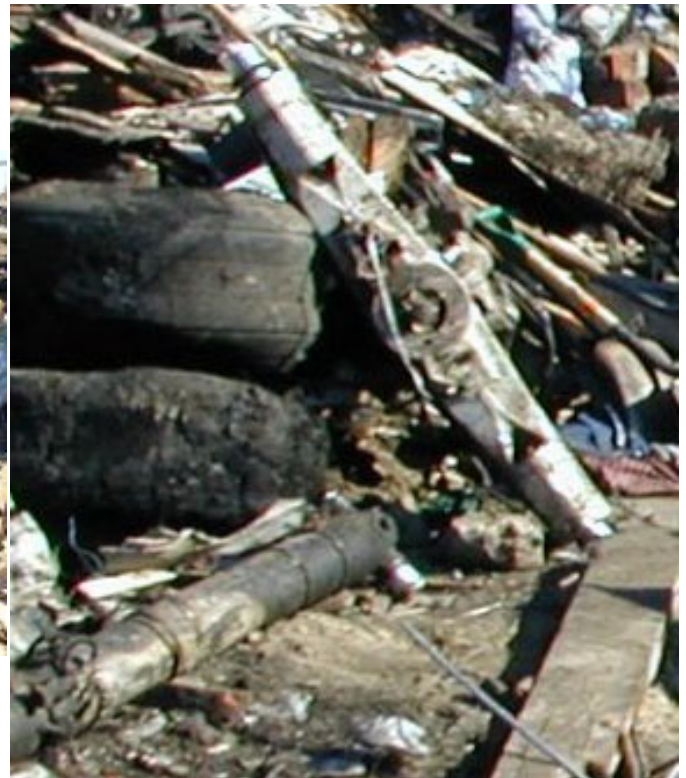
FIGURE 33 & 34

LEFT MAIN LANDING GEAR

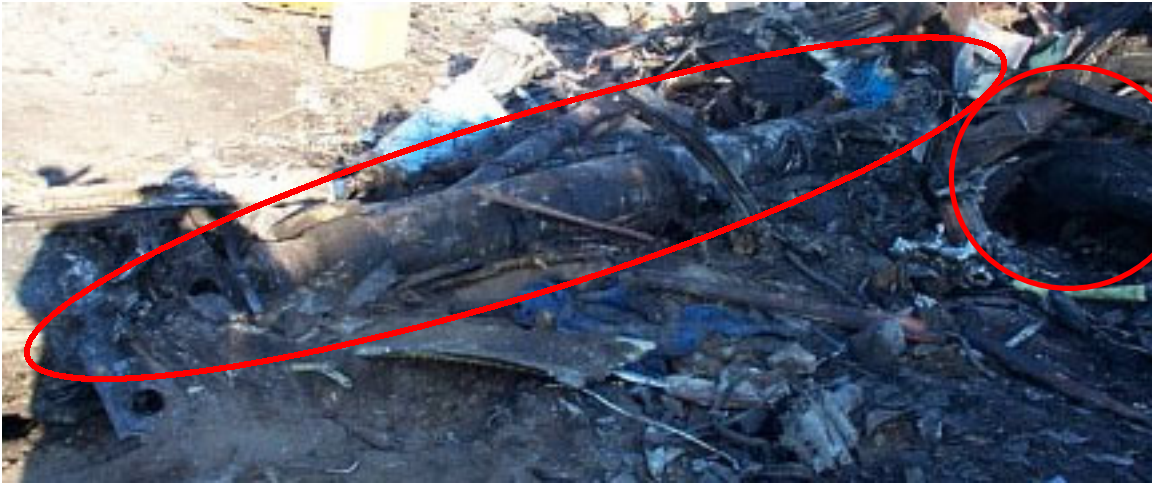
FIGURE 35

RIGHT MAIN LANDING
