ENGINE ANALYSIS REPORT

ENGINE MODEL IO-470-U (Right)

ENGINE SERIAL 118267-R

REGISTRATION NUMBER N8145M

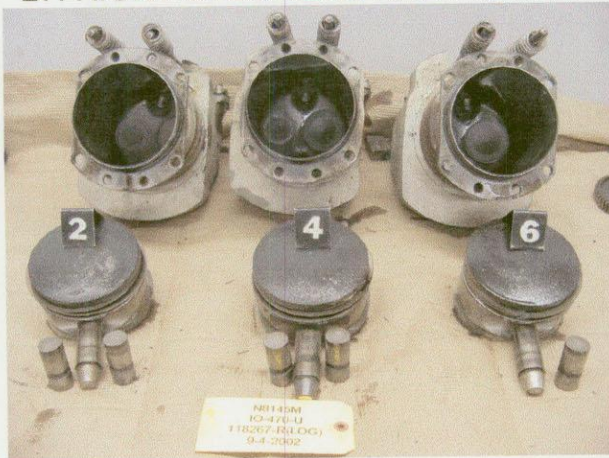
27. RIGHT CYLINDERS AND PISTONS

All steel cylinder bores had rusty spots due to lack of preservation. The combustion chamber exhibited dark colored deposits. Some fibrous debris was observed at the number 4 cylinder lower spark plug area.

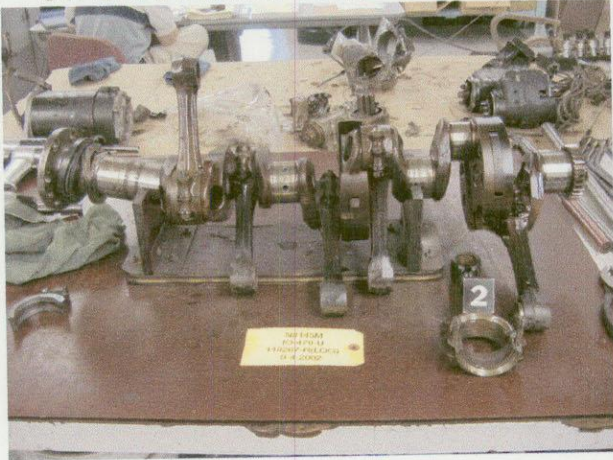
31. CRANKSHAFT AND CON RODS

The crankshaft was bent and fractured at the rear thrust face surface, due to impact. The number 1 connecting rod was removed to inspect its bearing and journal condition. All main journals and number 1 connecting rod journal exhibited normal lubrication signatures.

All connecting rods moved freely on crankshaft journals and were securely fastened in place. Number 1 connecting rod piston pin bushing was loose in the connecting rod. The bushing had moved into the piston pin boss removing some aluminum.

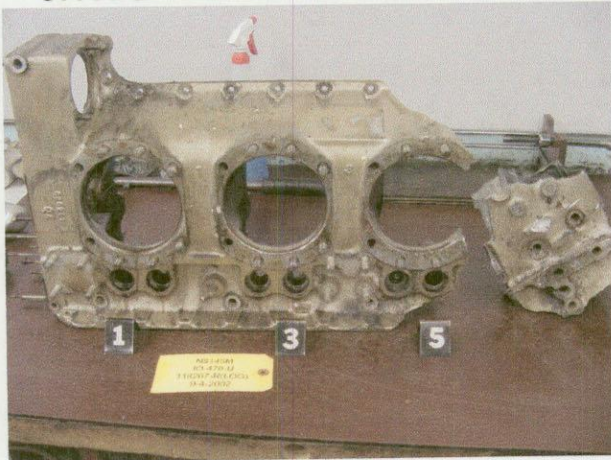
37. RIGHT CRANKCASE EXTERIOR

The crankcase exhibited massage damage at the nose from impact. The crankshaft was bent upward breaking away the front main bearing area. Fretting was observed at the number 2 and 3 main bearing boss parting surfaces. No bearing movement was observed at these areas.

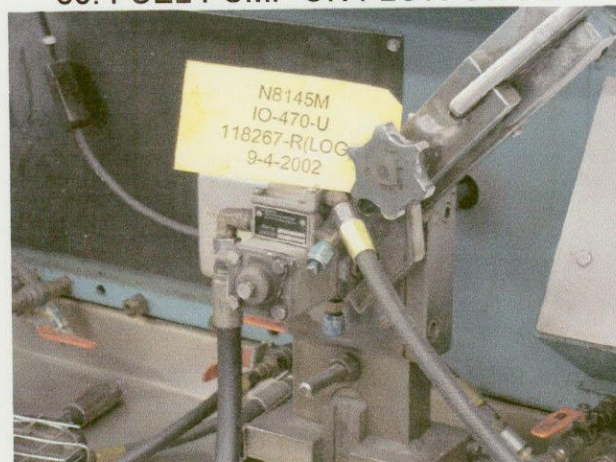
60. FUEL PUMP ON FLOW STAND

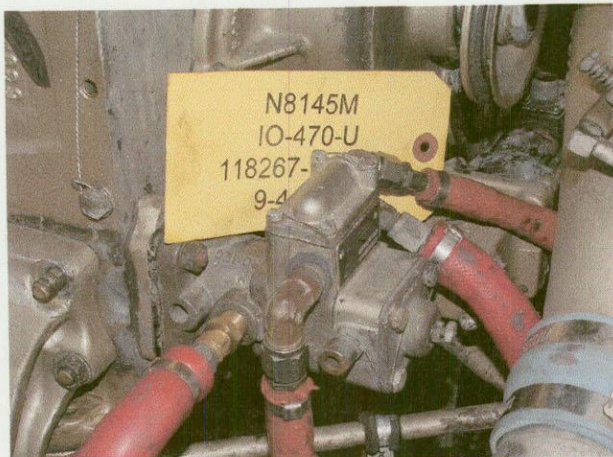
68. FUEL PUMP RAN ON LEFT ENGINE

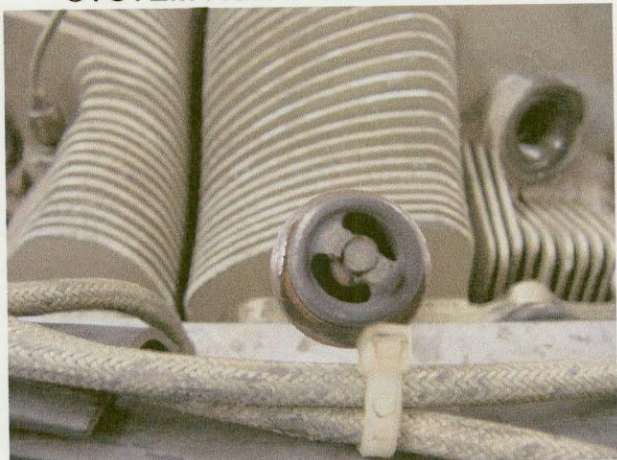
71. SPARK PLUG AFTER RIGHT FUEL SYSTEM RUN ON LEFT ENGINE
