NATIONAL TRANSPORTATION SAFETY BOARD

Group Chairman's Factual Report

DCA21FA085

SUBJECT: *Right Engine Fan Blade Out and Inlet/Fan Cowl Departure – Examination of recovered Inlet Cowl, Fan Cowls, and Thrust Reversers*

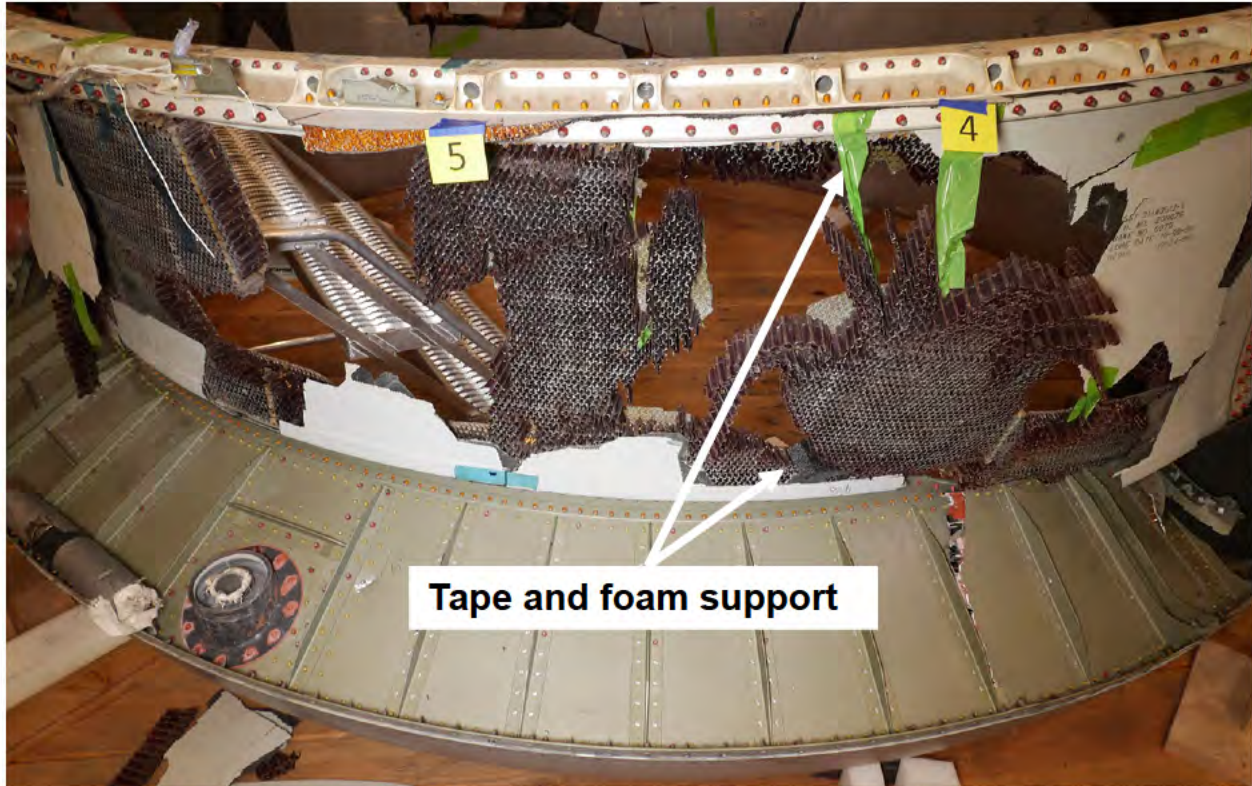
Figure 14: Inlet cowl with fragments reassembled to assist in incident investigation.

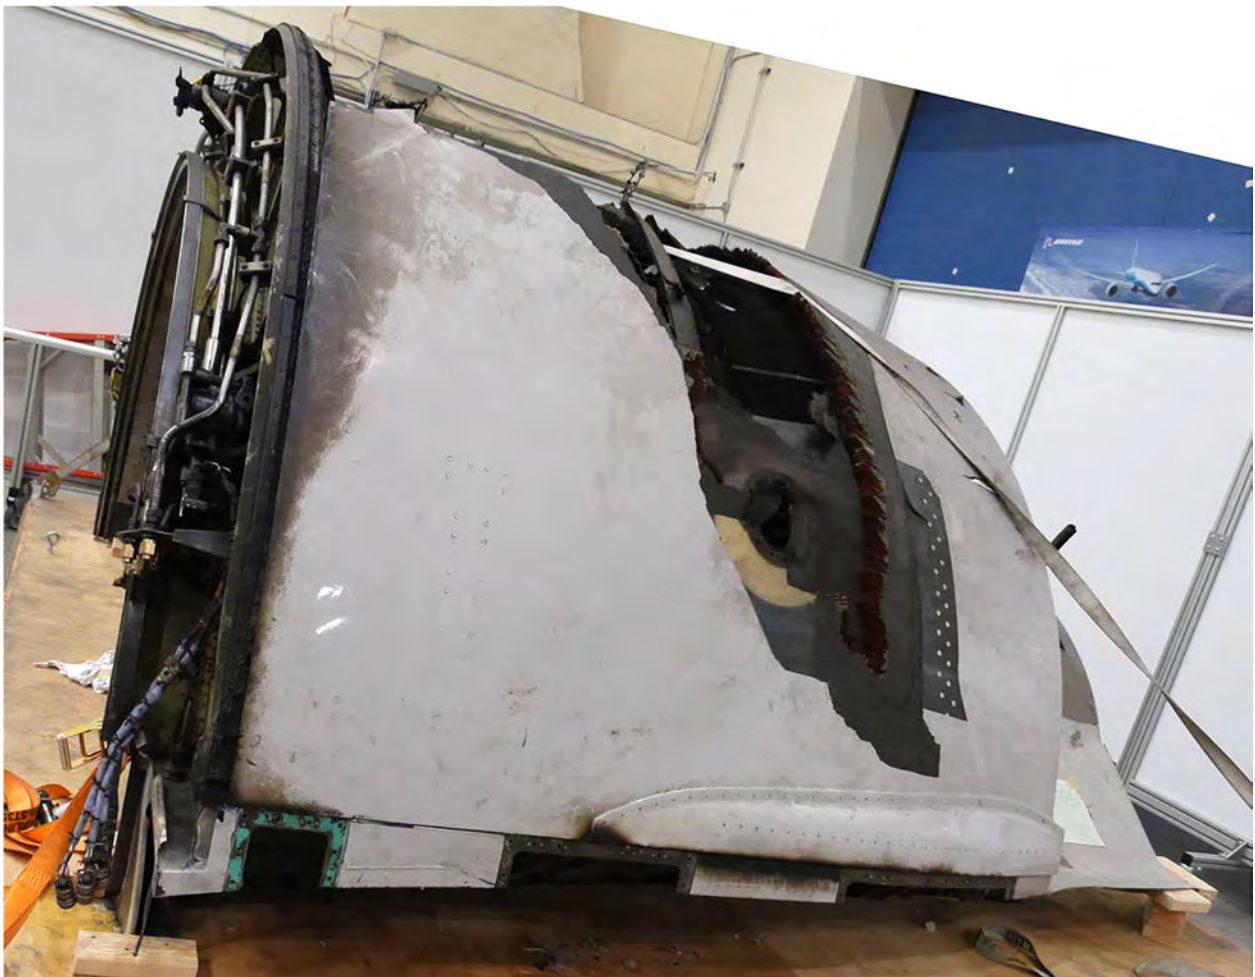
Figure 39: Outboard thrust reverser hinge beam and translating sleeve (view looking down).

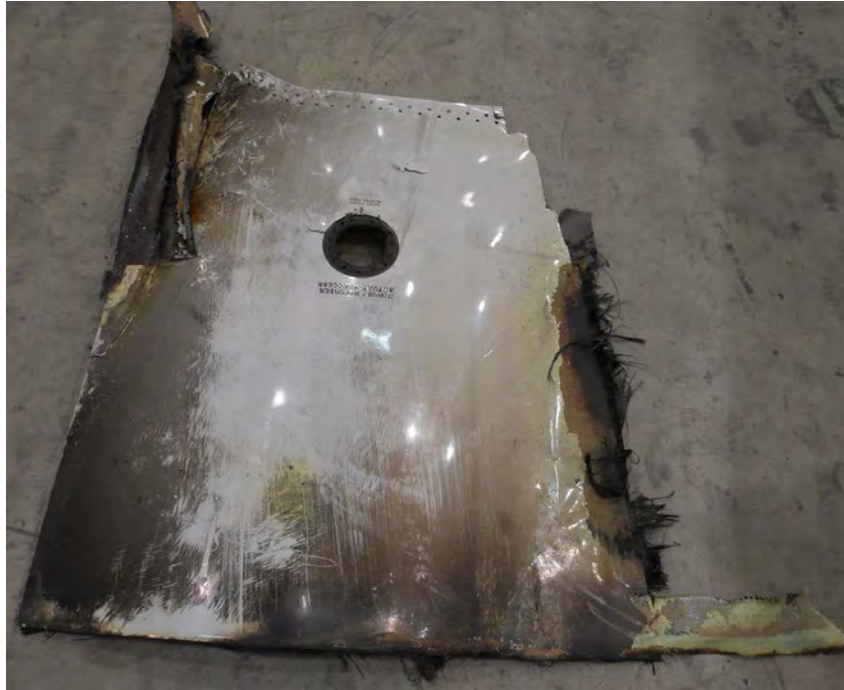
A large section of the translating sleeve was recovered from the incident location. In its installed location the part was located at the lower translating sleeve in the 6:00 to 4:00 position. Figure 46 and Figure 47 show the translating sleeve fragment outer and inner surfaces, Figure 48 shows the translating sleeve section near the installed location.

Figure 46: Translating sleeve separated from outboard thrust reverser, outer surface.

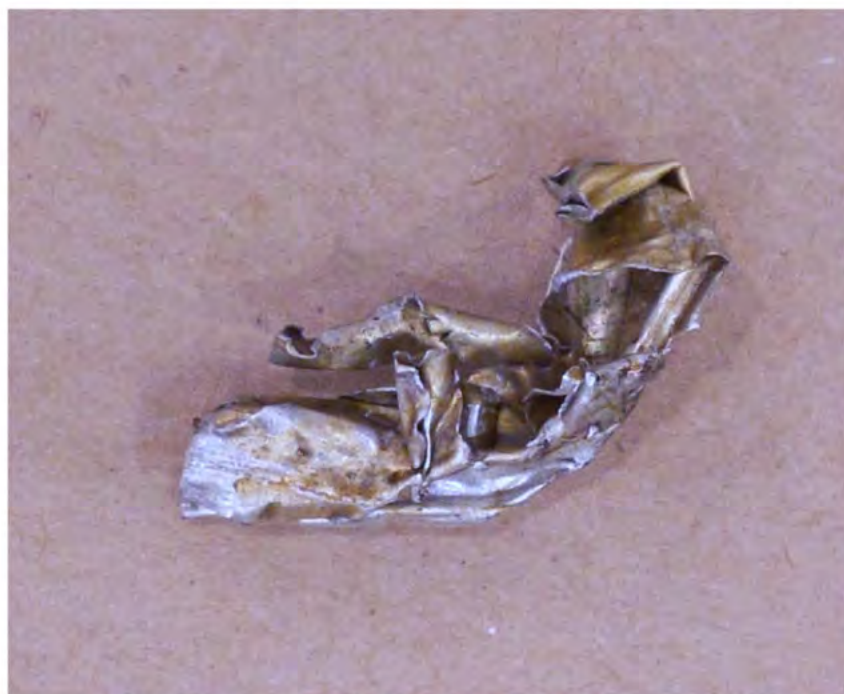
Figure 62: Fragment removed from inner wall of translating sleeve at 2:45.

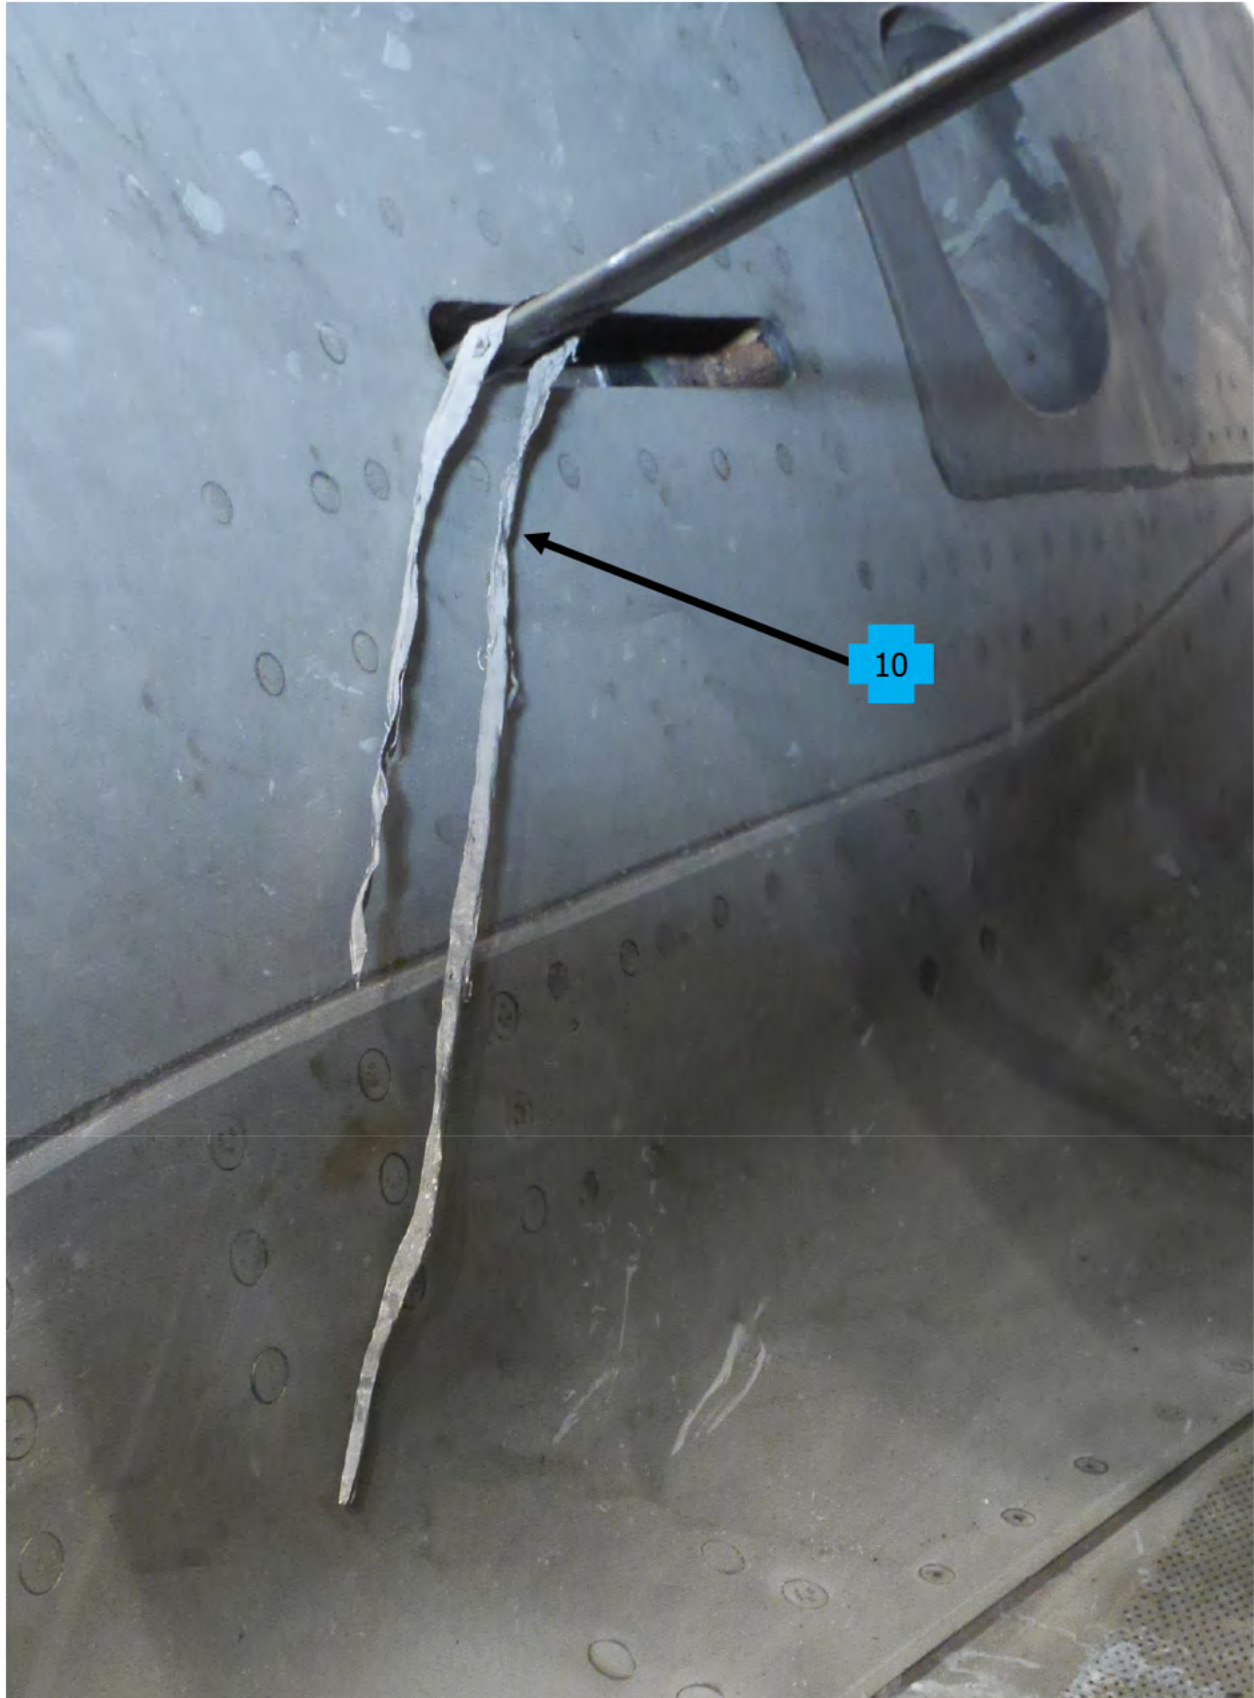
Figure 65: Material removed from blocker door drag link at 12:30.

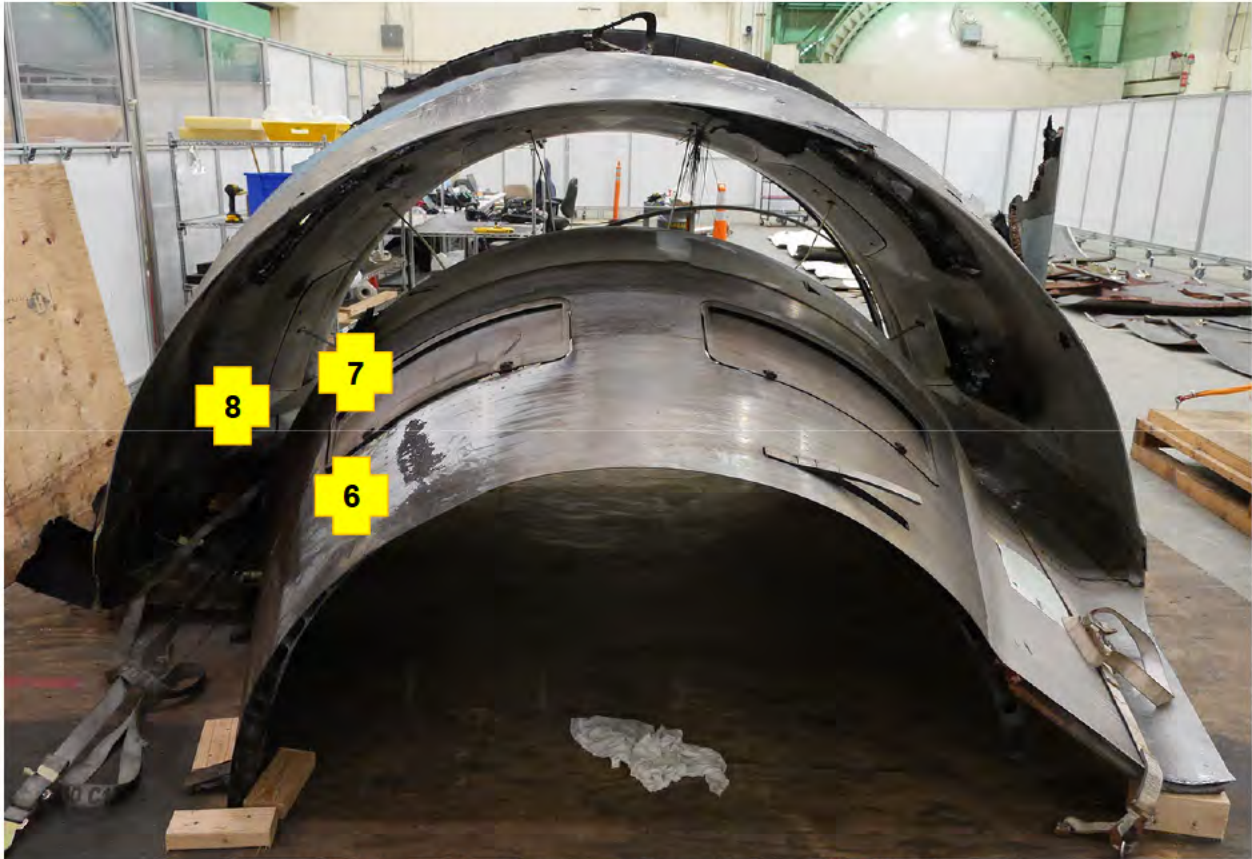
Figure 69: Inboard thrust reverser aft cowl (view aft looking forward).

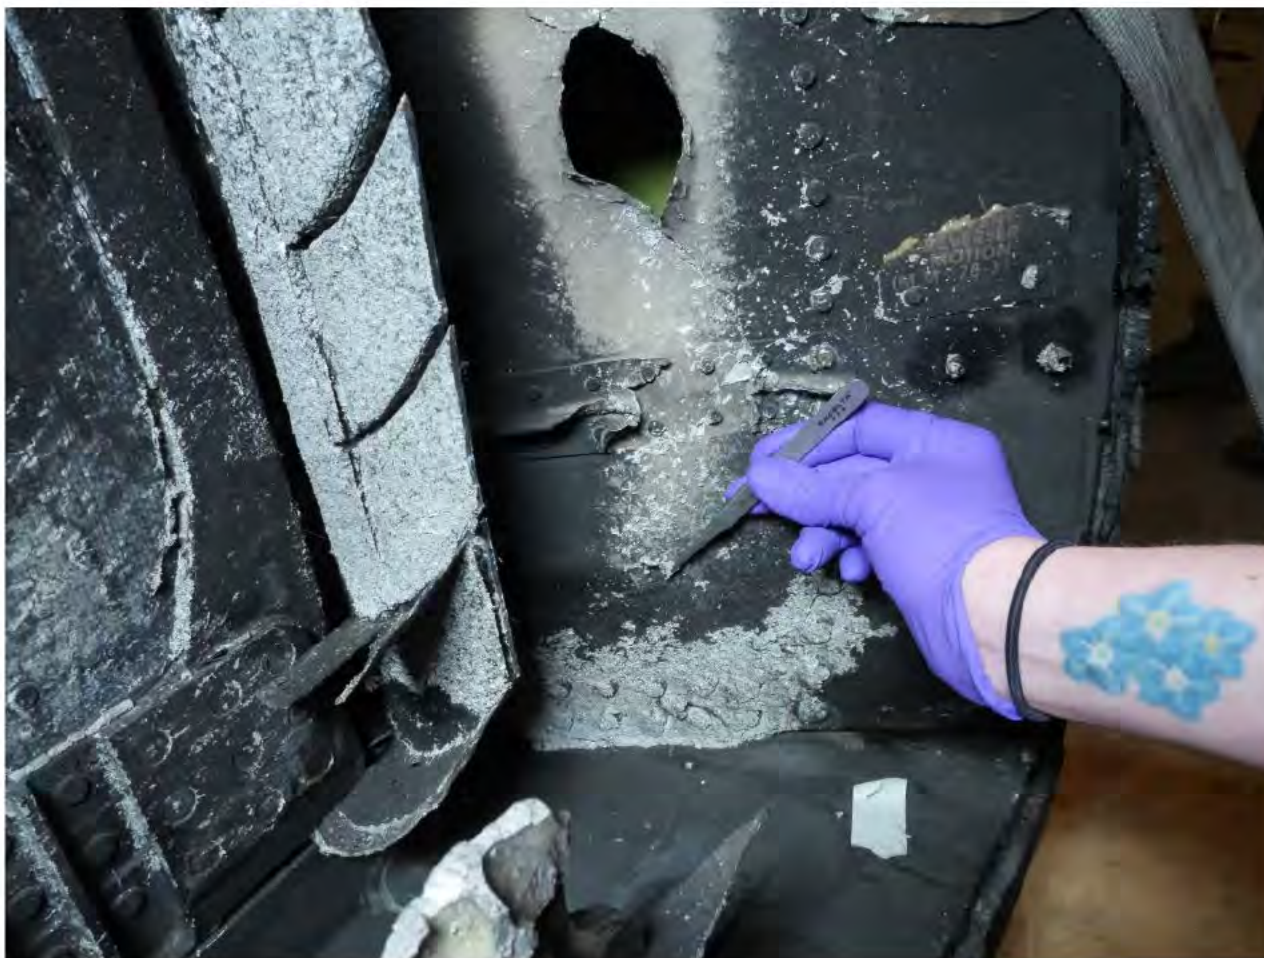
Sample #1 Right TR Metal slag aft side torque box 6:00

#1 RH TR metal: consistent with 7xxx aluminum, but has elevated phosphorous and oxygen content

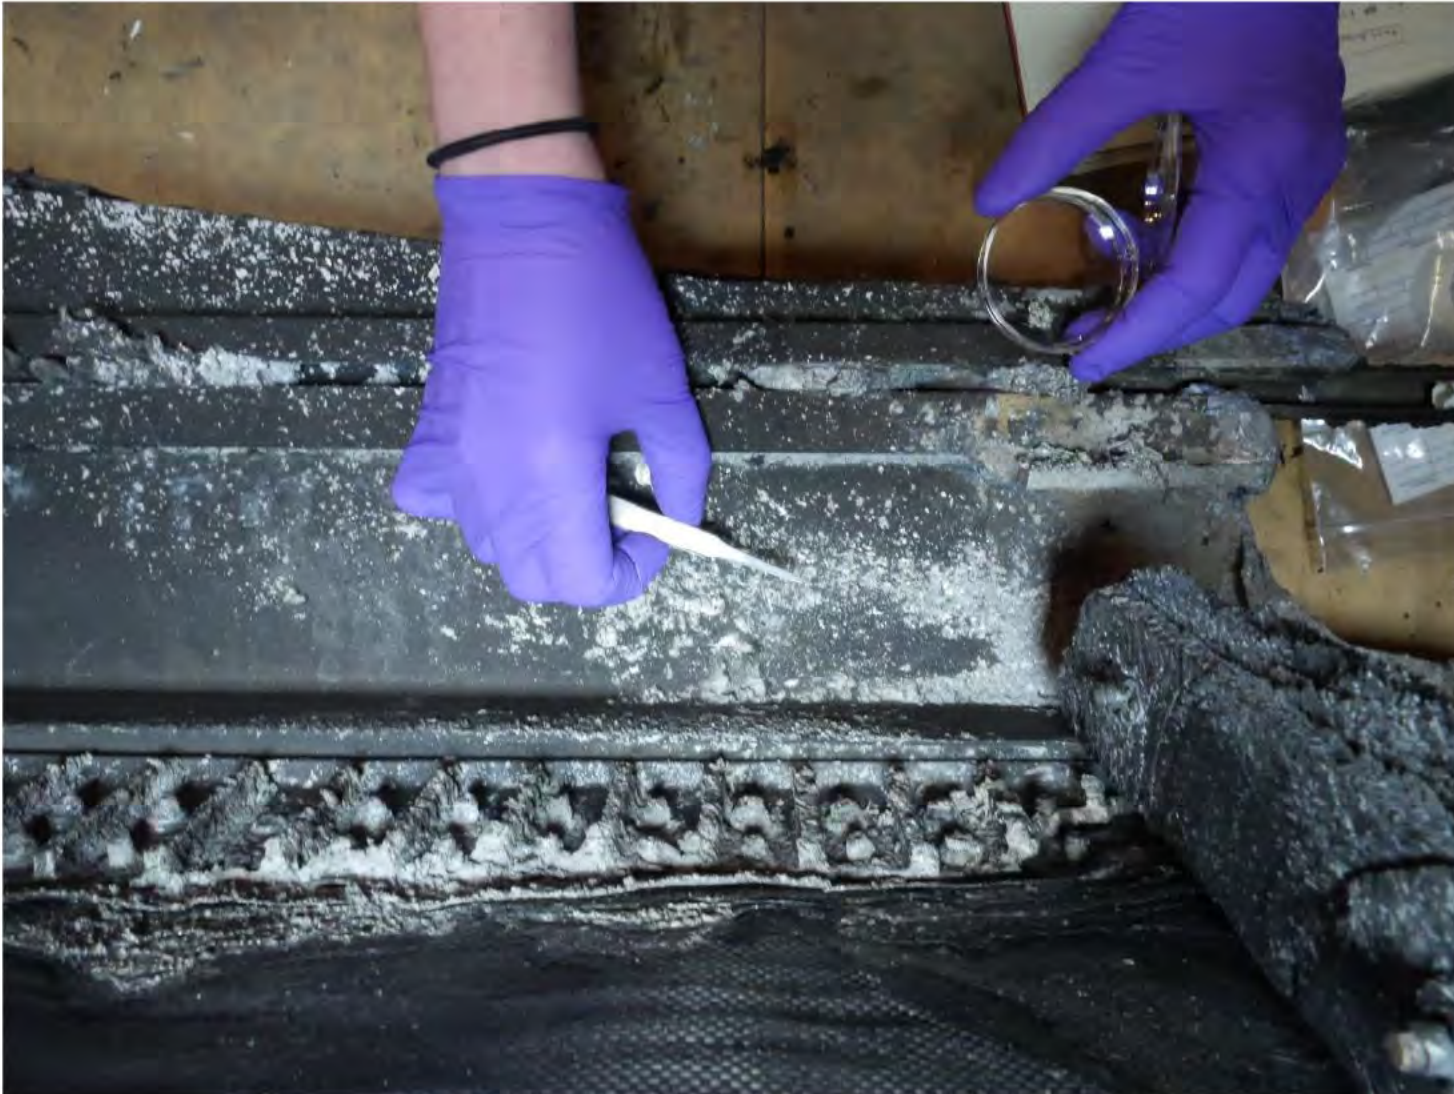
Sample #2 Right hand TR metal slag hinge beam

2 metal slag on RH TR hinge beam consistent with 7xxx aluminum

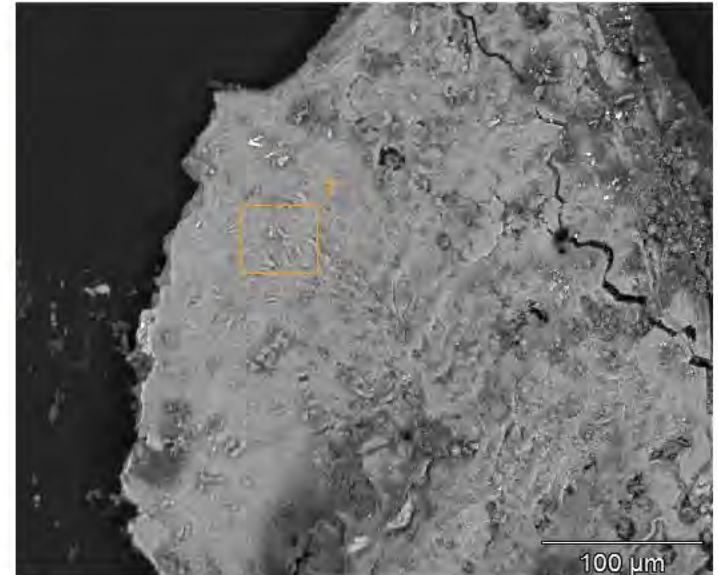
The organic residue on the #2 RTR metal pieces was similar in overall chemistry. This residue was similar to a mixture of turbine oil and phosphate ester hydraulic fluid.

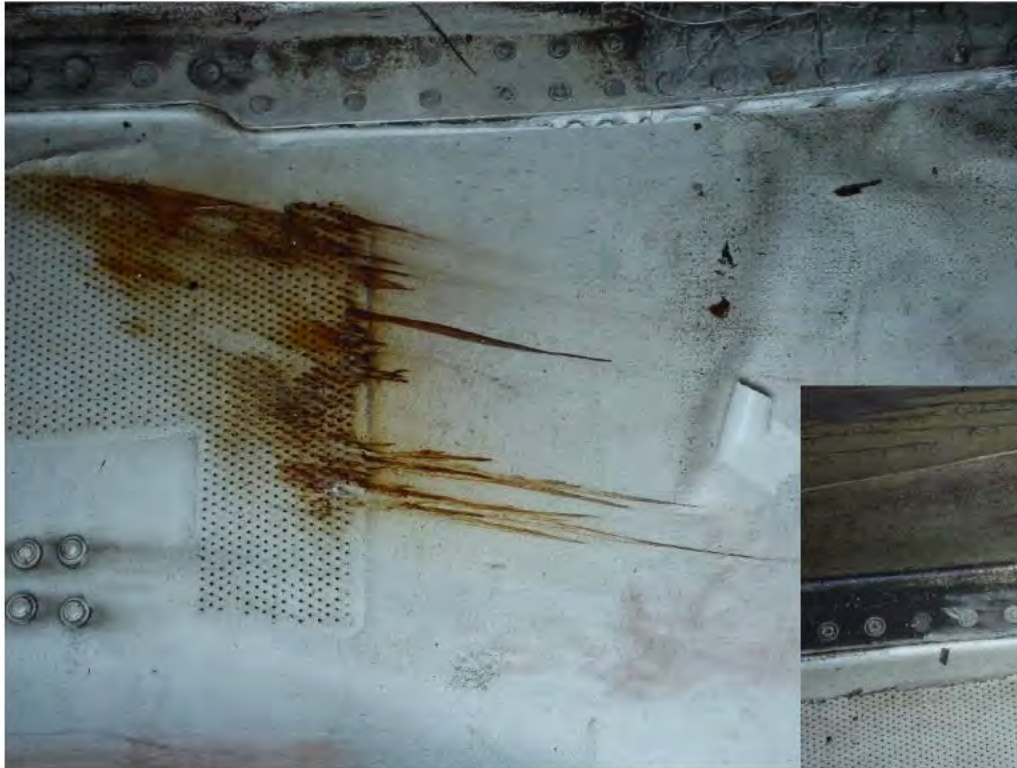
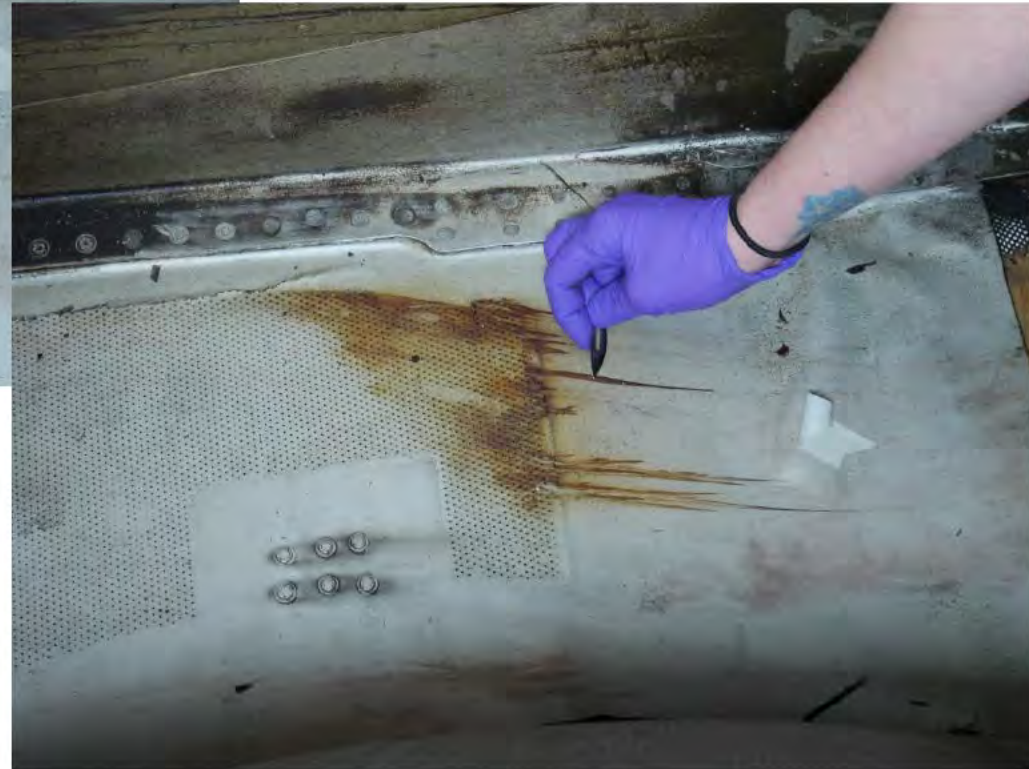
Sample #3 Right hand TR inner skin brown goo translating sleeve

#3 brown deposit on RH TR translating sleeve inner perforated skin was consistent with an epoxy resin which is likely oxidized

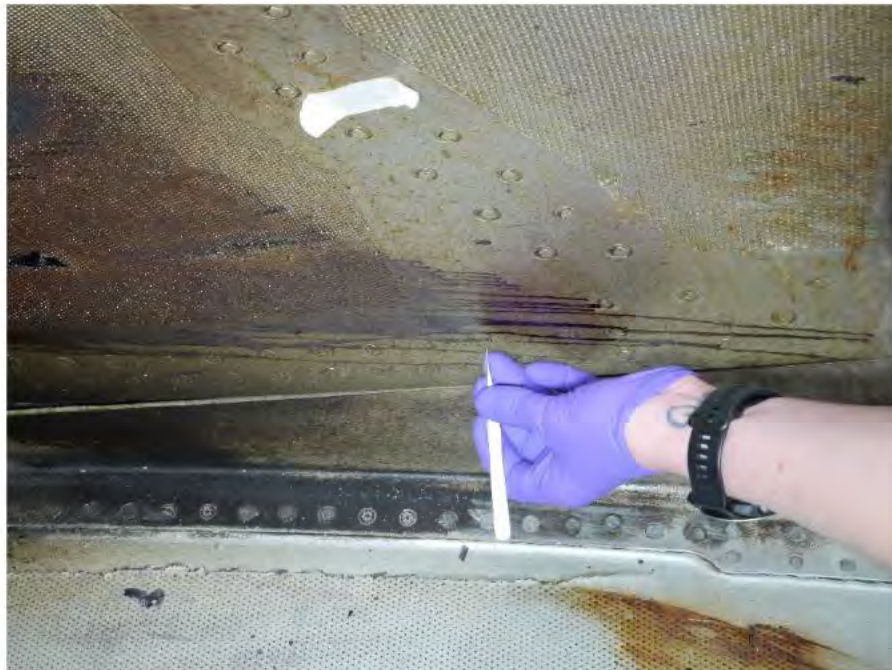
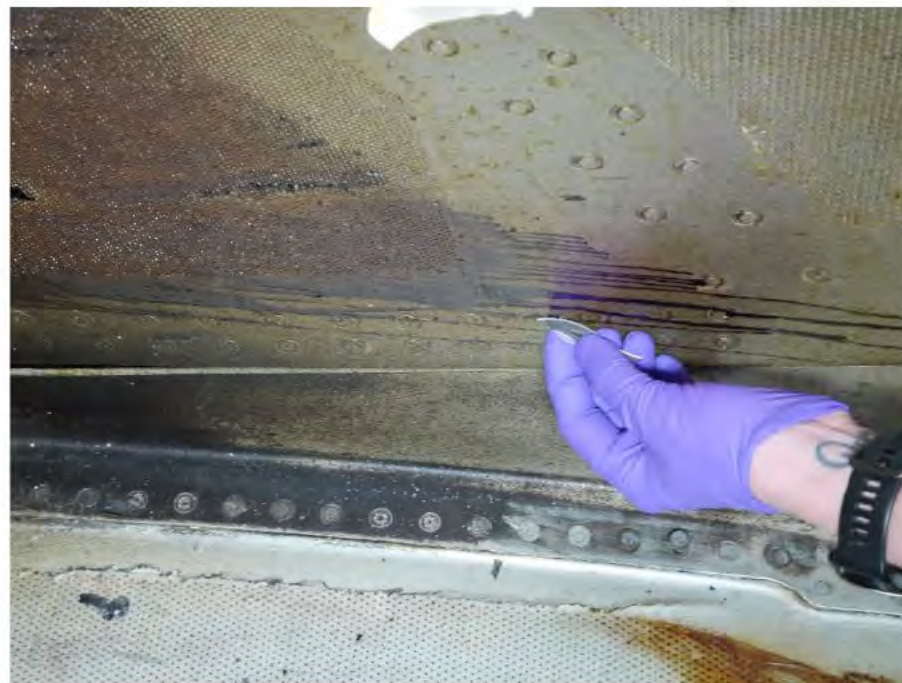
Sample #4 Right thrust reverser inner skin bifurcation brown goo

#4 brown deposit on RH TR bifurcation inner perforated skin was consistent with an epoxy resin likely in a mixture of cure / crosslinking states as well as an adipate chemistry which could be from handling or a plasticizer

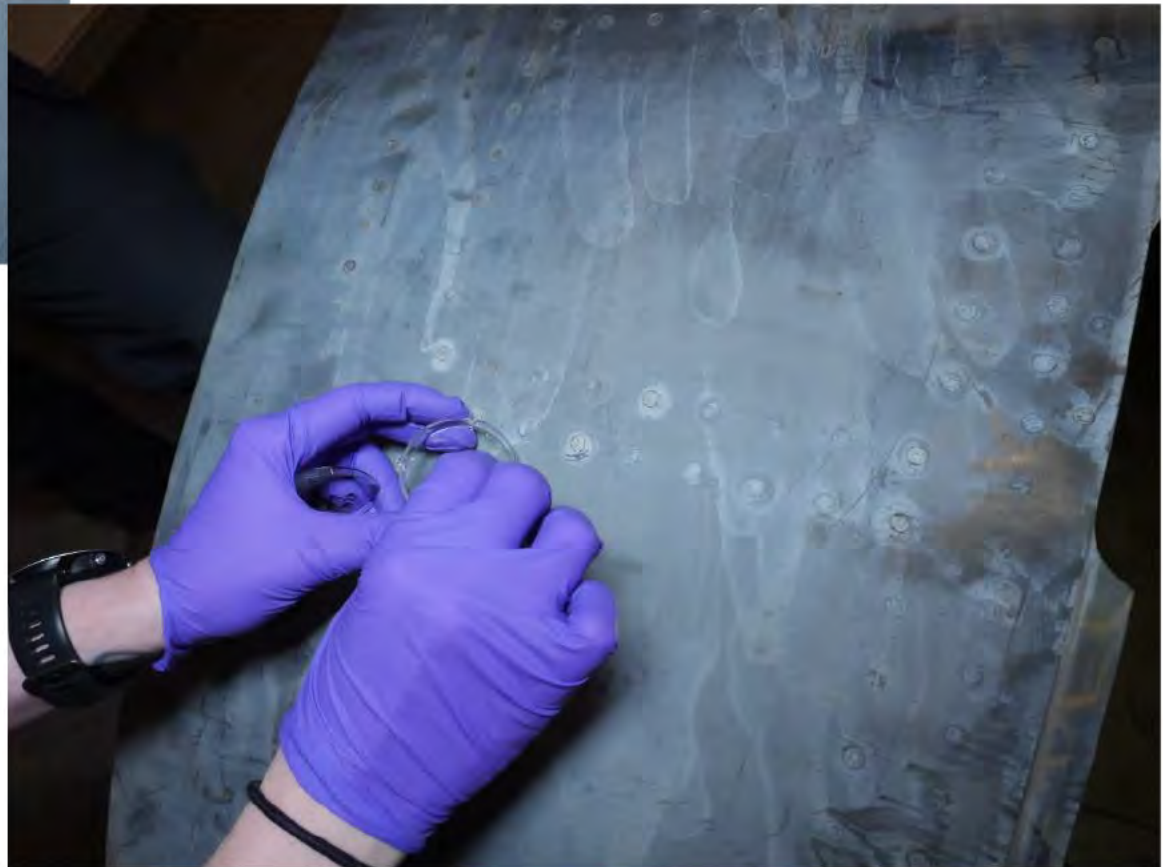
Sample #5 white residue

5 white residue – consistent with inorganic/mineral debris

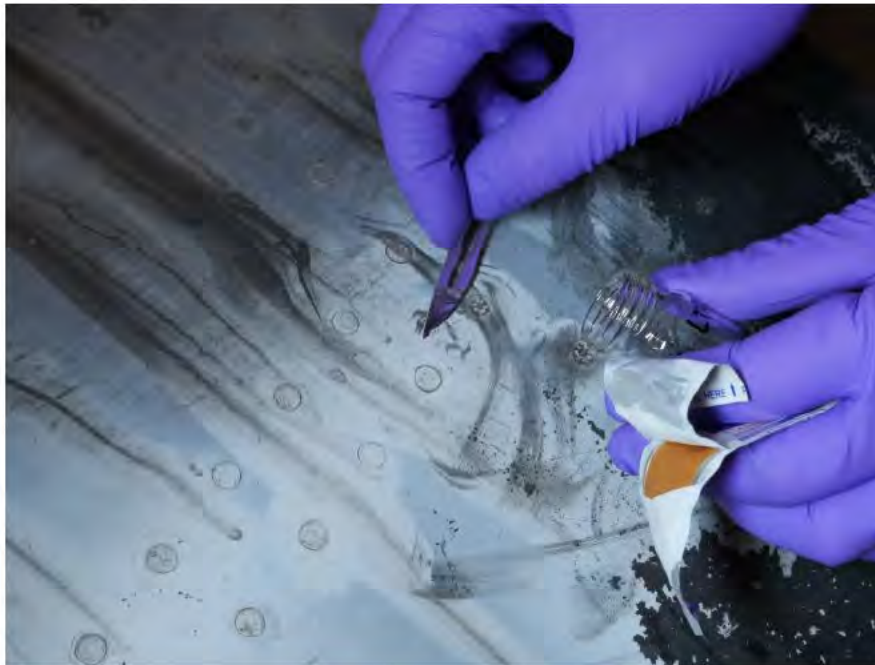
Sample #6 White residue

6 EDS white residue on LH TR AFT cowl is consistent with inorganic material

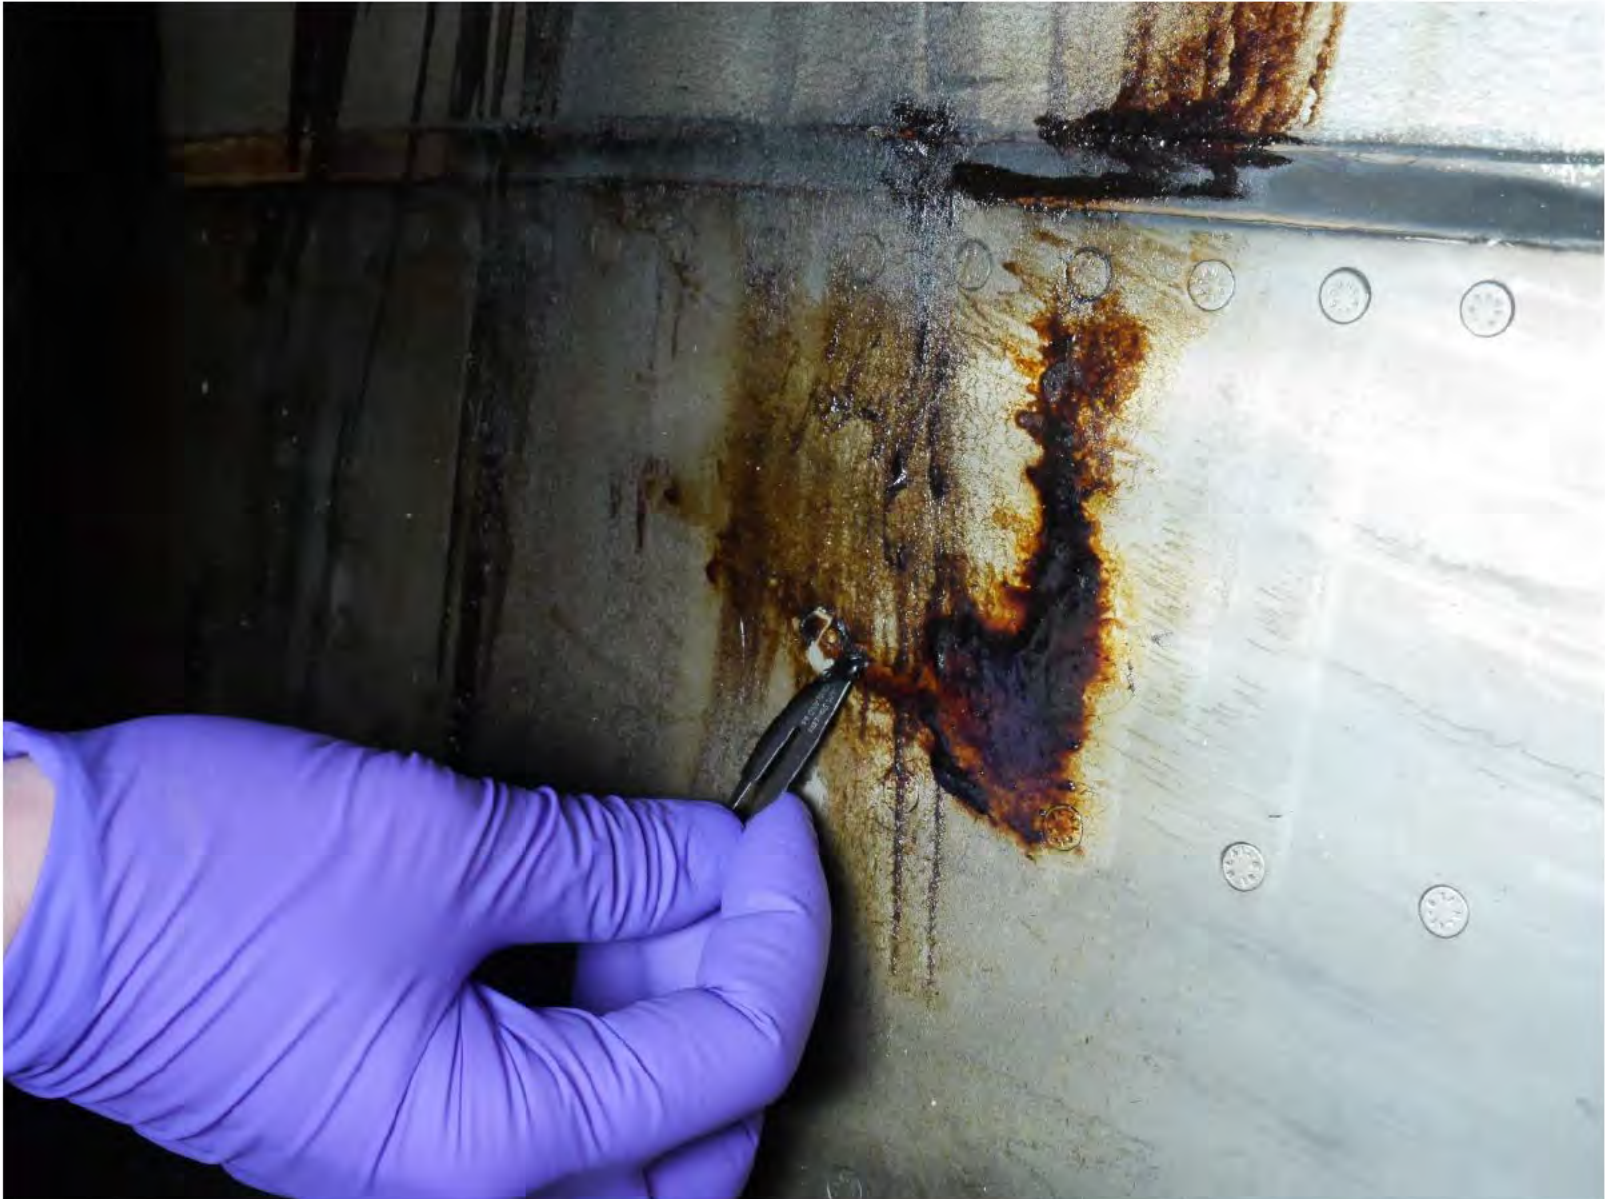
Sample #7 Left hand TR core skin brown goo

7 brown deposit on LH TR core cowl perforated skin was consistent with a mixture of epoxy resin and a chemistry similar to an methyl adipate (adipate-based chemistry could be from handling or plasticizers)

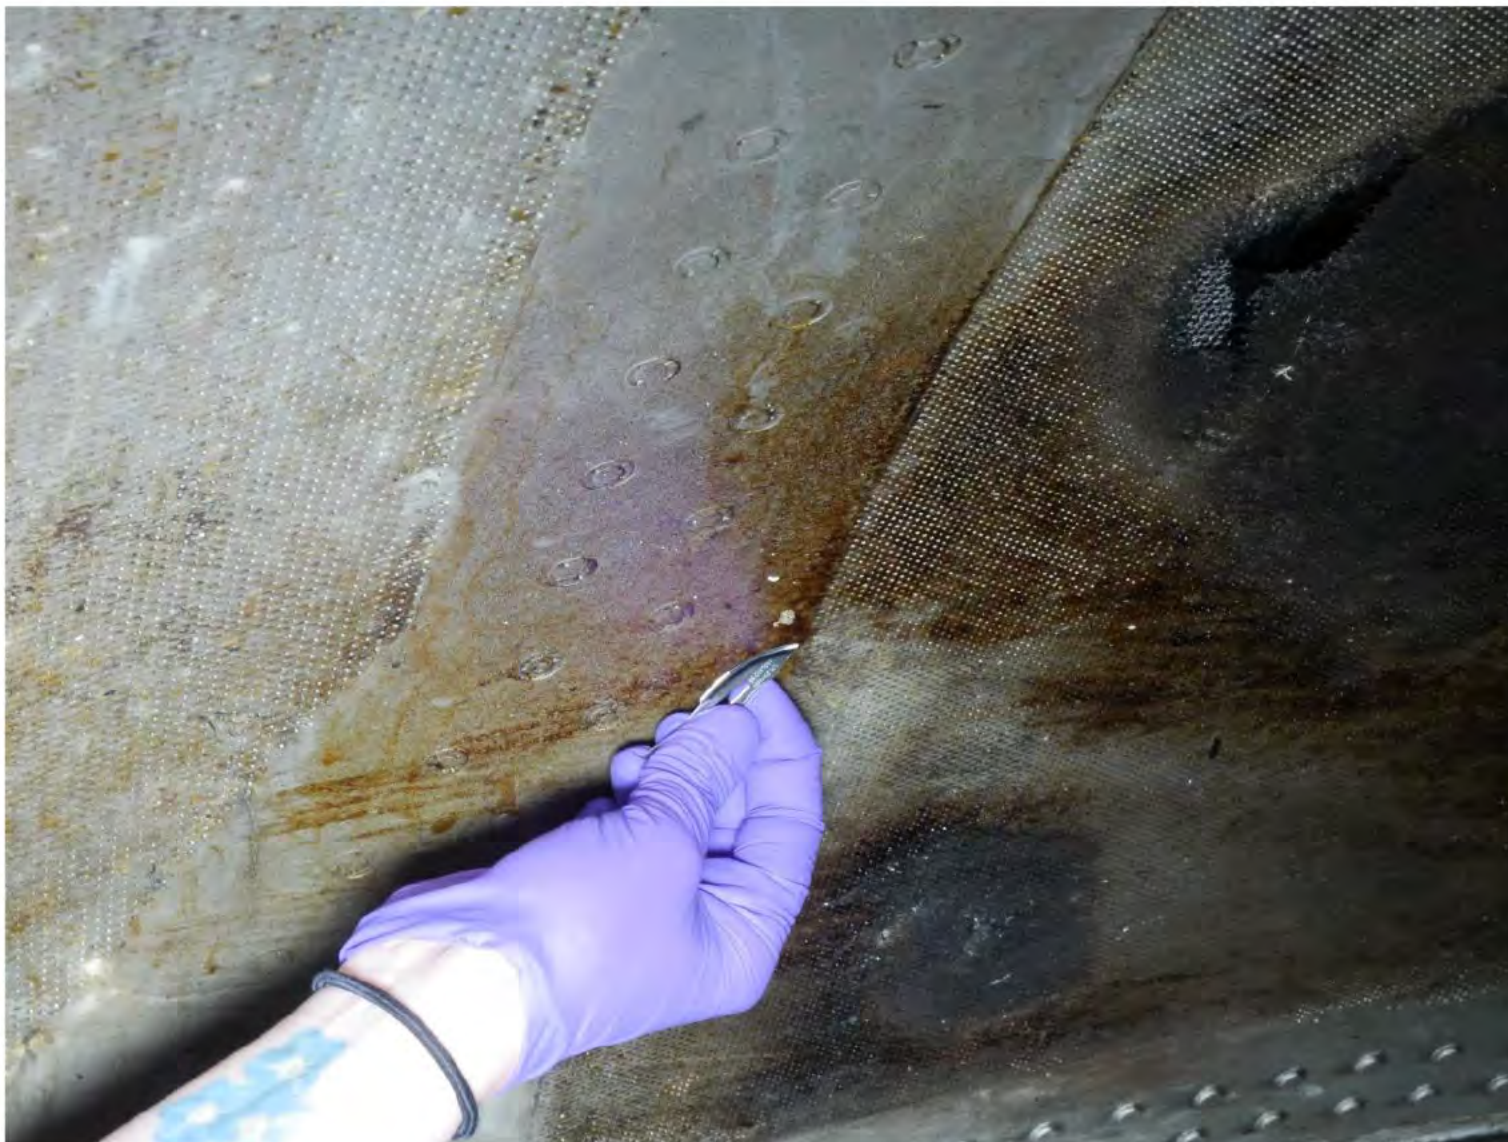
Sample #8 Left hand TR inner skin brown goo

8 brown deposit on LH TR translating sleeve inner perforated skin was consistent with a mixture of epoxy resin and adipate (adipate-based chemistry could be from handling or plasticizers)

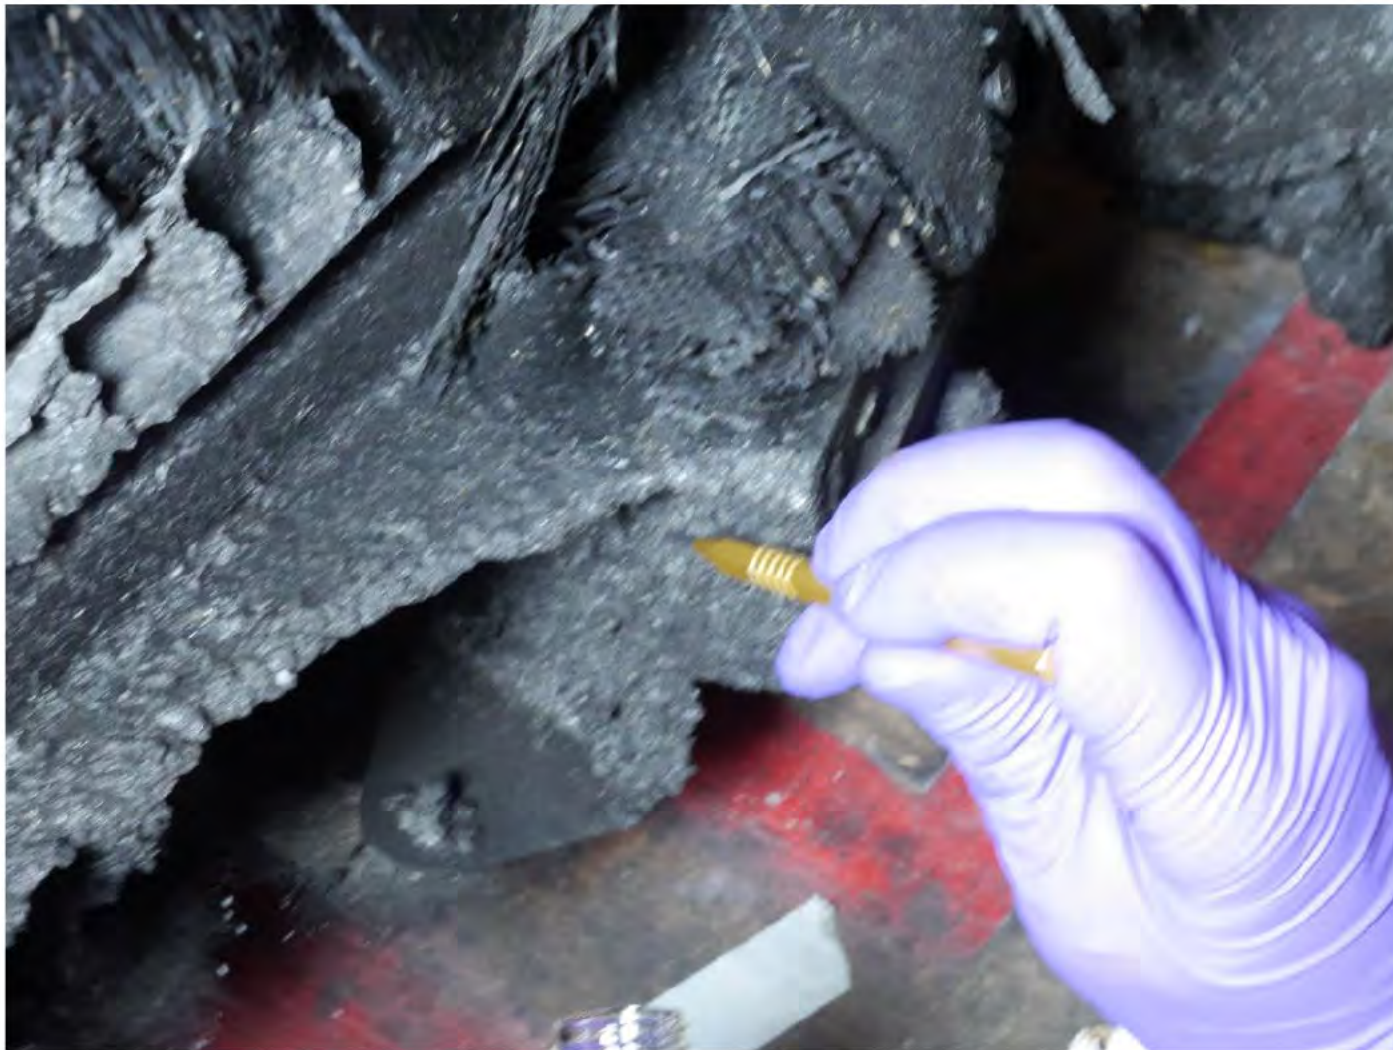
Sample #9 Left hand TR soot hinge beam

9 soot on LH TR latch beam was consistent with a mixture of synthetic oil (likely engine oil) and phosphate ester hydraulic fluid (i.e. BMS3-11)

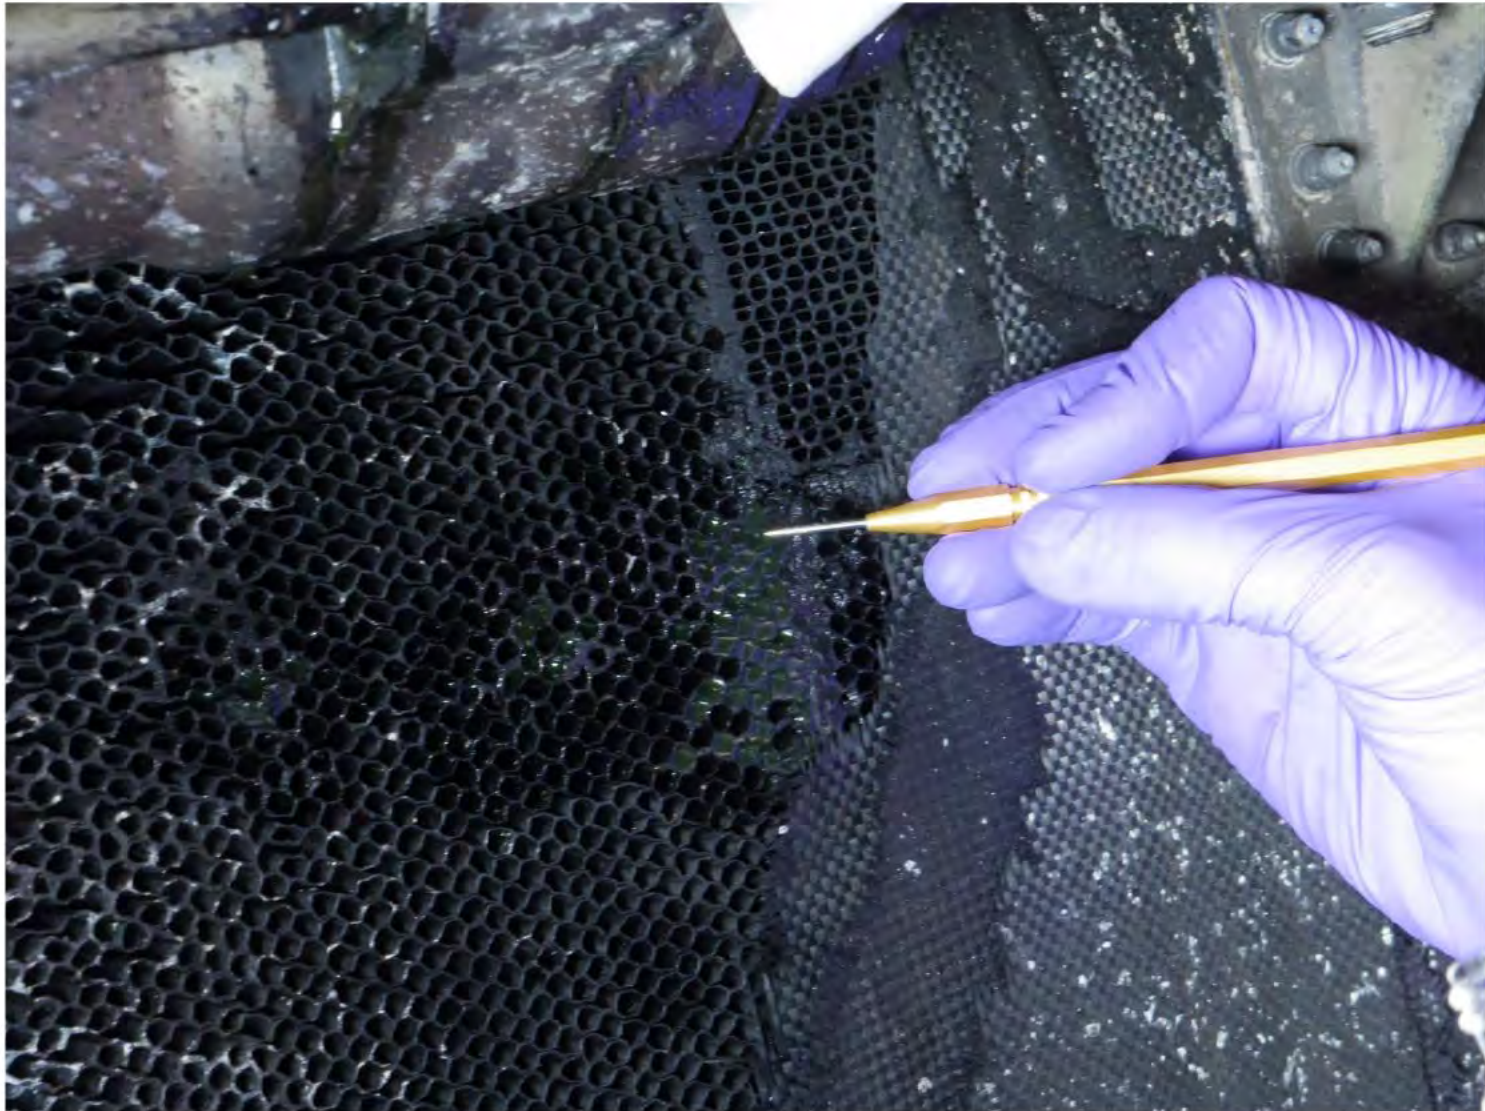
Sample #10 Fluid near actuator

#10 fluid near actuator was consistent with BMS3-11 phosphate ester hydraulic fluid

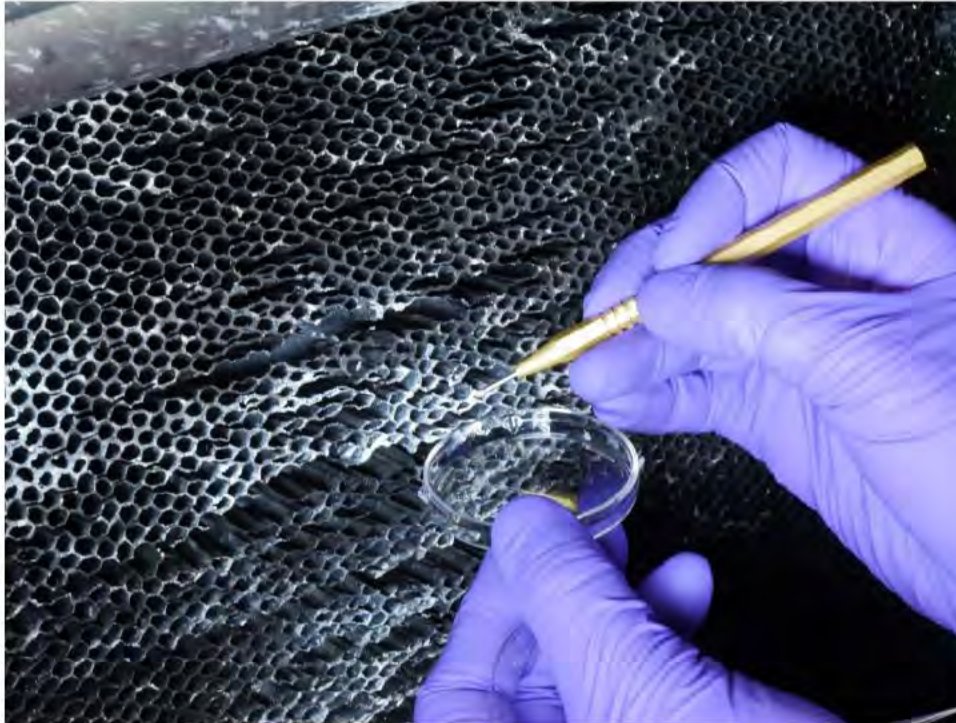
#11 white residue on LH TR exposed honeycomb consistent with inorganic material
