NATIONAL TRANSPORTATION SAFETY BOARD

Group Chairman's Factual Report

DCA21FA085

SUBJECT: *Right Engine Fan Blade Out and Inlet/Fan Cowl Departure – Examination of recovered Inlet Cowl, Fan Cowls, and Thrust Reversers*

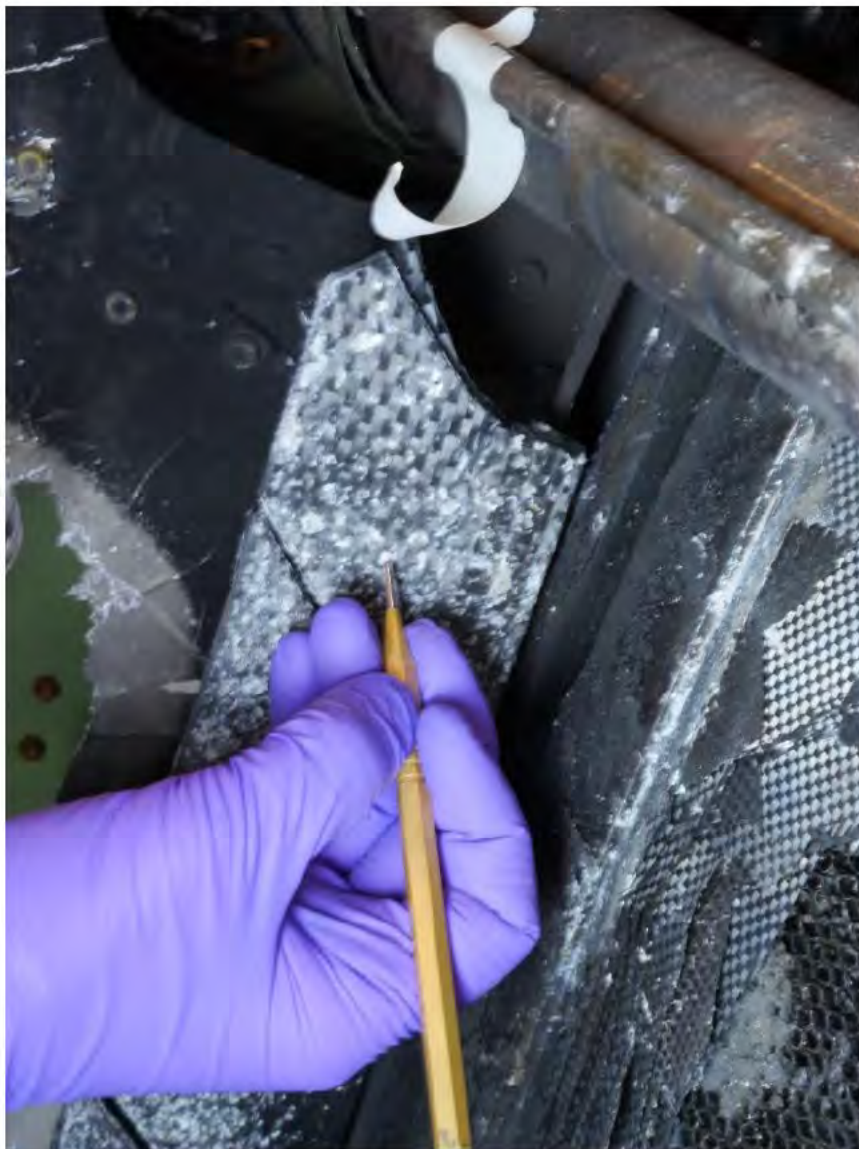
Sample #12 Left hand TR metal slag on cascade remnants

#12 white residue on LH TR cascade is consistent with an inorganic material (+ fluorine)

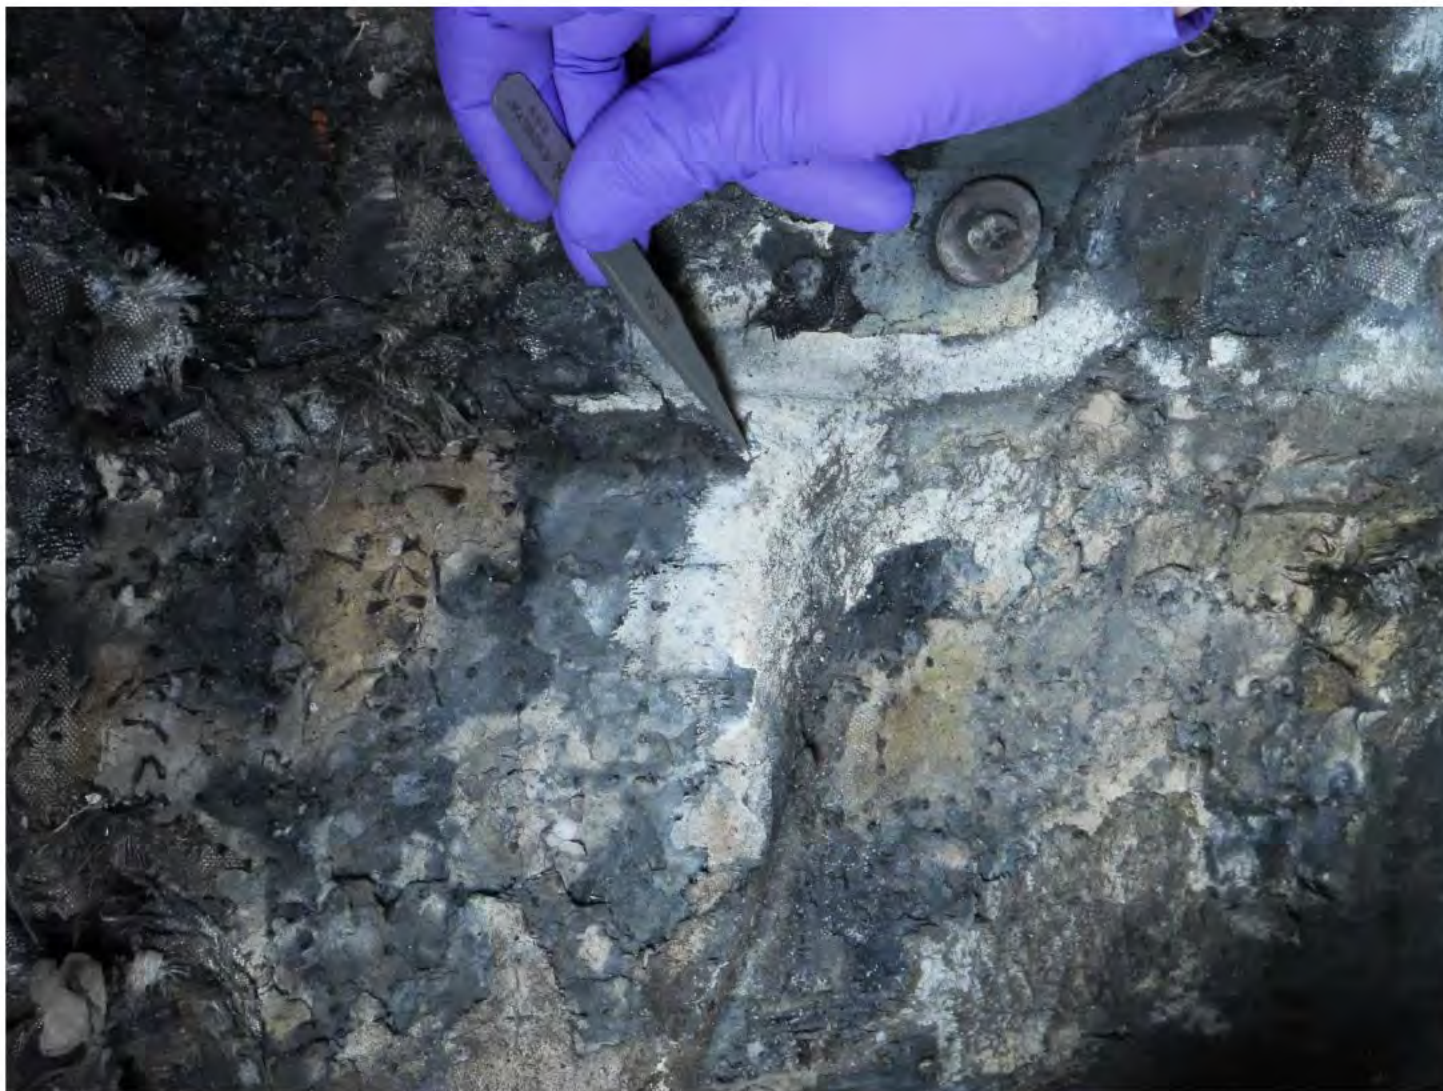
Sample #13 Left hand TR White residue on heat blanket

#13 white residue on LH TR bifurcation heat blanket consistent with a magnesium oxidation product

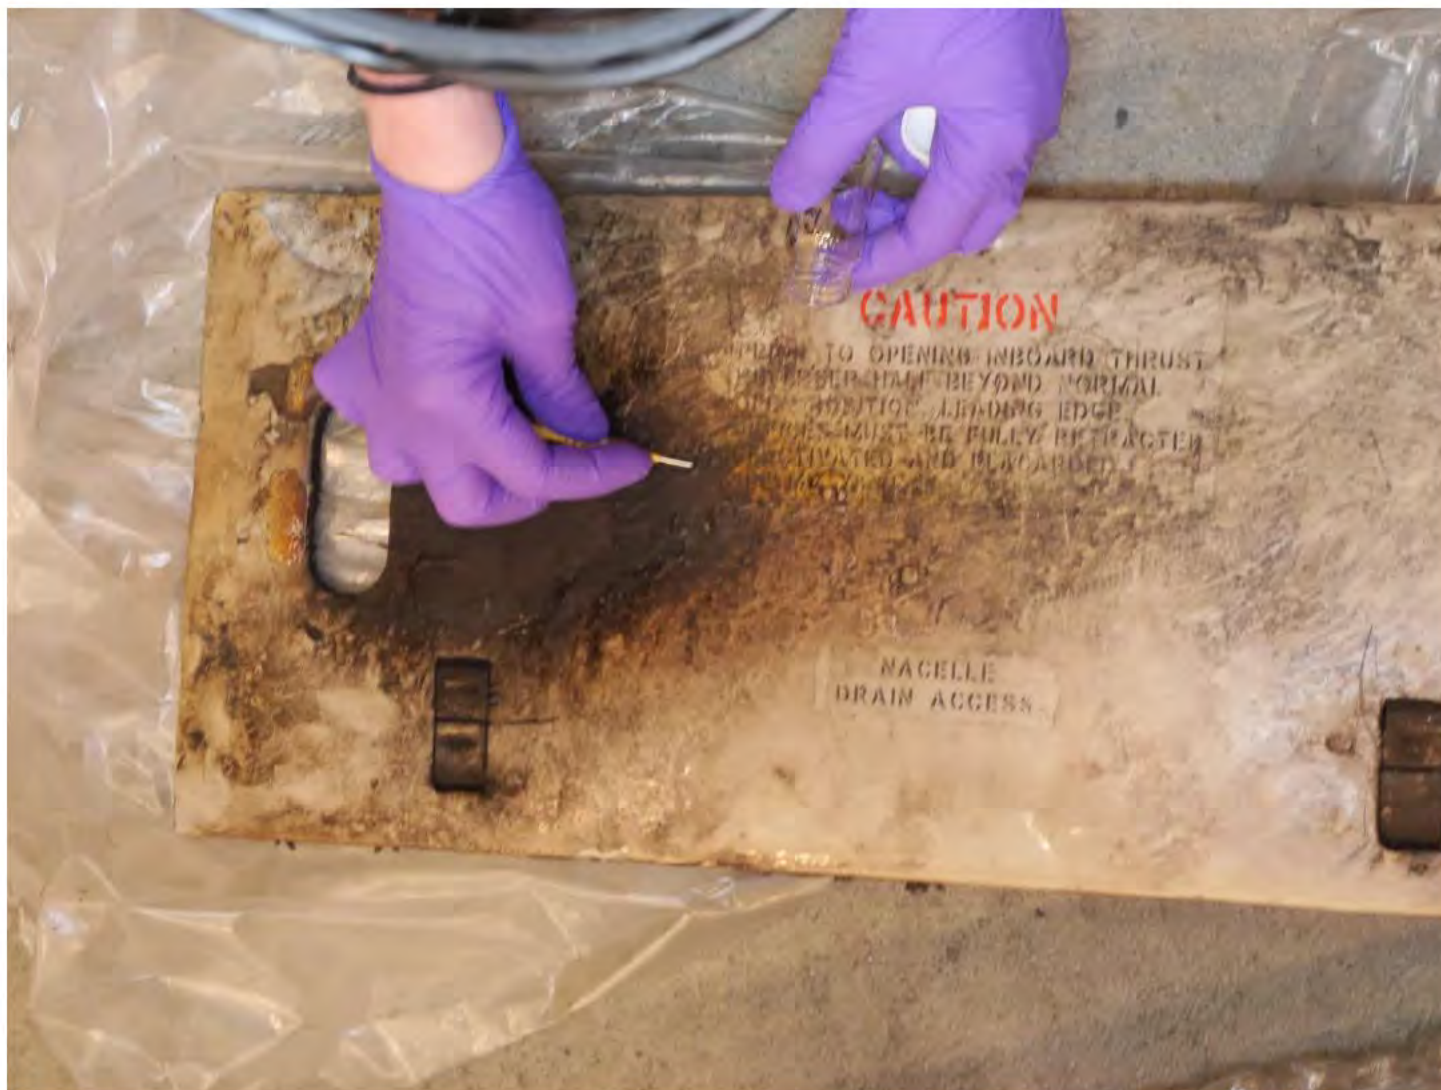
Sample #15 soot on outer surface of nacelle drain access door

#15 soot on outer surface of nacelle drain access door was consistent with a mixture of synthetic oil (likely engine oil) and a poly(acrylate) which is likely tape residue

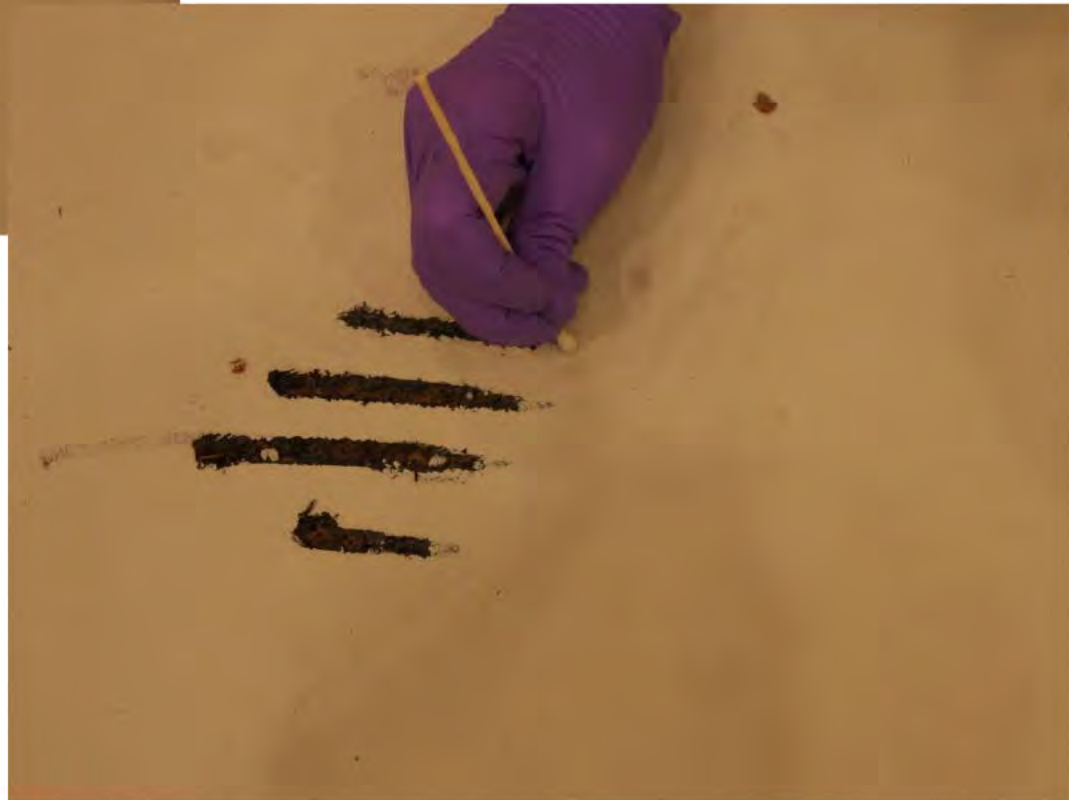
Sample #16
Inlet Cowl
inside of
outer barrel
at 10:00

#16 hexane extraction is consistent with a stearate chemistry (ester modified hydrocarbon – fatty acid)

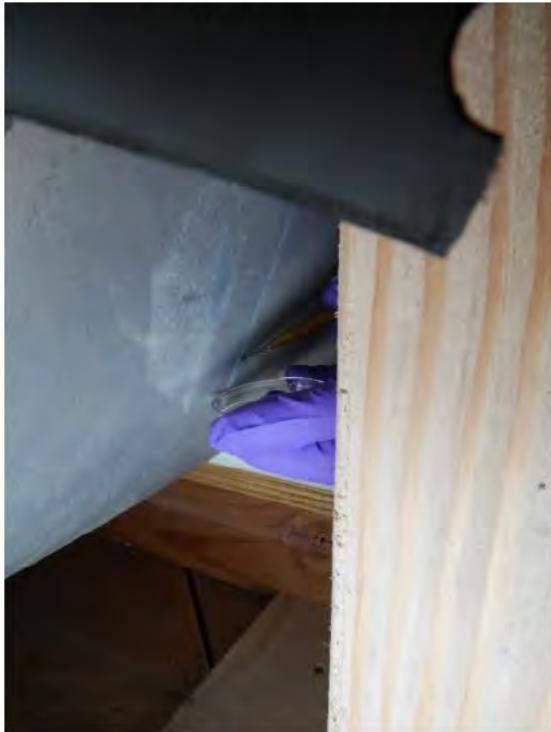
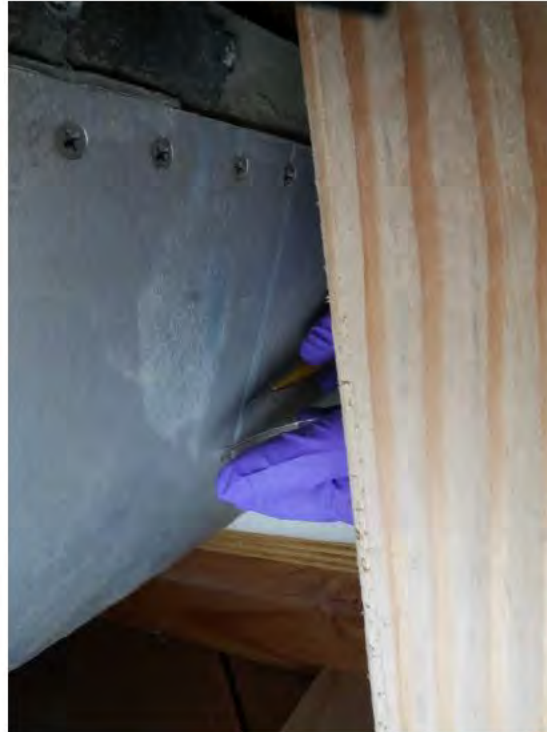
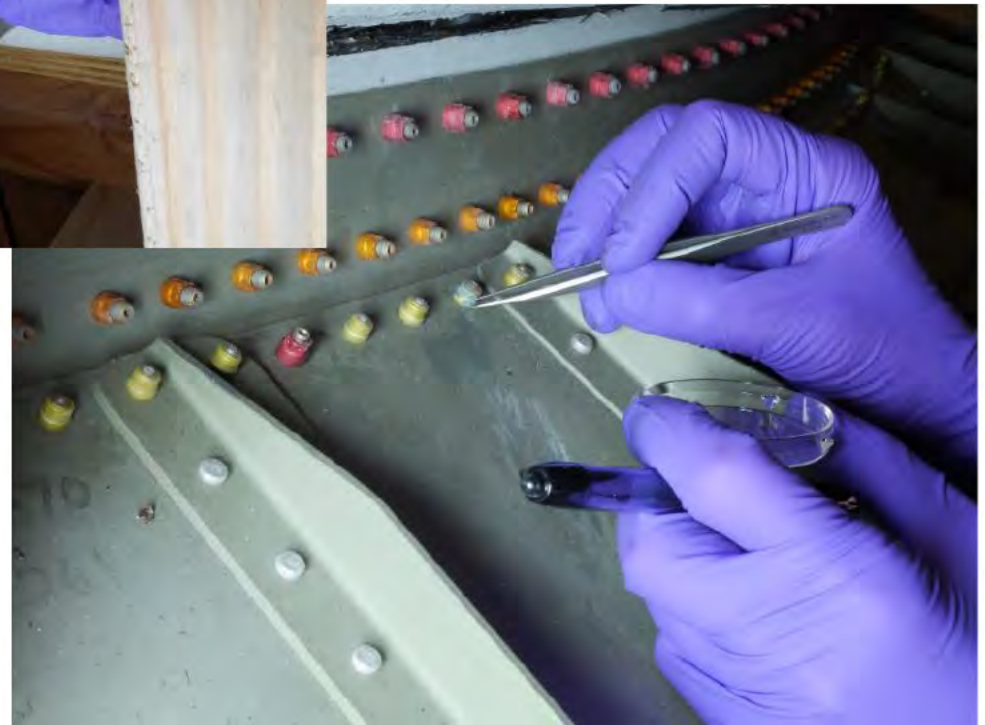
Sample #18 Inlet cowl blue paint

#18 blue paint on inlet lipskin near 0530 was consistent with a carbamate based paint; more similar to an automotive paint (carbamate) than an aircraft (polyurethane) topcoat

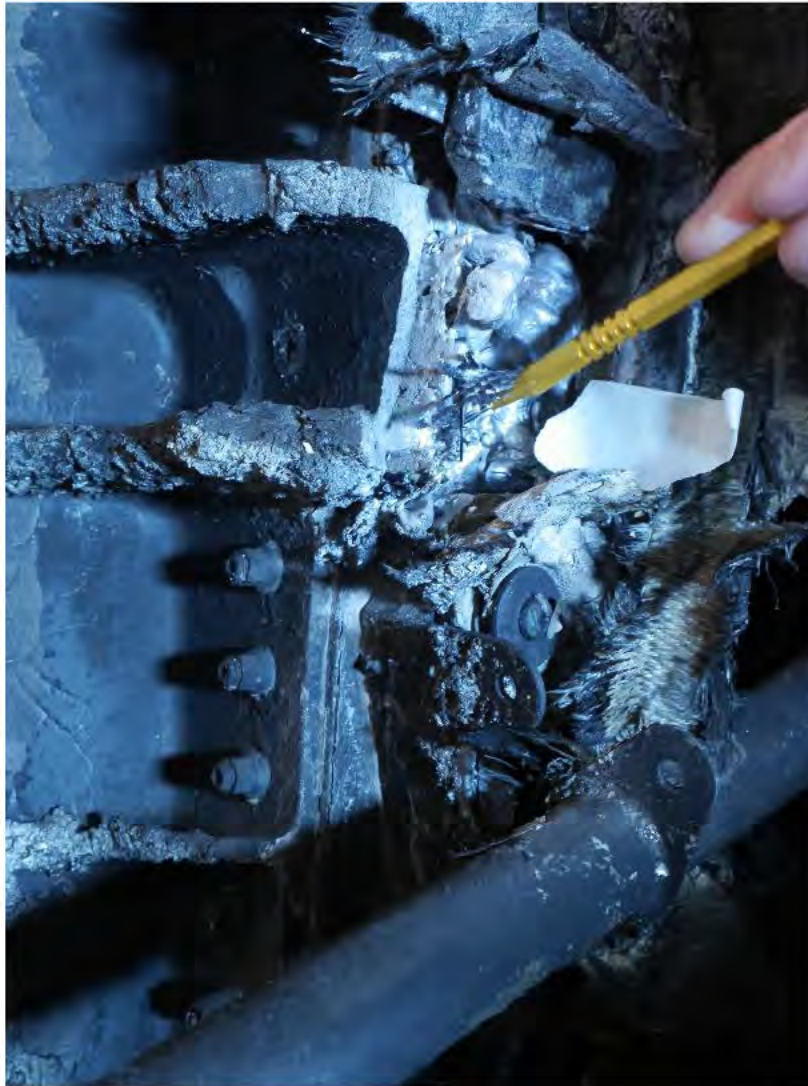
Sample #23 Left TR metal mid splatter on bifurcation near drain

#23 LHTR metal mid splatter on bifurcation is possibly a 7xxx alloy with elevated magnesium

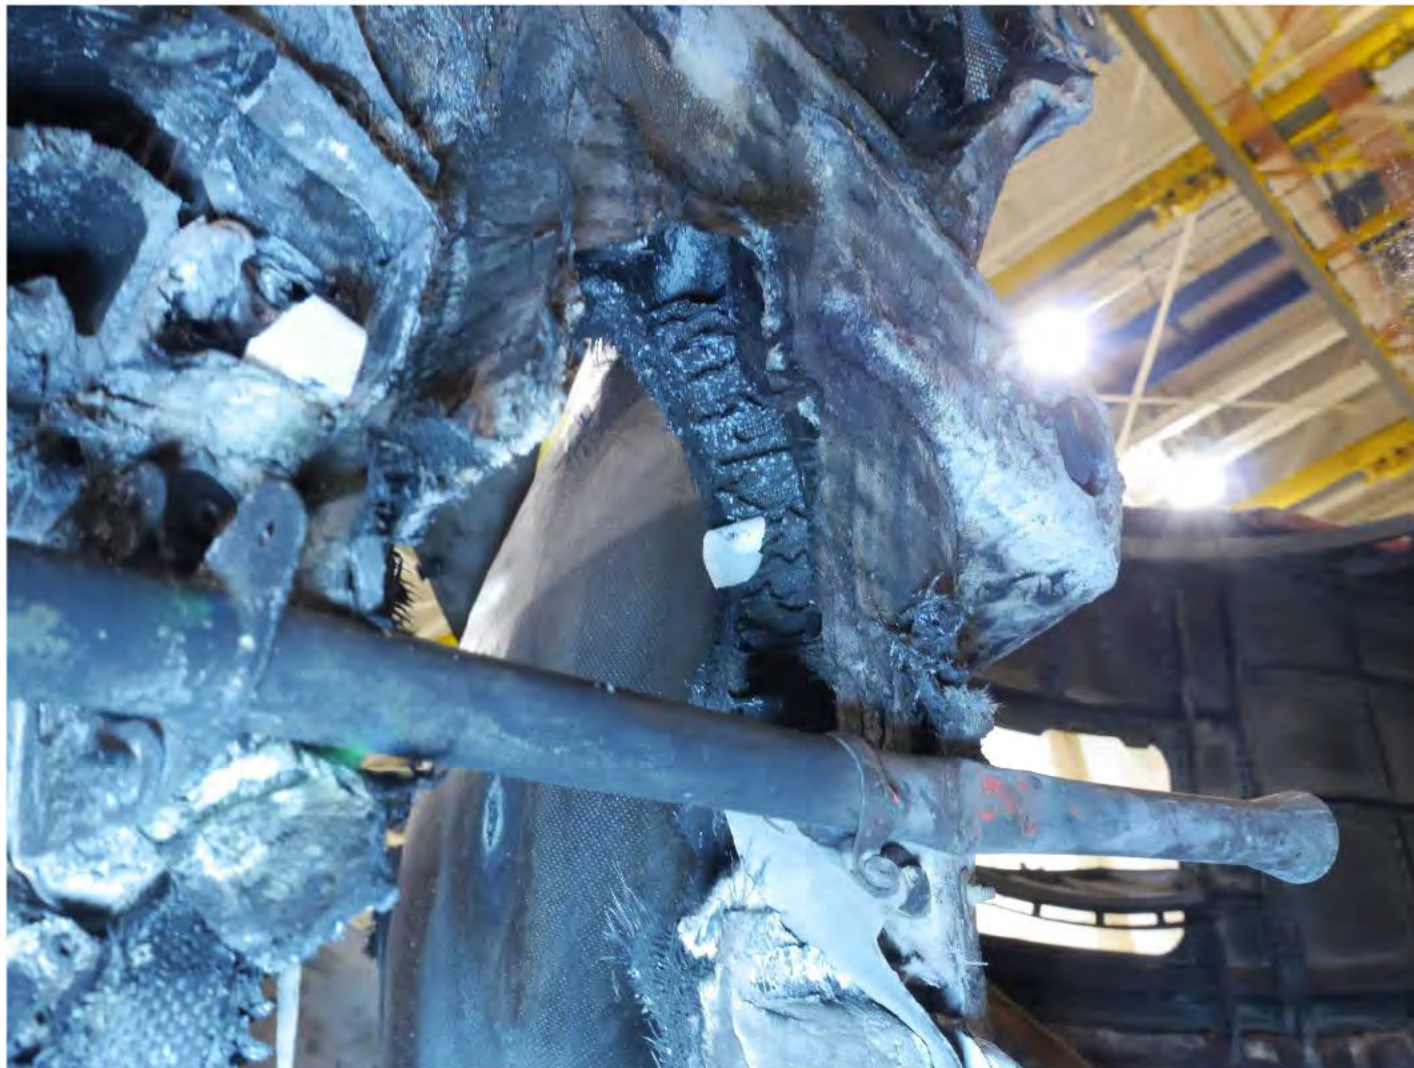
Sample #24 Left TR metal splatter on honeycomb

24 LHTR metal splatter is most similar to a 2xxx aluminum alloy

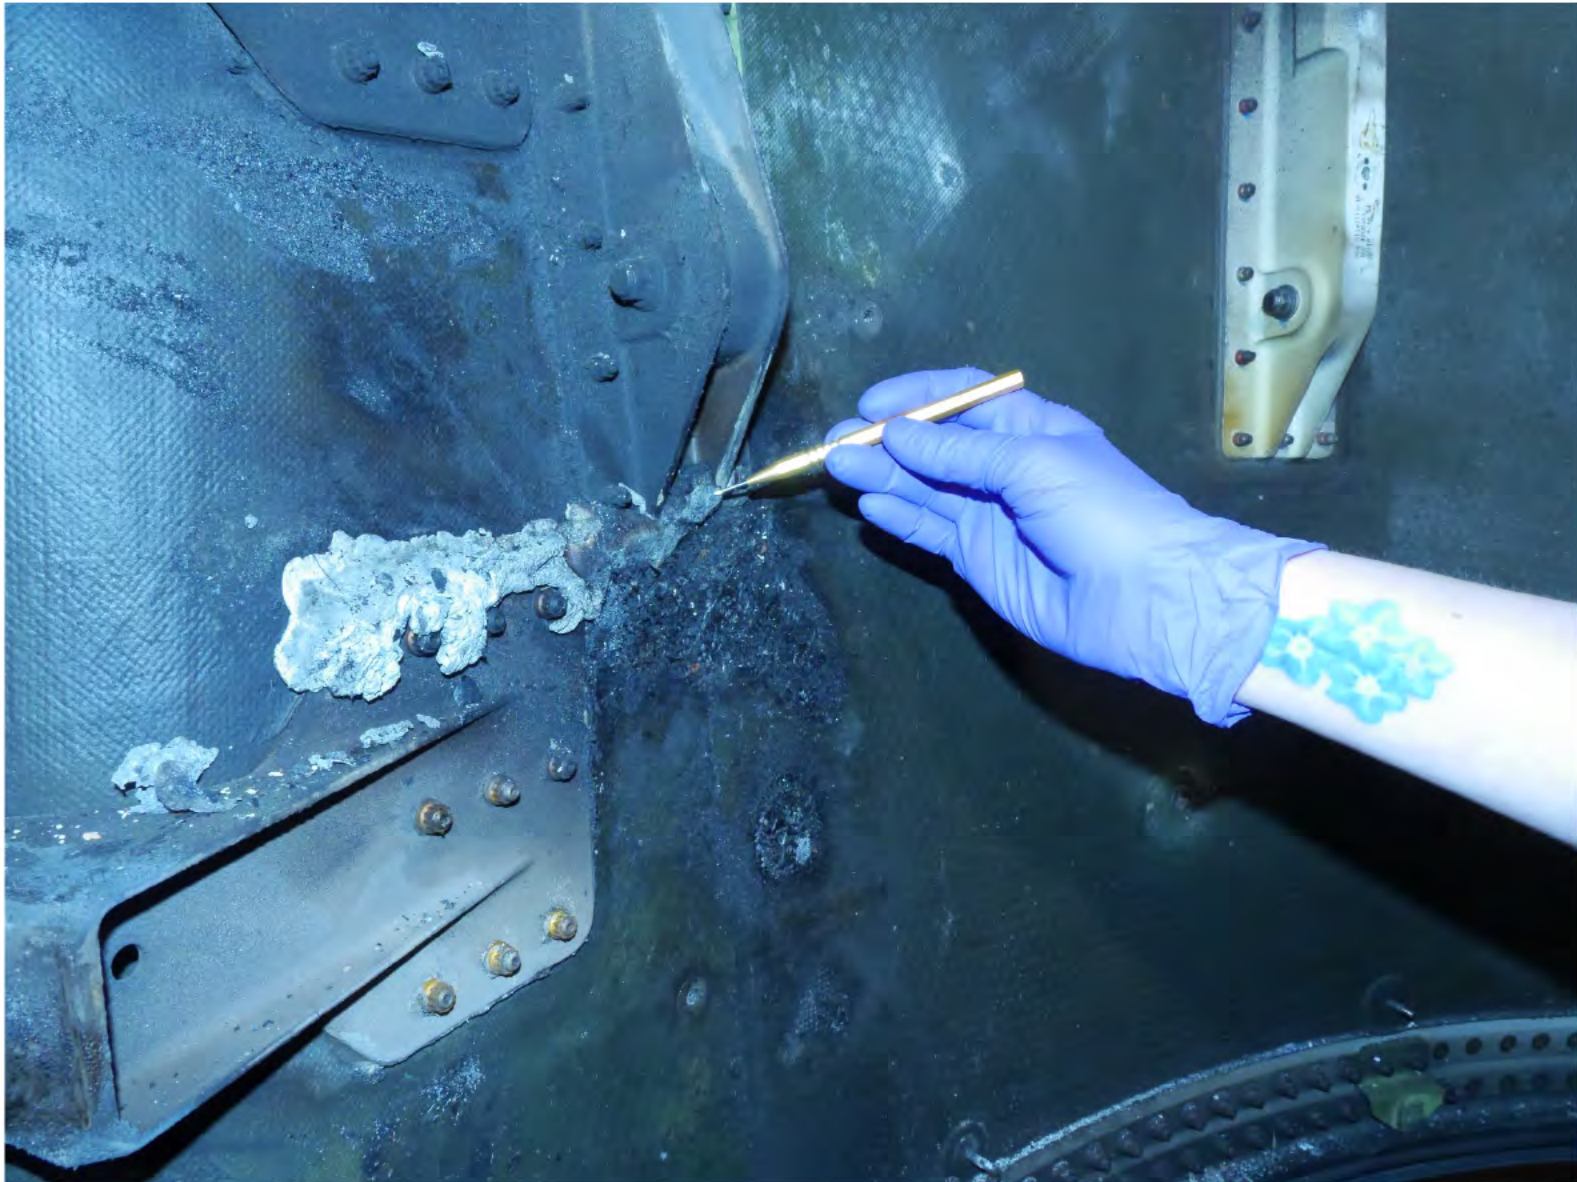
#25 melted metal near bifurcation (more INBD) – possibly 7xxx aluminum + additional Mg (remelted material)

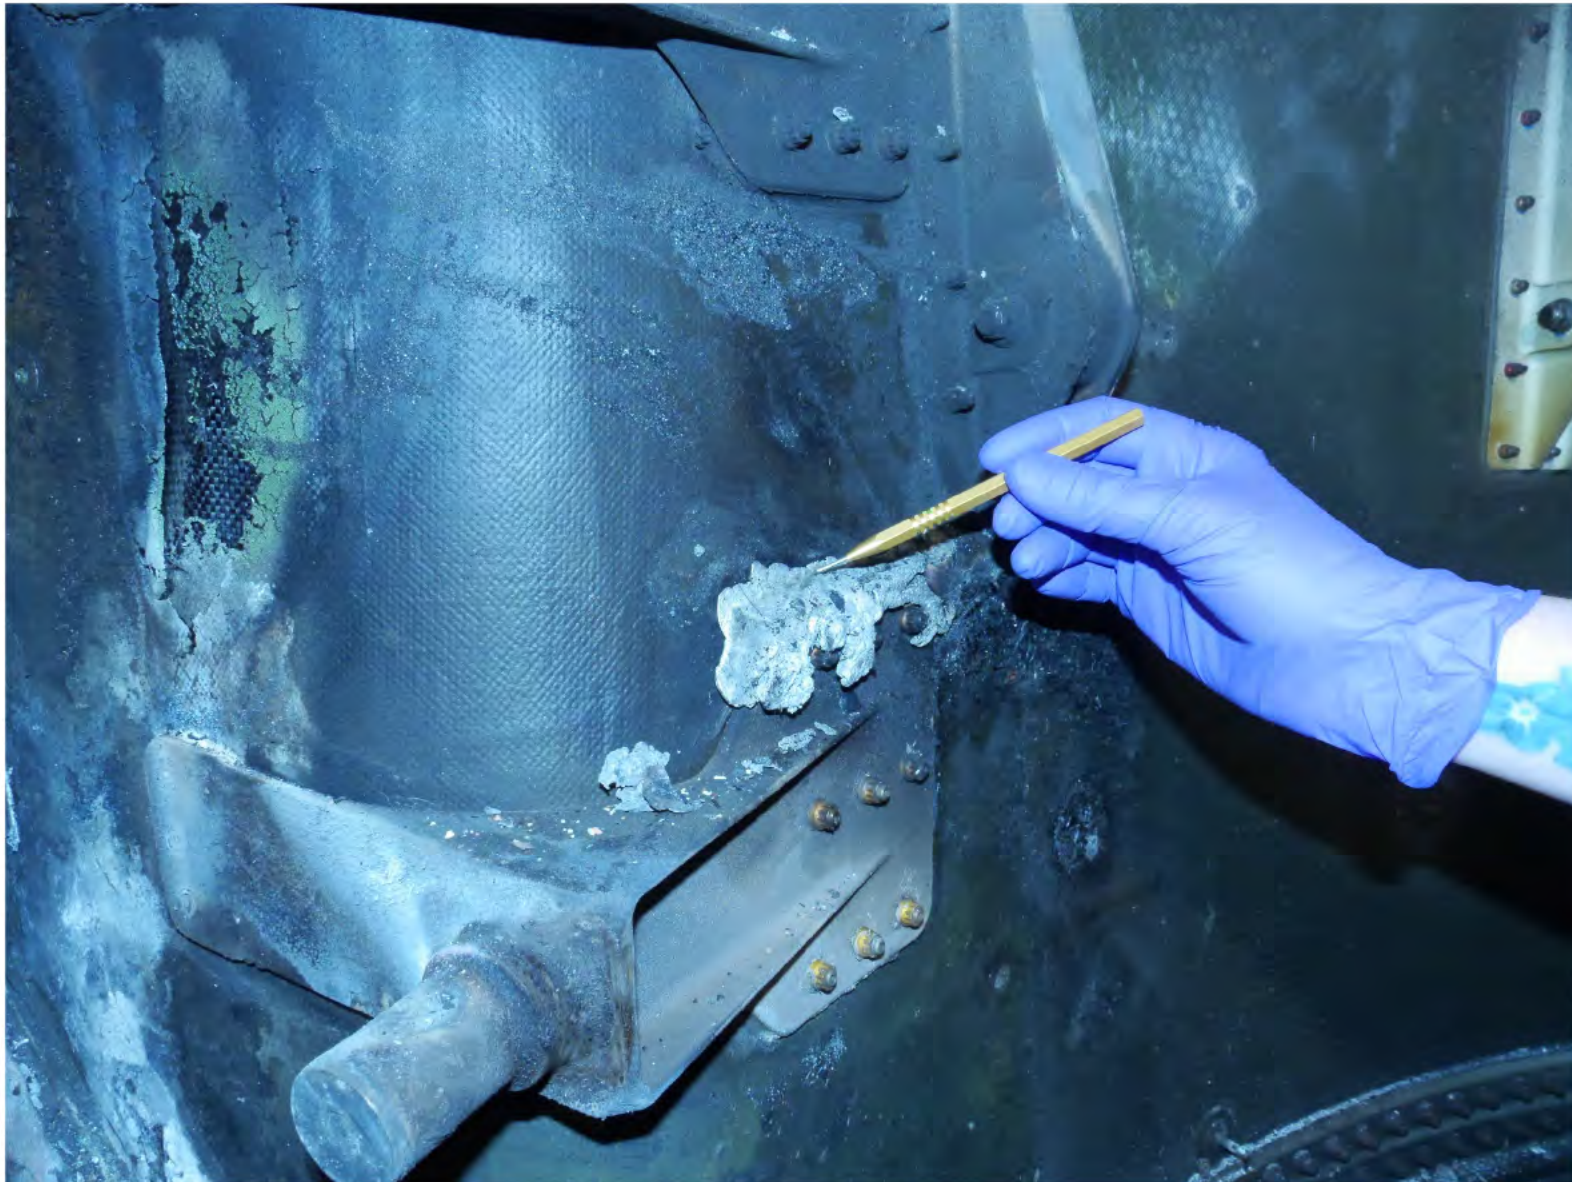
Sample #26 Left TR melted metal near bifurcation

#26 melted metal near bifurcation – possibly 7xxx Al + additional magnesium.

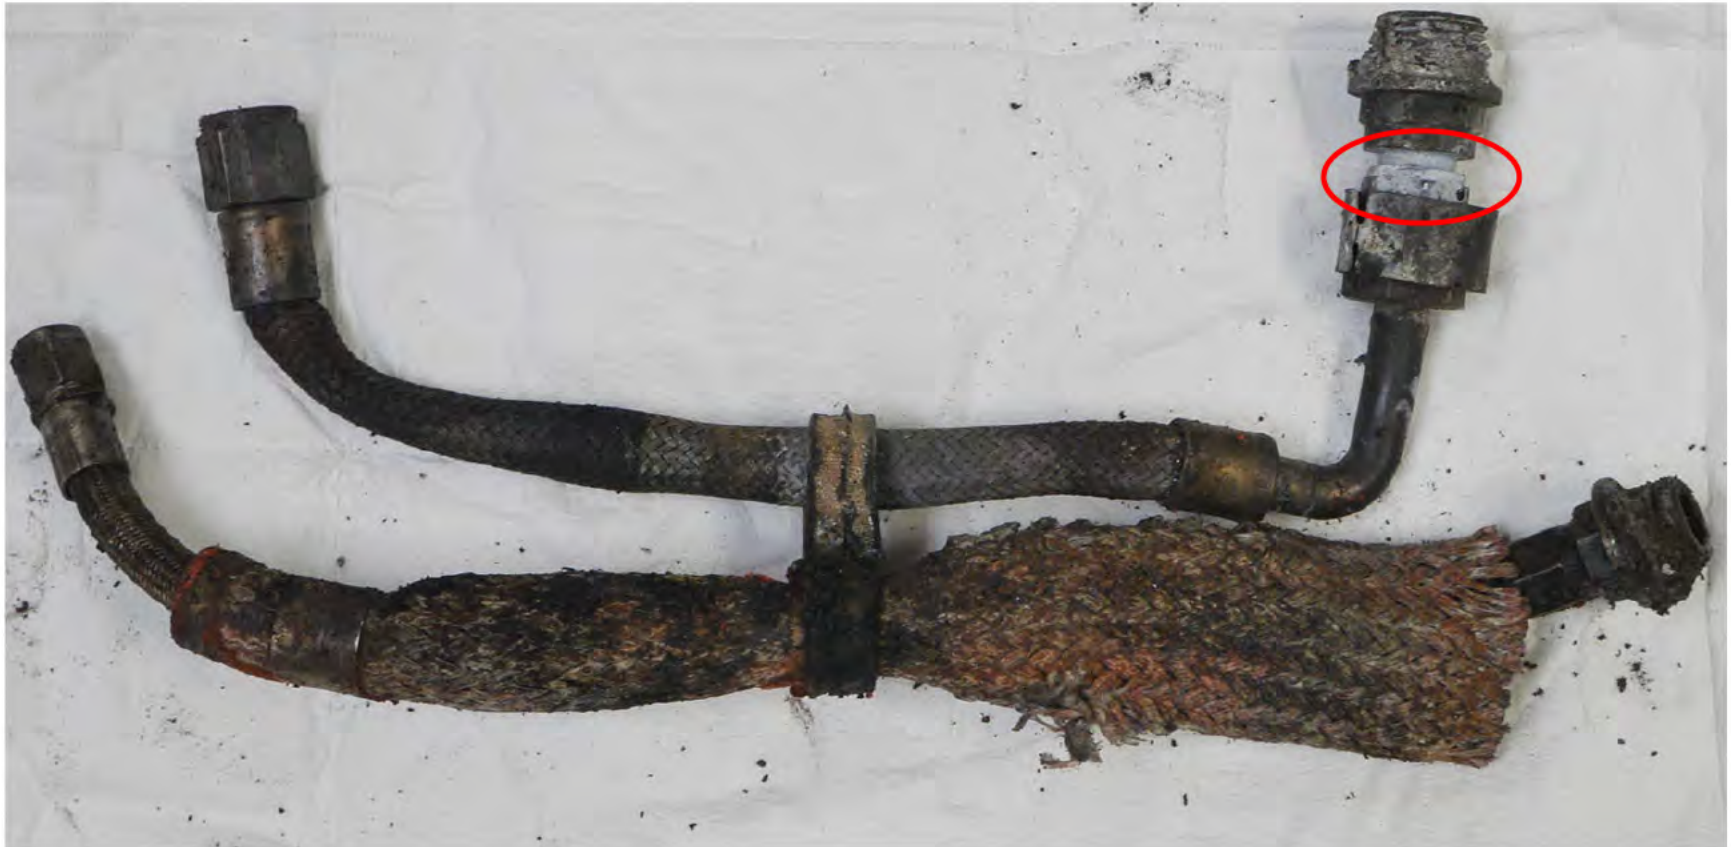
Sample #27 backup generator (BUG) white material near connector

27 backup generator (BUG) white material near connector is consistent with magnesium oxidation products

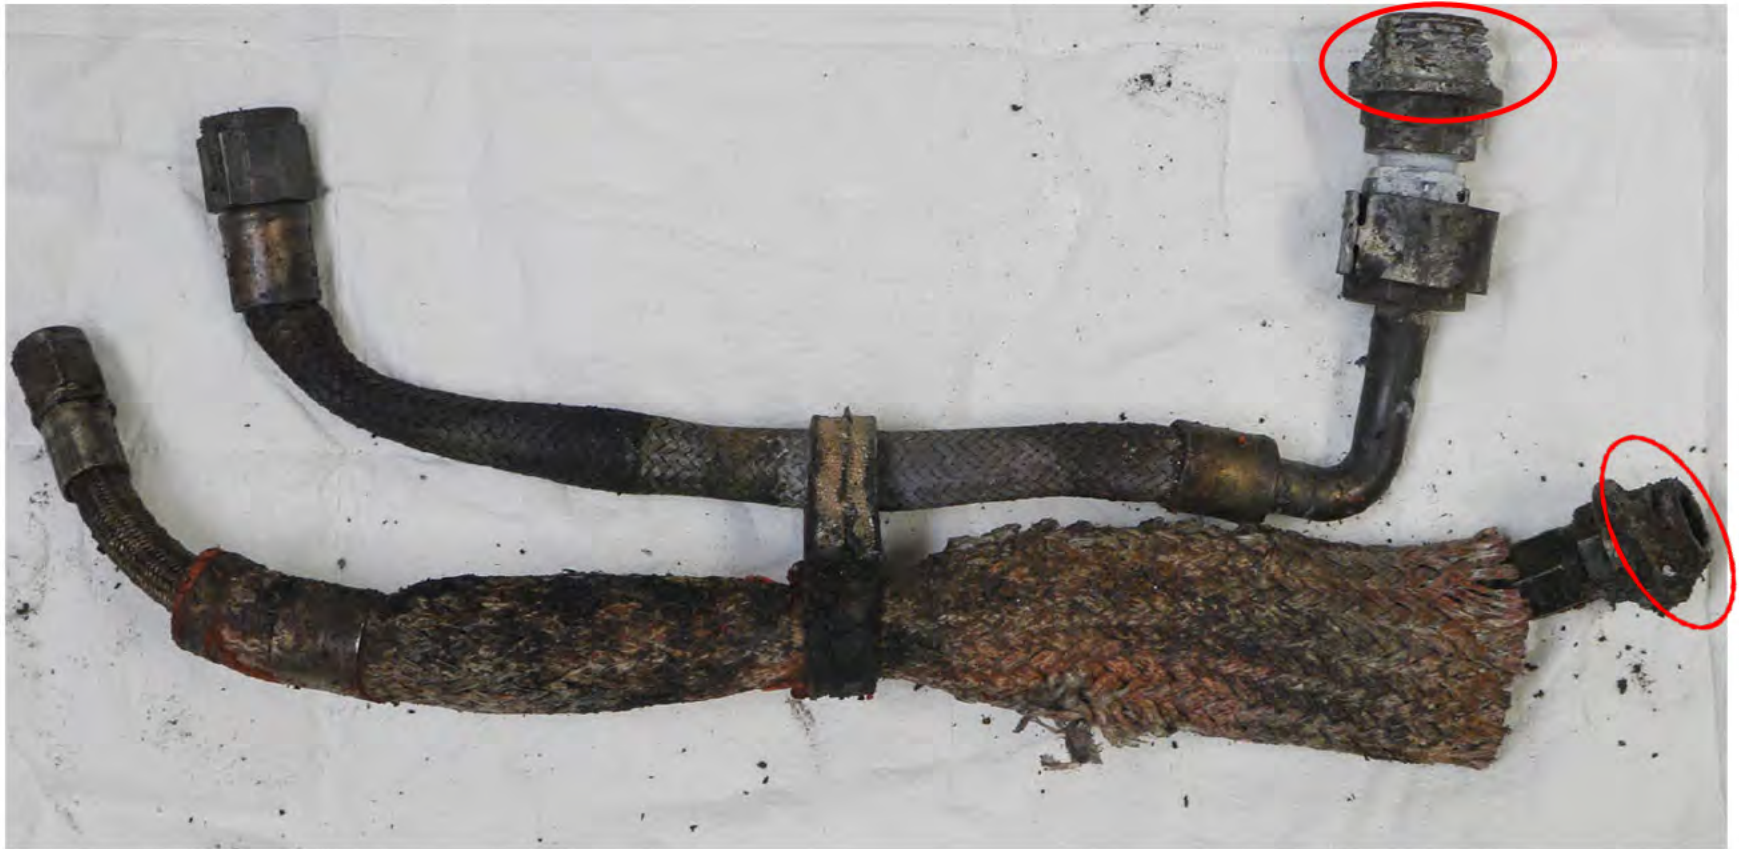
Sample #27 BUG loose material in threads

#27 BUG loose material in threads cont. – consistent with magnesium oxidation products

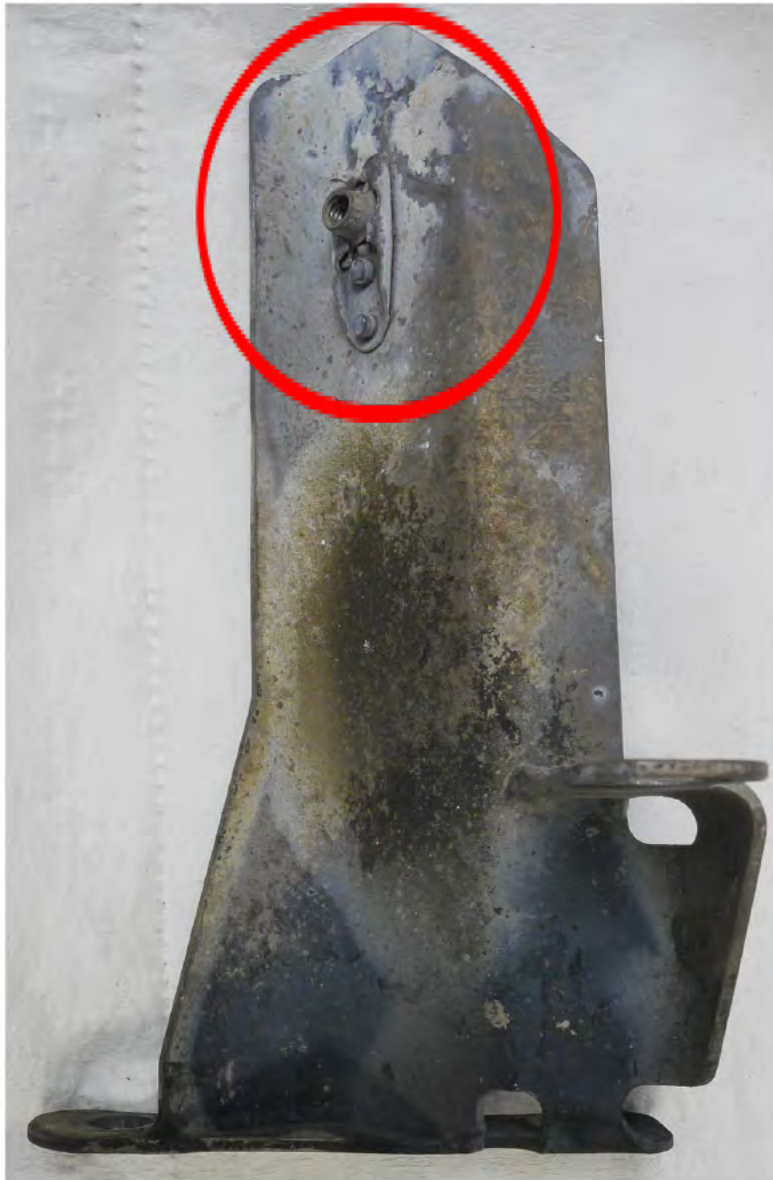
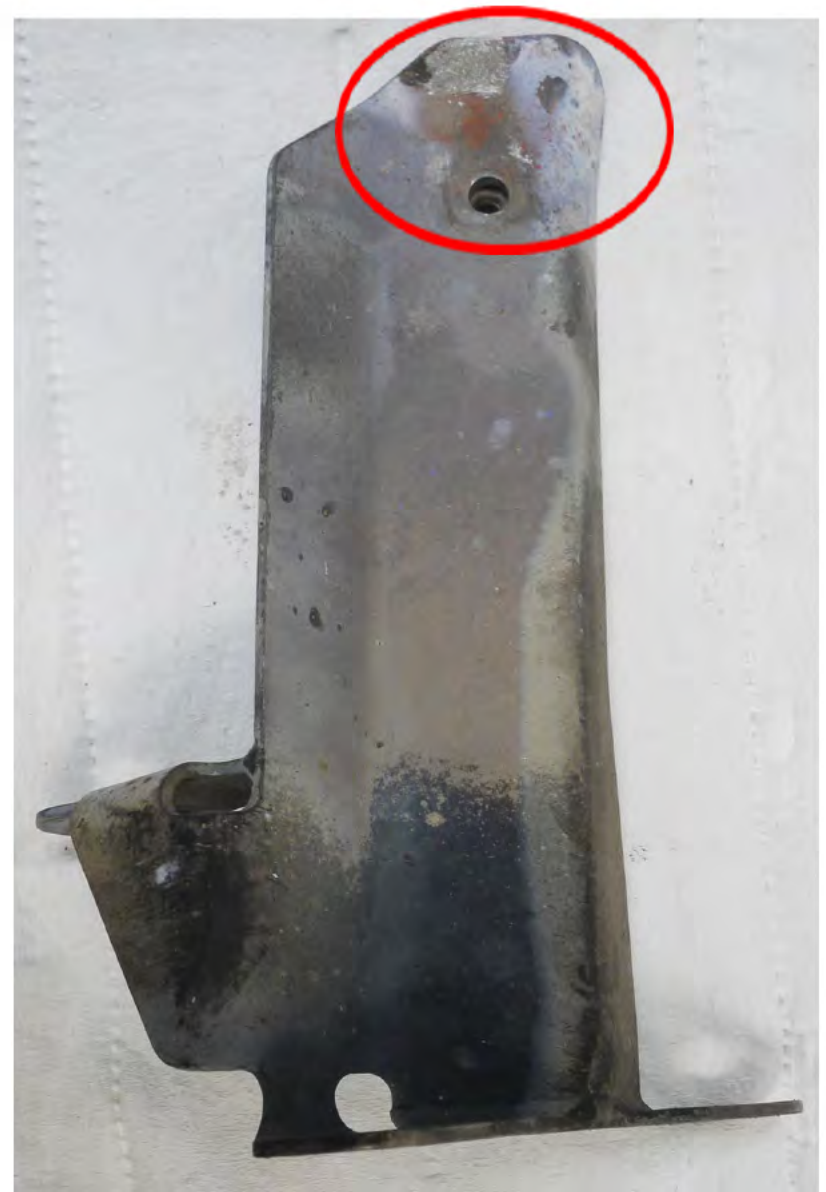
#28 Gearbox mounted bracket white material

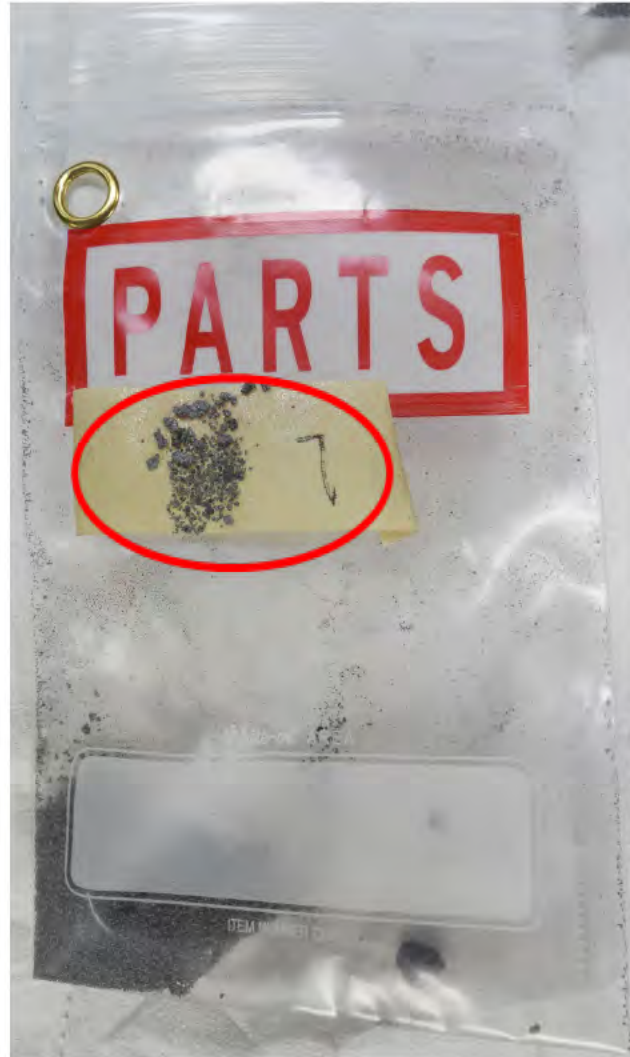
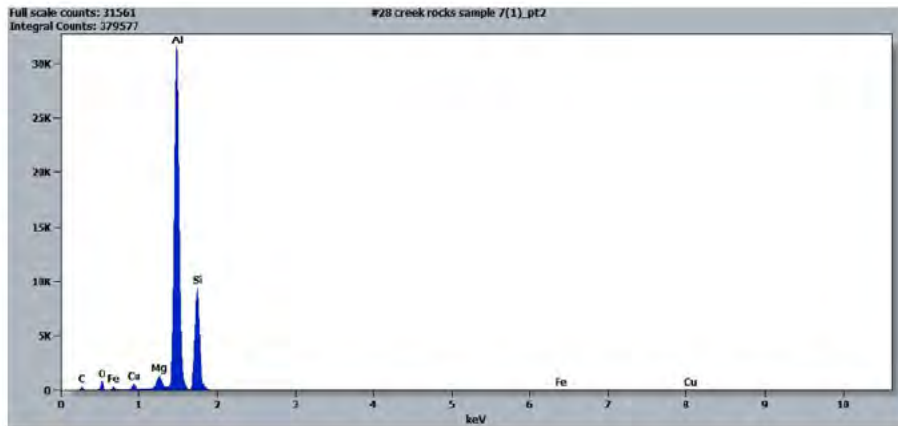
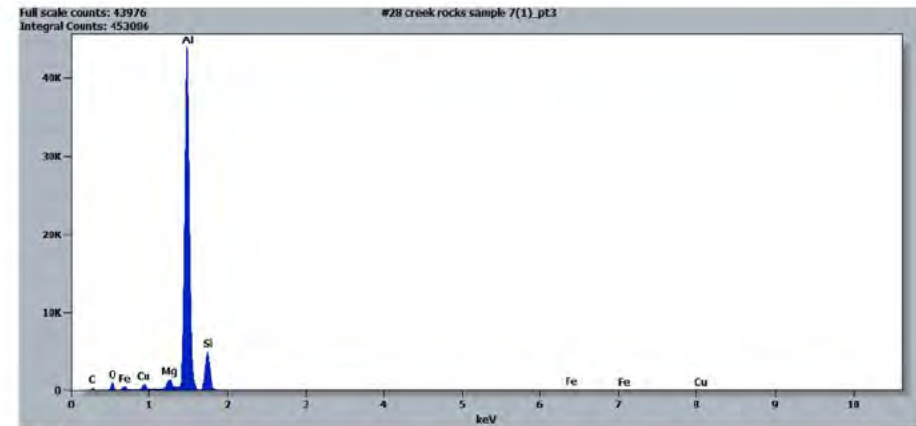
#28 'creek rocks' sample 7 – possibly cast aluminum.

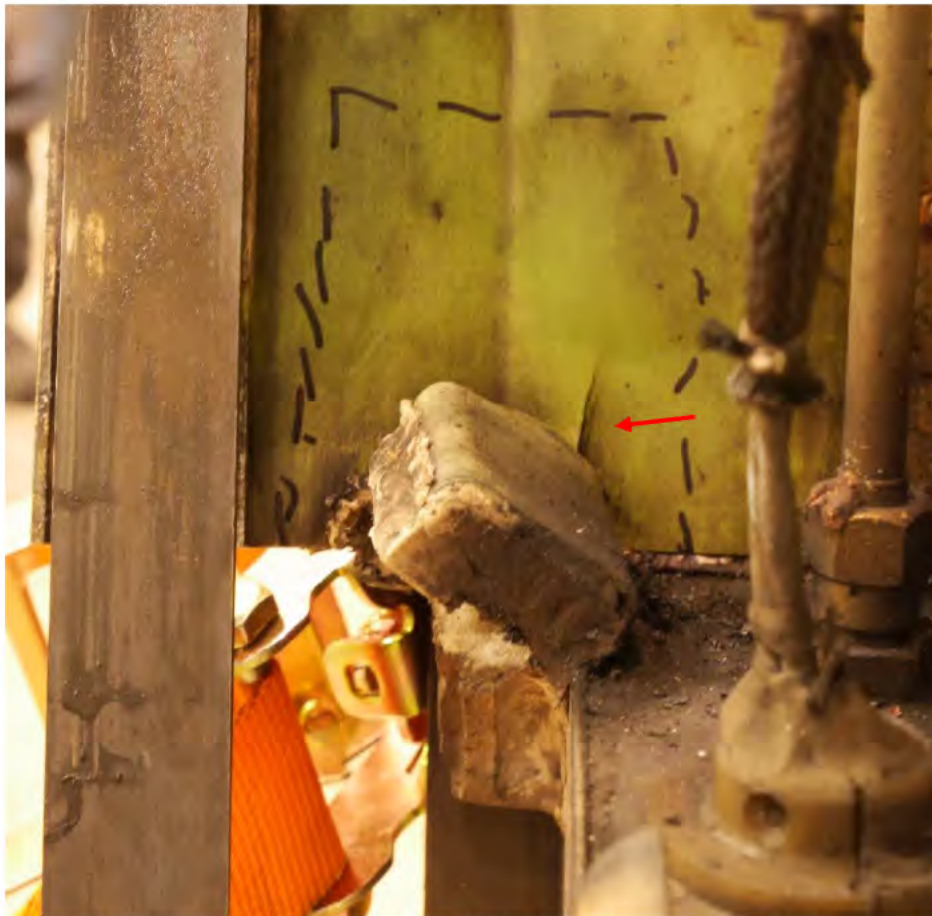
Figure 1 shows the Right Thrust Reverser (P/N 315W3001-4AA) before sectioning. An approximately 1.5 inch crack extended from the edge of the part in the 12:00 region and was excised for analysis (Figures 2 – 4). Figure 5 contains SEM images of the fracture surface of this portion of the crack. Some portions of the fracture surface were obscured by post fracture damage, but in the undamaged area the fracture mode was entirely ductile separation, consistent with a single event and showing no signs of fatigue or crack advancement after the event.

Figure 2. Right Thrust Reverser fracture at the 12:00 clock position before removal.

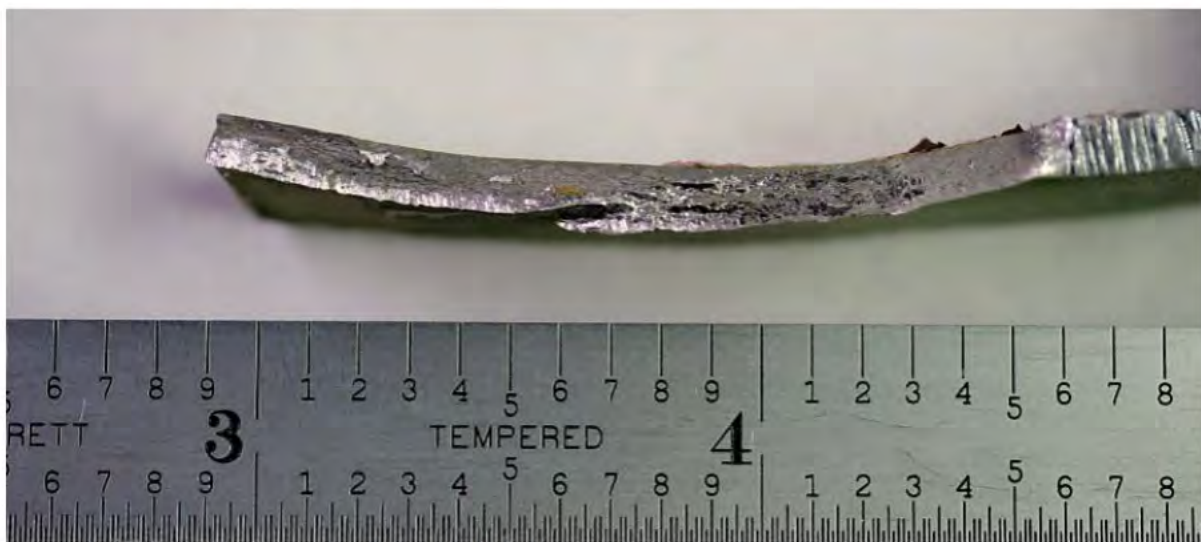
Figure 4. Macro photograph of the Right Thrust Reverser fracture initiation.

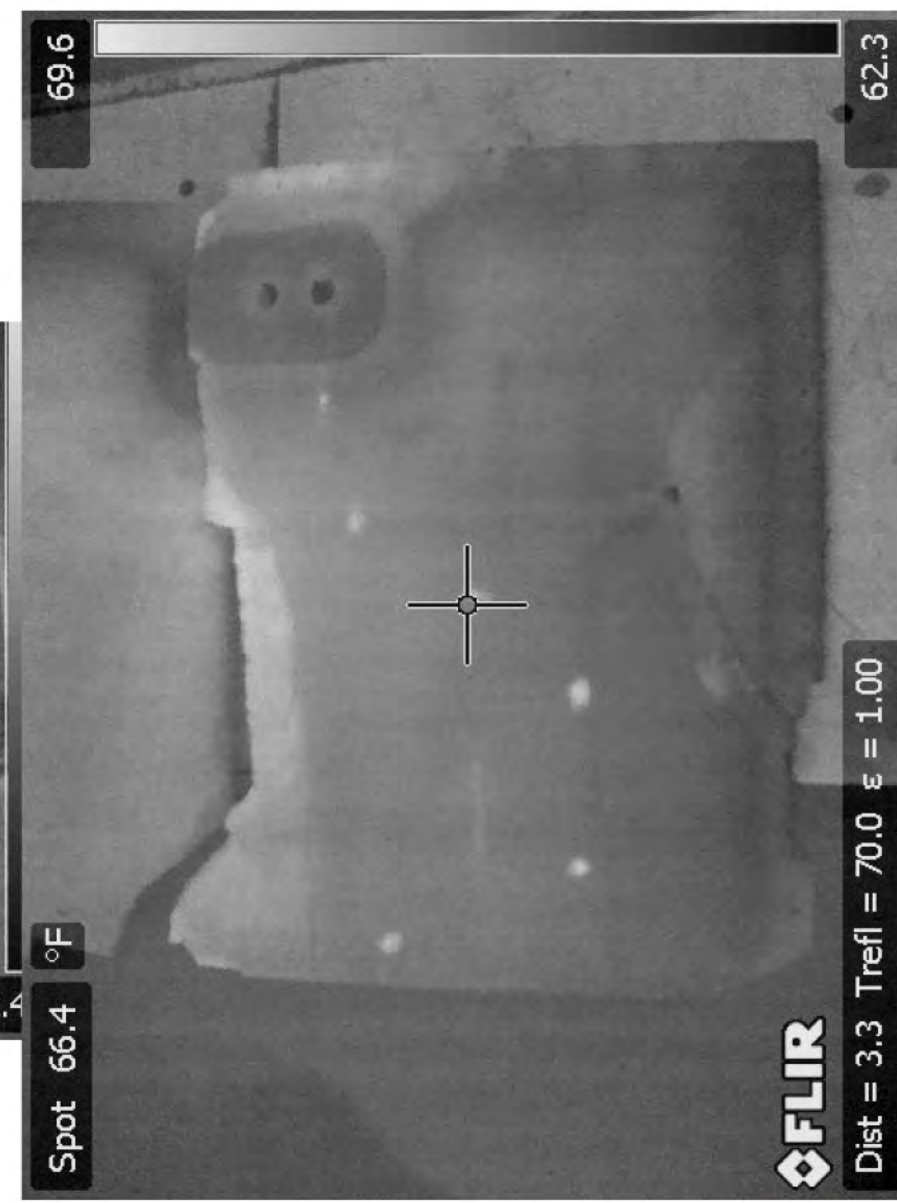
- On the previous slide there are dark indications as well as a large area that has a clear contrast difference line. This could be due to fluid or a change in core density or skin thickness

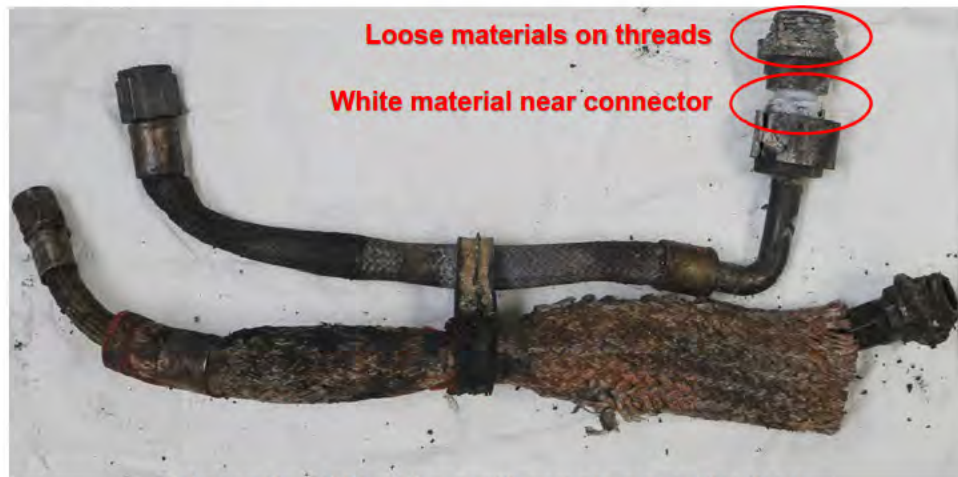
Figure 6 – BUG oil lines with sample areas identified

Boeing ASI and DE identified areas on the oil lines for material analysis, as shown in Figure 6. Areas of interest were loose materials on the threads of the connector fitting and white material near the connector base and on the hard line.

BUG oil line samples of the white material near the hose connector, Figure 6, were consistent with magnesium oxidation products.

BUG oil line samples of the loose material in the hose connector threads , Figure 6, were consistent with magnesium oxidation products.
