NATIONAL TRANSPORTATION SAFETY BOARD

Group Chairman's Factual Report

DCA21FA085

SUBJECT: *Right Engine Fan Blade Out and Inlet/Fan Cowl Departure – Examination of recovered Inlet Cowl, Fan Cowls, and Thrust Reversers*

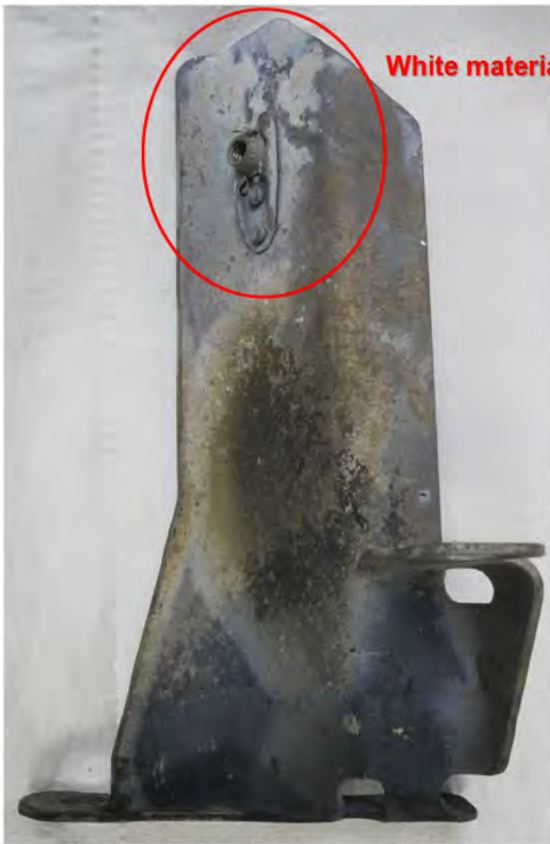
Figure 8 – Gearbox mounted bracket

Boeing ASI and DE identified areas on the gearbox mounted bracket for material analysis, as shown in Figure 8 and Figure 9. Area of interest was white material near the end of the bracket.

Gearbox mounted bracket samples of white material, Figure 8 and Figure 9, were consistent with magnesium oxidation products.

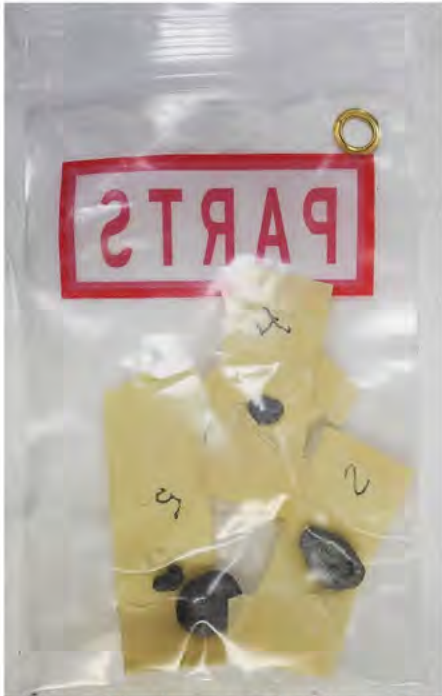
Figure 10 – Loose material samples

Loose material samples collected from the engine oil sump are shown in Figure 10 through Figure 12. The larger material samples were referred to by the investigative team as “creek rocks”, and this terminology was used in the material analysis. Sample 7 was stuck between the Figure 11 and Figure 12 parts bags, as shown in Figure 12.

Engine oil sump loose material samples, Figure 10, Figure 11, and Figure 12, were most consistent with cast aluminum and aluminum alloys.

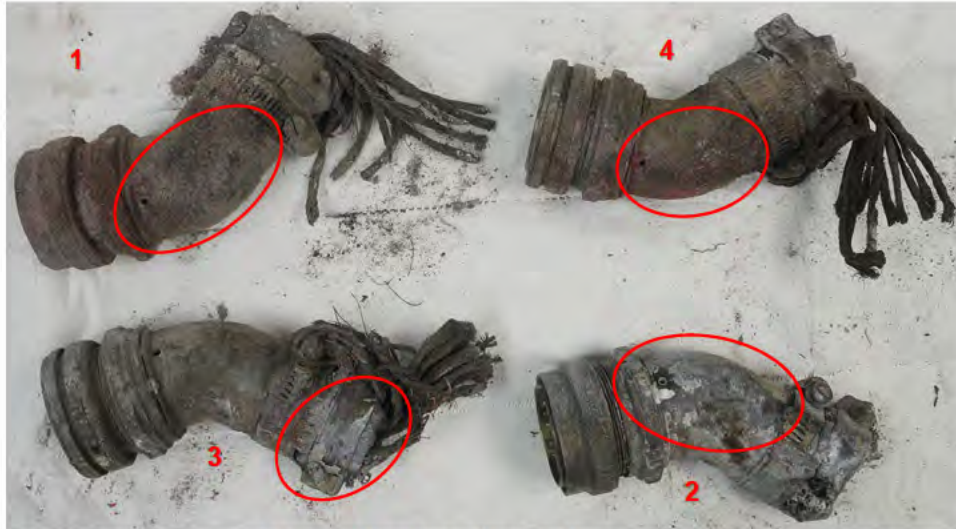
Figure 15 – Bug electrical connectors

Boeing ASI and DE identified areas on the electrical connectors for material analysis, as shown in Figure 15 and Figure 16. Areas of interest were white material and other deposited materials on the connector backshells. The connector numbers in Figure 15 and Figure 16 are for reference to BR&T analysis only, and do not represent connector positions on the aircraft.

Material samples collected from the four provided electrical connectors, Figure 15 and Figure 16, were consistent with corrosion products and an inorganic silicon compound.
