HAZARDOUS MATERIALS GROUP FACTUAL REPORT

**Derailment of Union Pacific Railroad Train UEBLTG 20
on April 24, 2019, with Subsequent Hazardous Materials Release**

Fort Worth, Texas

RRD19FR007

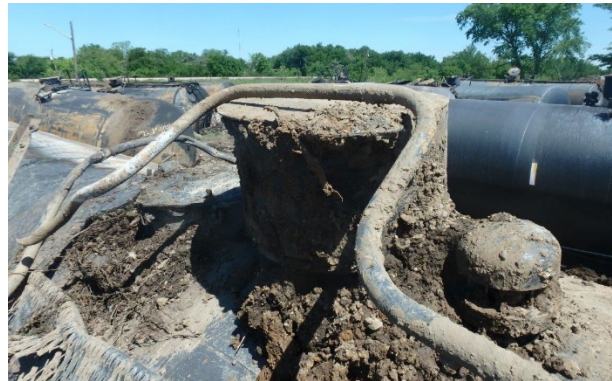
1(b) Top fittings caked in mud.

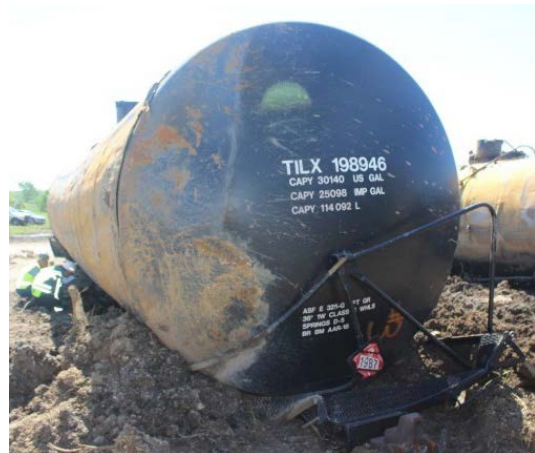
2(b) A-end head with dent at 10 o'clock.

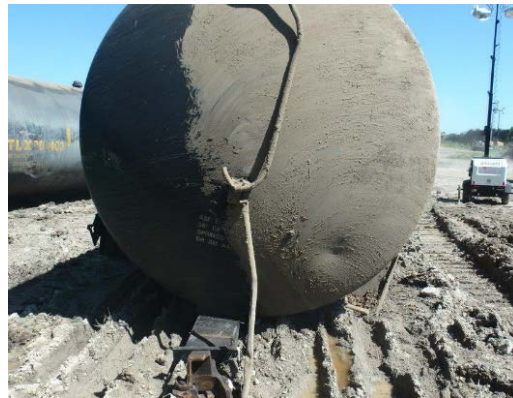
3(b) A-end head gouge at 5 o'clock.

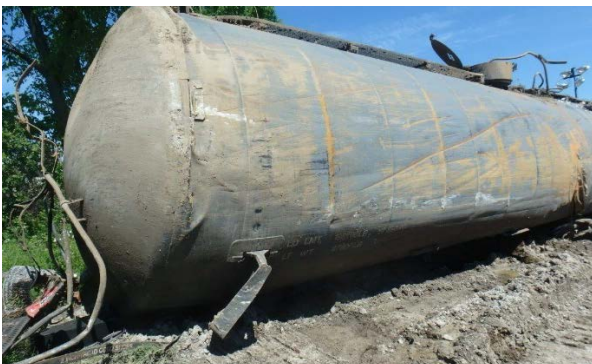
4(c) A-end and left side, bent A-L body bolster.

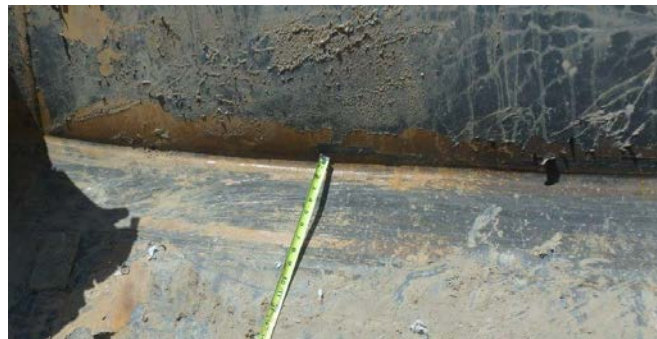
8(b) B-R gouge 116-inches in length, 2-inches wide.

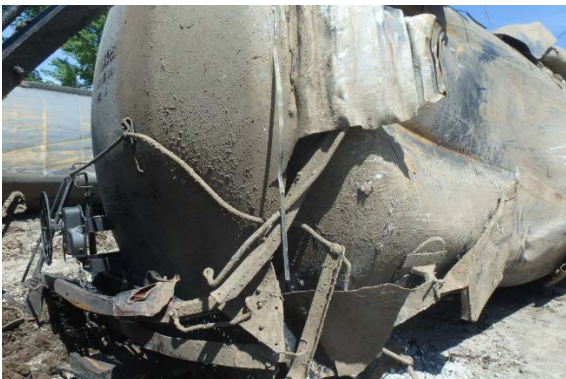
8(c) B-end head, with partially detached head shield.

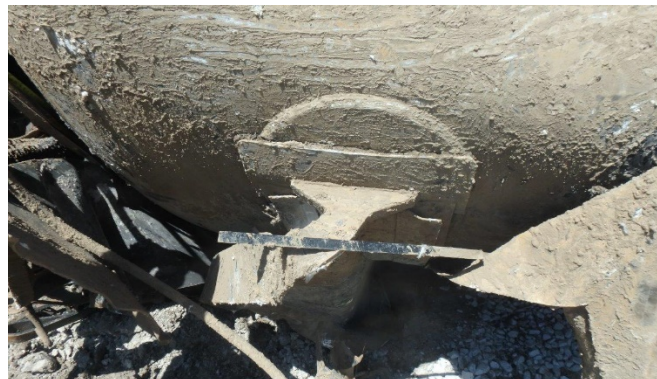
8(d) B-R bolster bent toward the B-end.

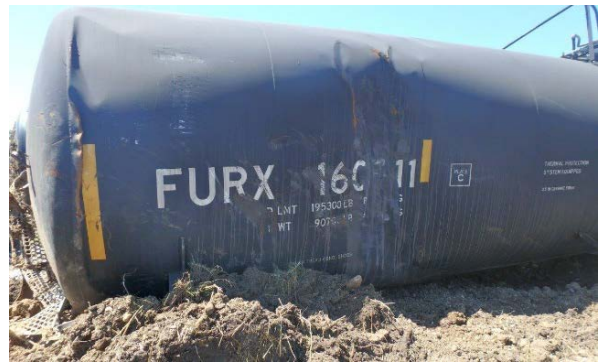
11(b) A-L shell dent, 7’x8’, 15” deep.

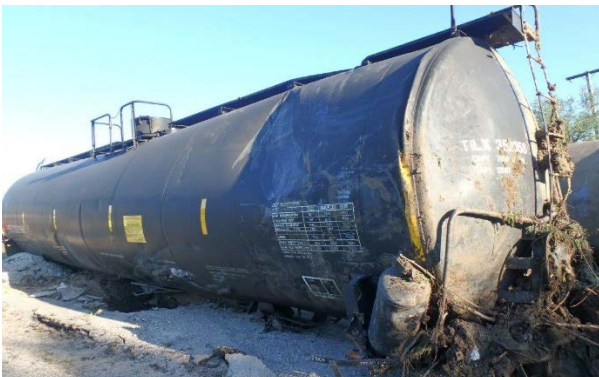
12(a) B-end head and B-L jacket dent.

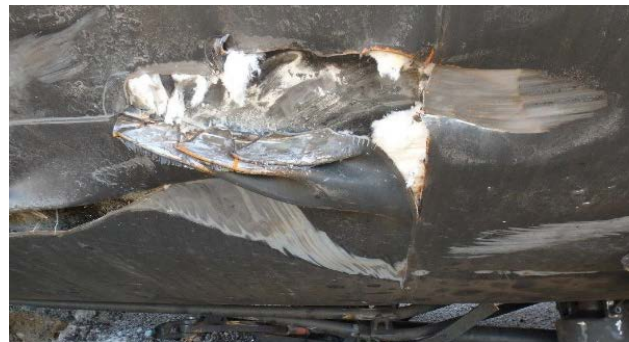
12(b) B-L jacket tear and non-breaching shell gouge.

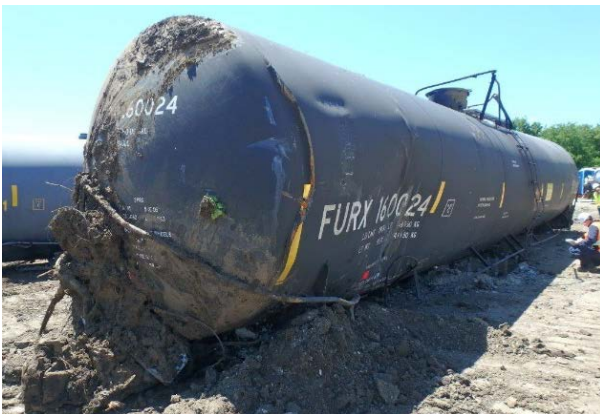
15(c) B-end head and B-R jacket dent, 5' x 5'.

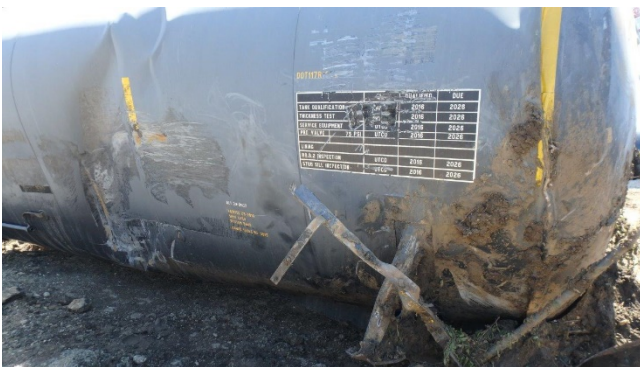
16(e) A-end head and A-R 4'x6' dent.

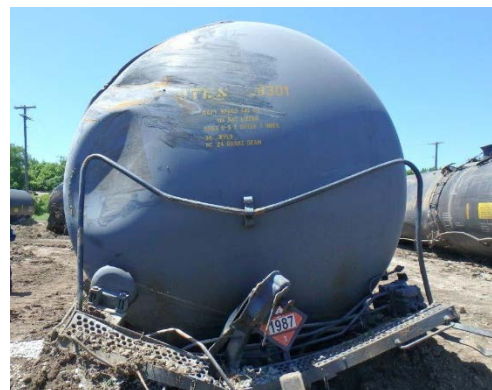
16(f) B-end head dents, 2' x 3' and 2' x 2'.

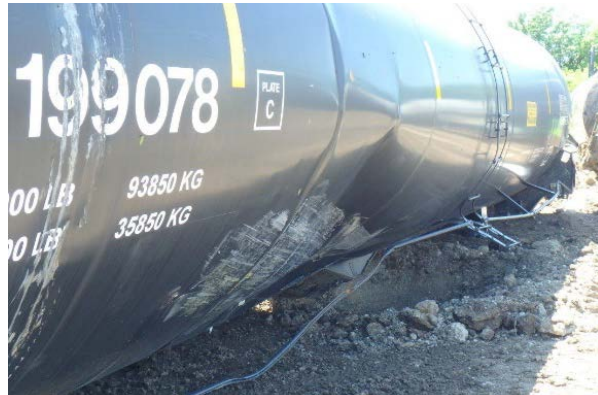
17(b) A-L dent, 5' x 8', depth was not measured.

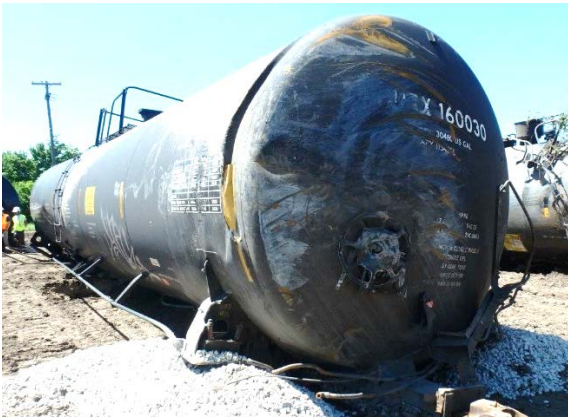
18(a) B-end head, crushed brake wheel and head shield gouges.

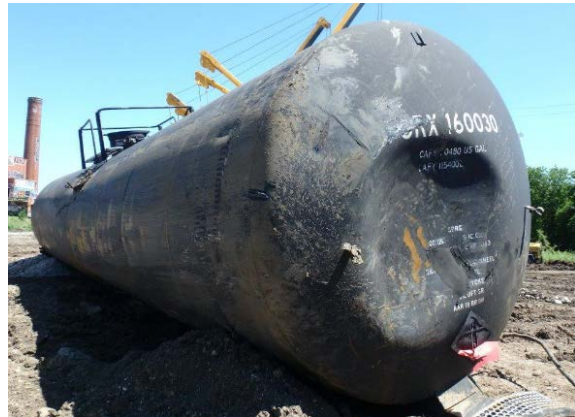
18(b) A-end head dent, 4' x 4', 12' deep.

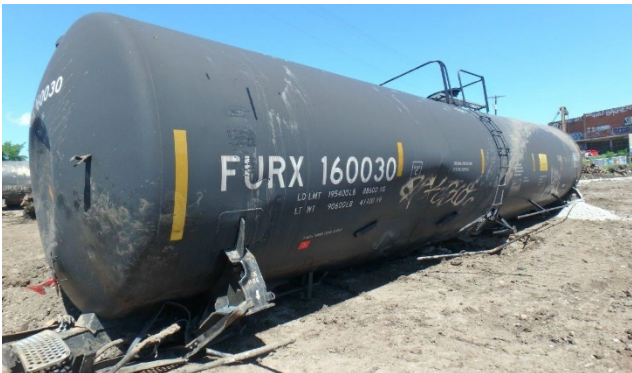
18(c) Lower A-L dent 5' x 6'.

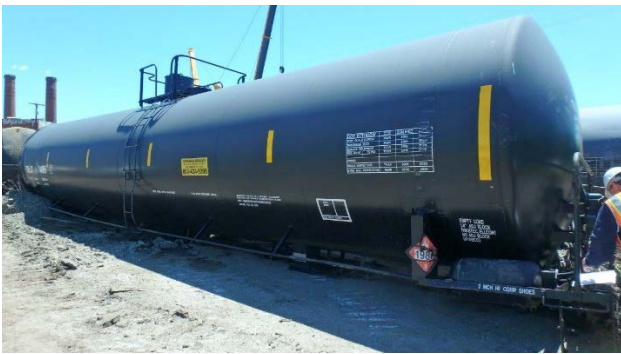
19(a) B-end head and left side of the tank car.

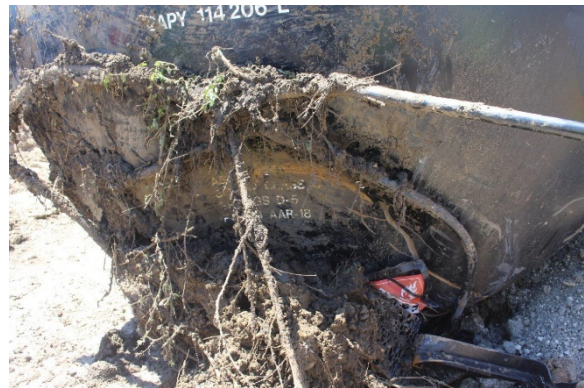
19(b) A-end head dent, 3' x 4' below center.

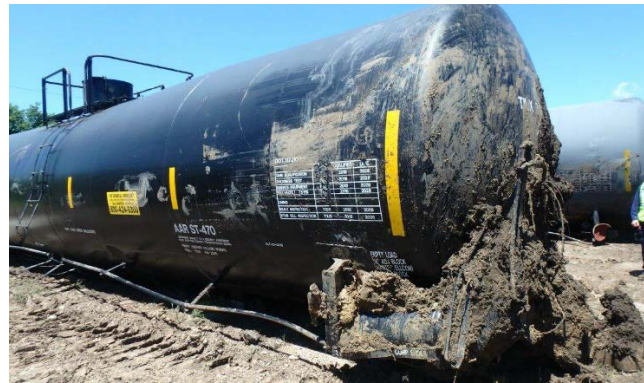
21(b) B-end head and left side.

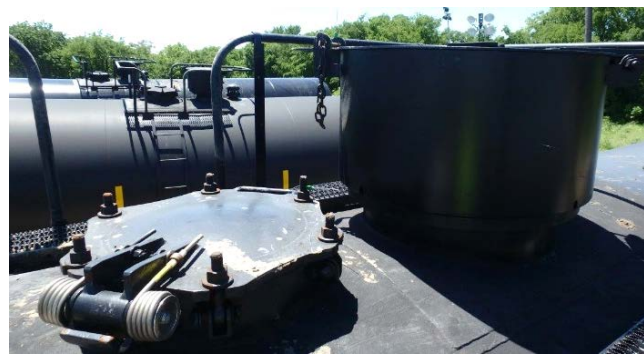
21(d) Transquip 6-bolt manway assembly under AAR service trial no. ST-470.

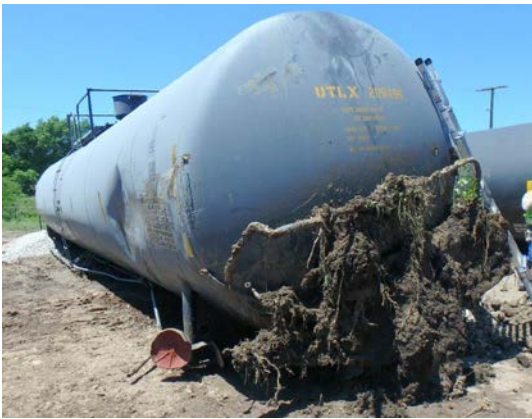
22(a) B-end head.

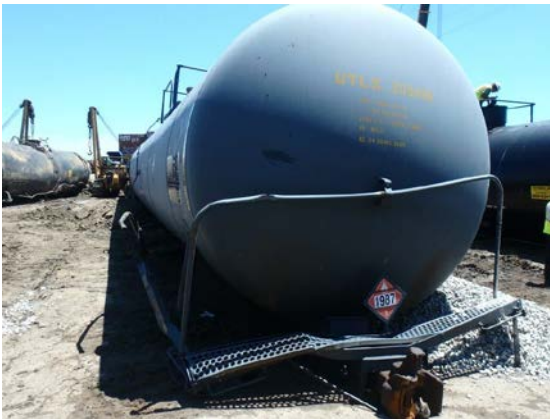
22(c) A-end head.

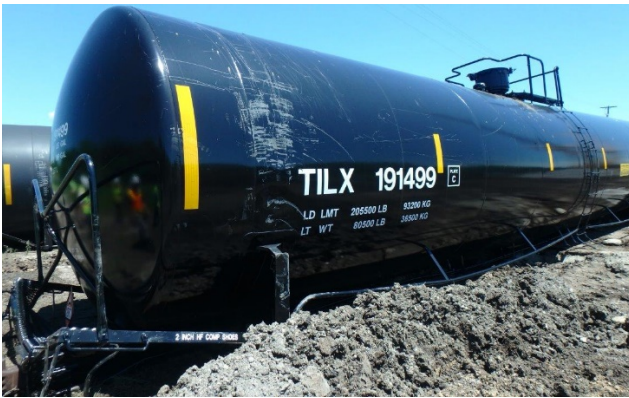
23(a) B-end head and left side.

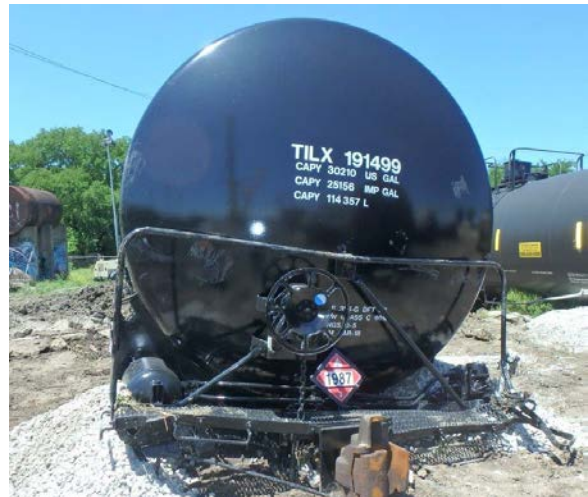
23(b) B-end head.

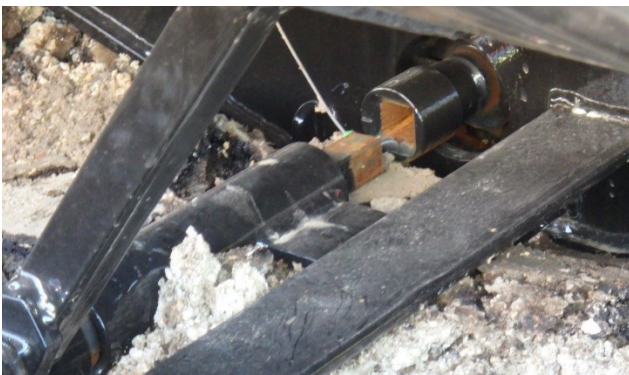
23(c) Disengaged BOV operating handle extension.
