# National Transportation Safety Board

HMD22LR001

## **HAZARDOUS MATERIALS**

Group Chair's Factual Report  
July 20, 2022

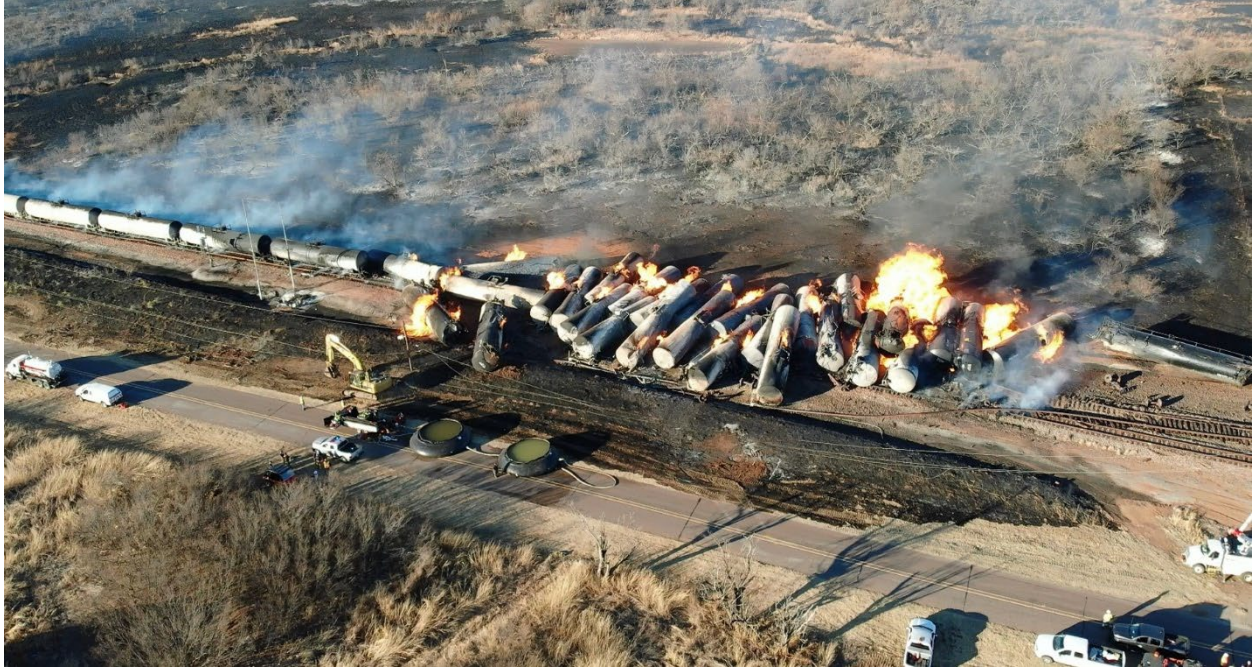
Figure 1: Accident scene, Oklaunion, Texas, looking north, 1/8/2022, Courtesy: BNSF

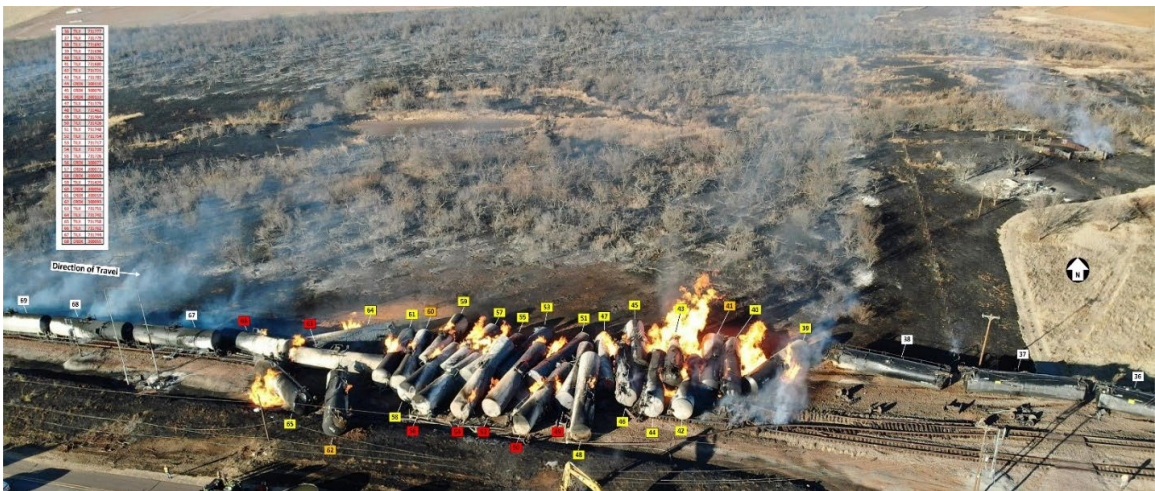
Figure 21. Breached tank cars in-situ with orientation marks.

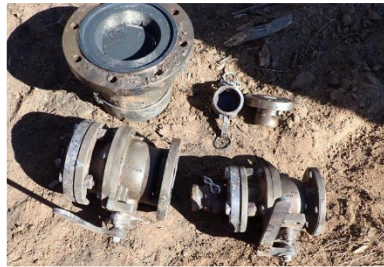
10(b). Top fittings valves, PRD, and VRD removed for examination.

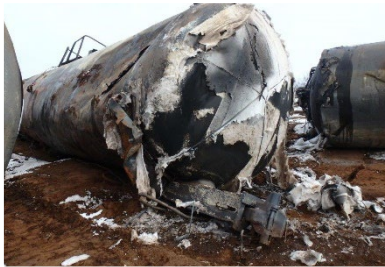
Consist order	<b>59</b>
Orientation in the consist	A
Heads	No damage
Shell	Jacket sustained thermal damage. Large (16x6) dent in the side of car (Figure 12a).
Bottom outlet valve	Adaptor sheared off - ball still in place. BOV Skid intact.
Top fittings, PRD and Manway	Thermally damaged fittings and gaskets
Stub sills	No recorded damage
Breach/ Loss of Product	Thermal / 6,345 gallons

12(a). A-end head with head shield and jacket removed.

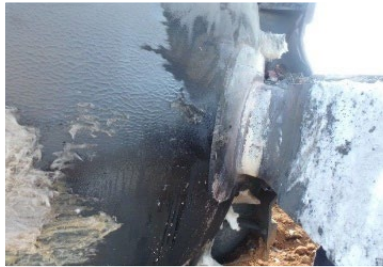
18(b). A-end stub sill/head pad.

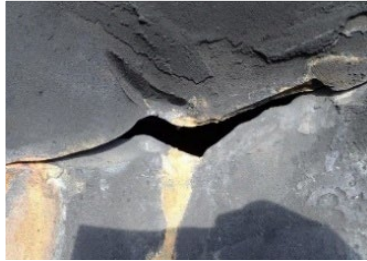
19(b). B-end head puncture and gouge.

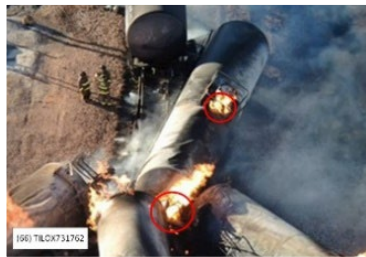
Consist order	<b>66</b>
Orientation in the consist	<b>B</b>
Heads	B-end head pad A-1 and A-2 fillet welds cracked, but head pad did not separate from the tank (Figure 19a). B-end head was punctured about 12-in above and to the right of the stub sill (Figure 19b). The puncture was an angular 4-inch-long tear within a shallow dent. There was a 1- to 2-inch-long gouge in the head material above this tear.
Shell	B-end head/ shell puncture - angular 4-inch tear with shallow dent
Bottom outlet valve	Eduction pipe and mounting flange were displaced from the sump and situated behind the ball valve 19(c)
Top fittings, PRD and Manway	PRD gasket was thermally damaged/ destroyed. Liquid valve gasket was thermally damaged. Manway area thermally damaged.
Stub sills and couplers	A-end coupler shank pushed upward. The top draft sill plate was torn and bent upward. Both A-end draft gear bottom carrier plates were deformed downward.

19(d). Flame from B-end head puncture and manway area.
