MARiTECH COMMERCIAL, INC.

Report No.: 185286

SURVEY REPORT

M/V "SIROCCO" (Voy.32L)

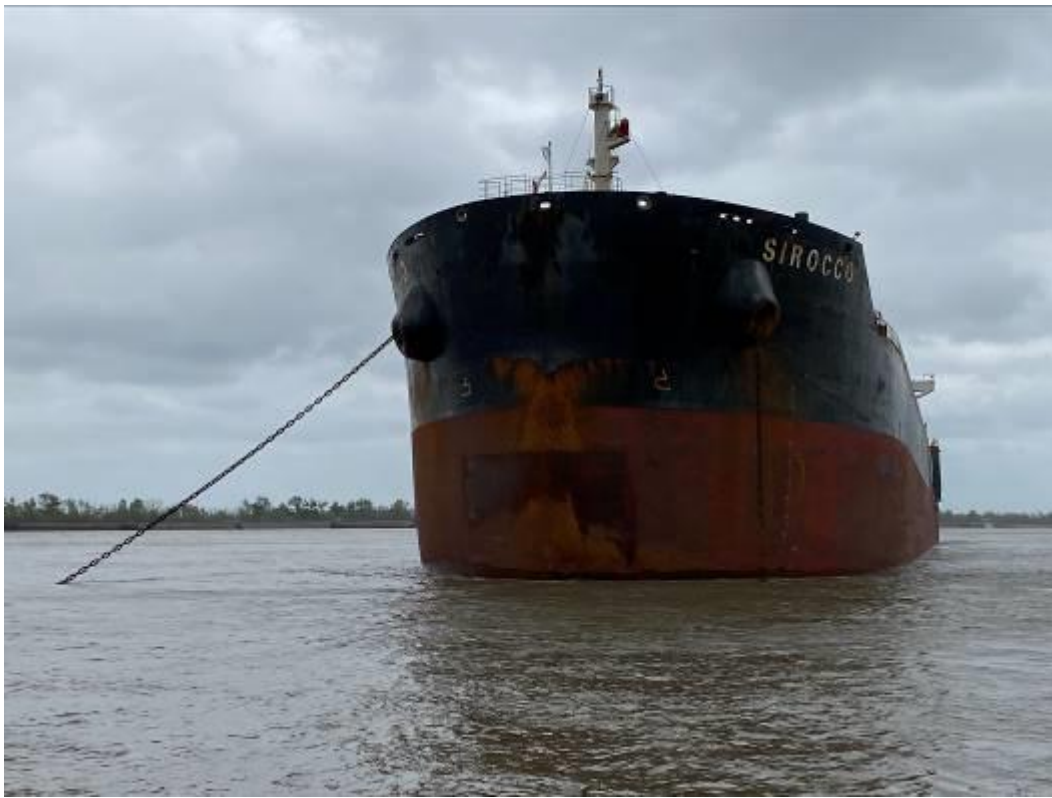
1. Viewing at the M/V "SIROCCO" while she was lay afloat and anchored at Ama anchorage in the Mississippi River, Louisiana.

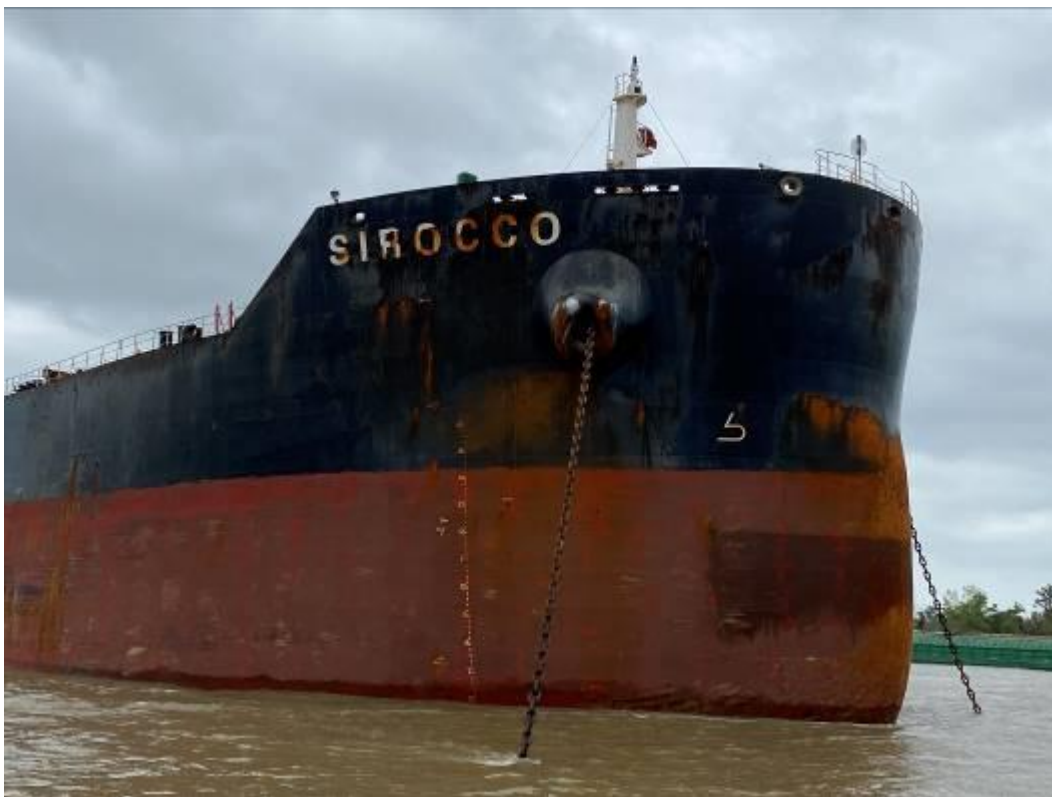
2. Viewing Starboard side hull forward section.

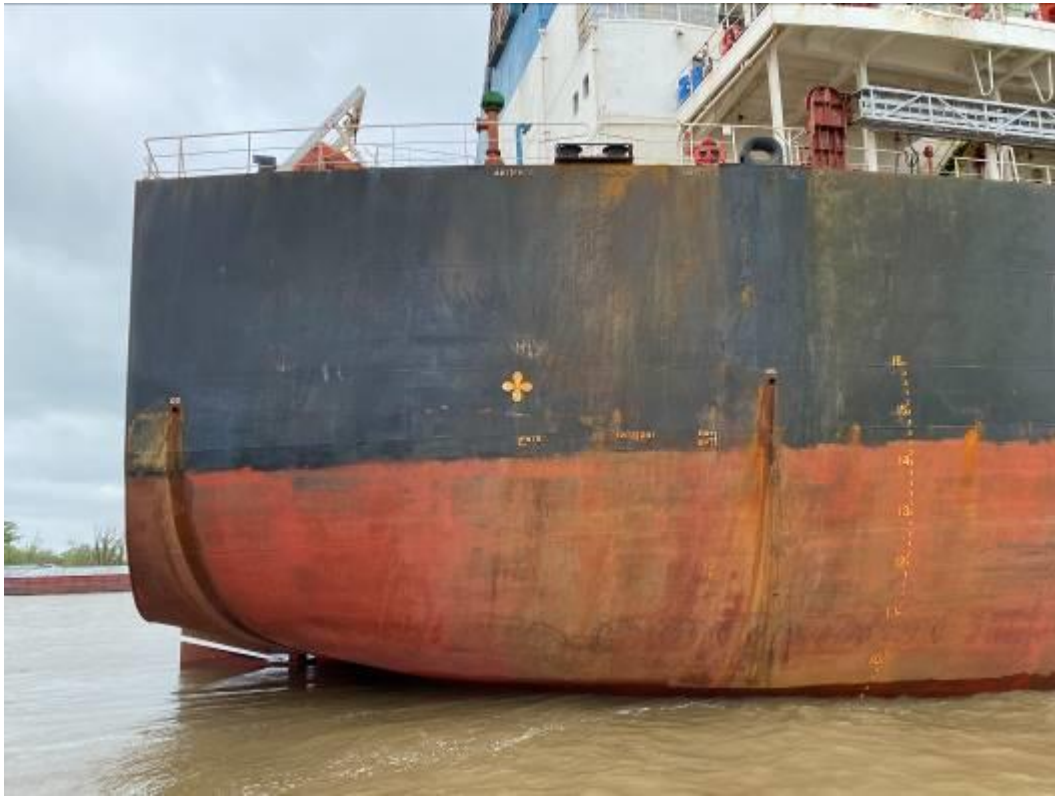
5. Viewing Starboard side after section.

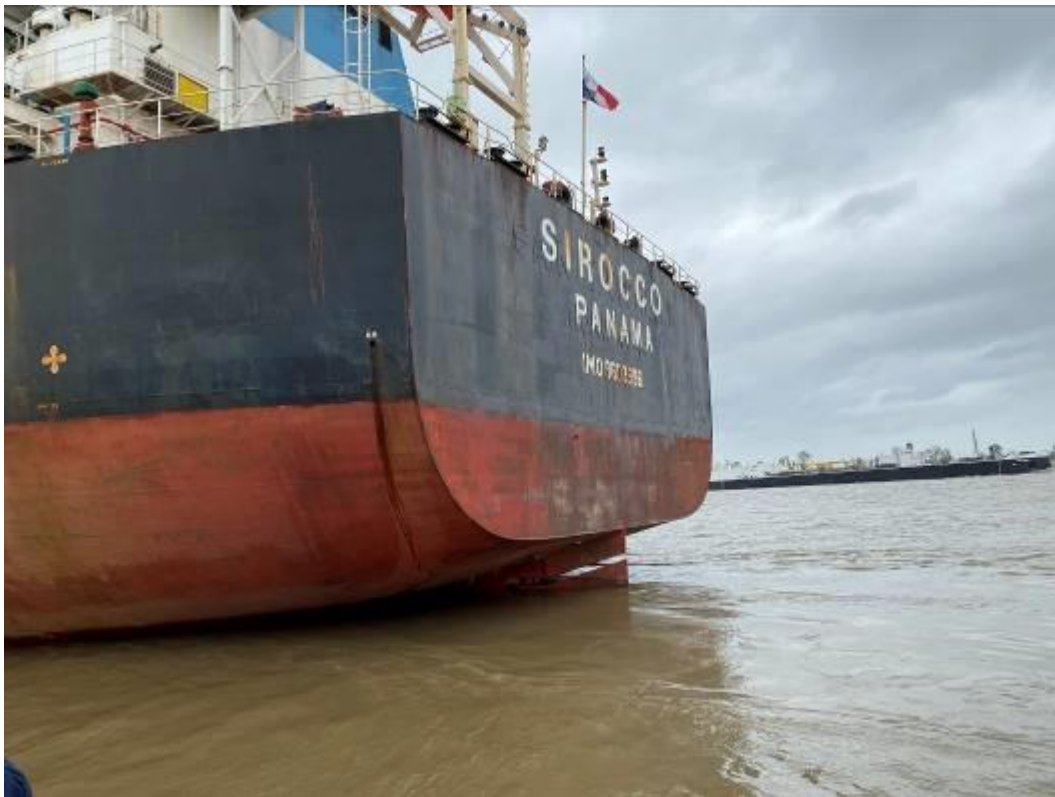
6. Viewing at her transom stern.

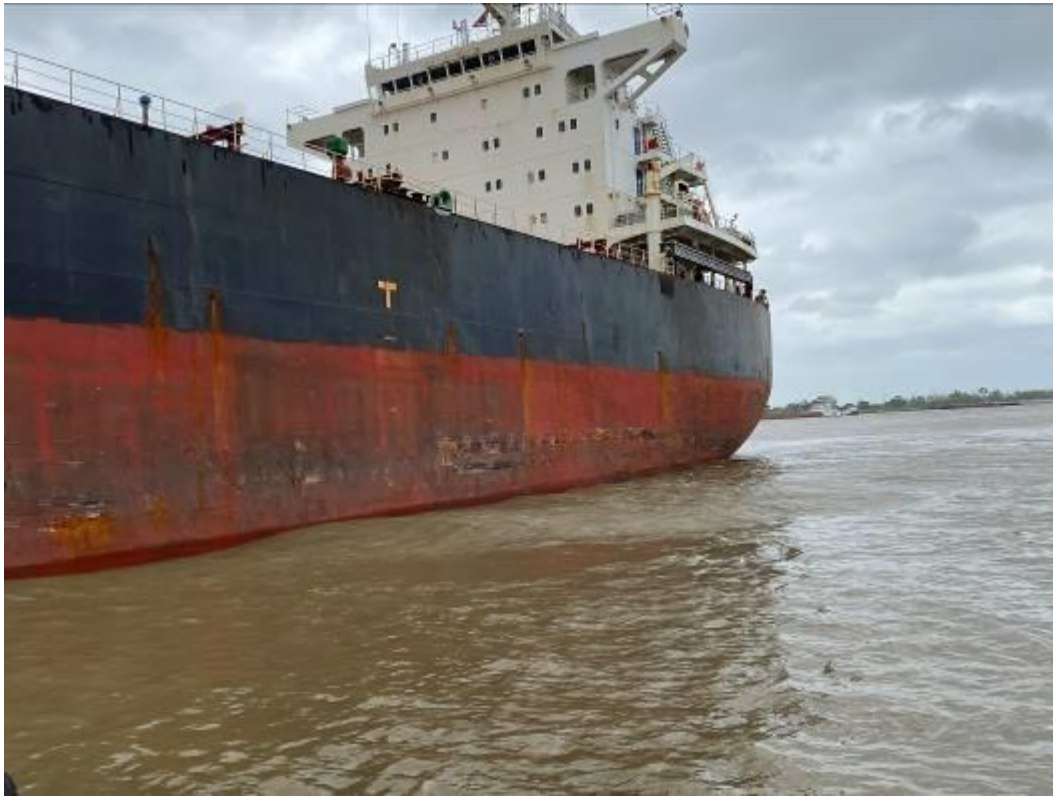
7. Viewing at her Port side hull after section.

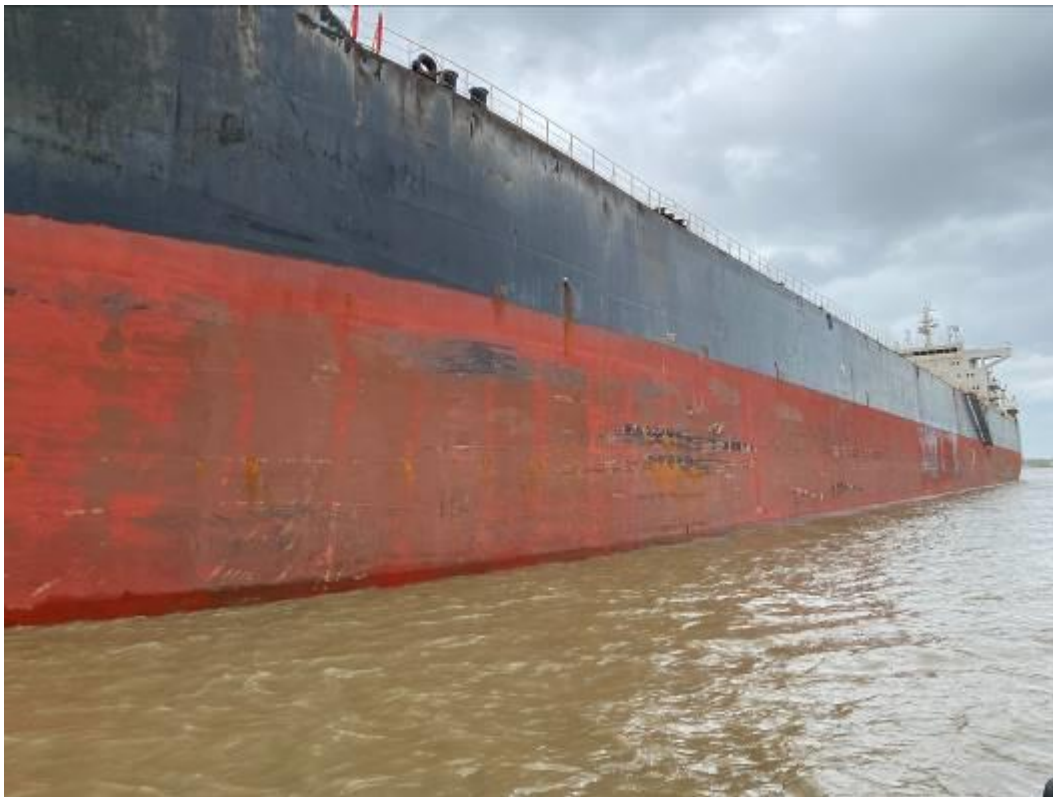
8. Viewing at her Port side hull mid to fwd section.

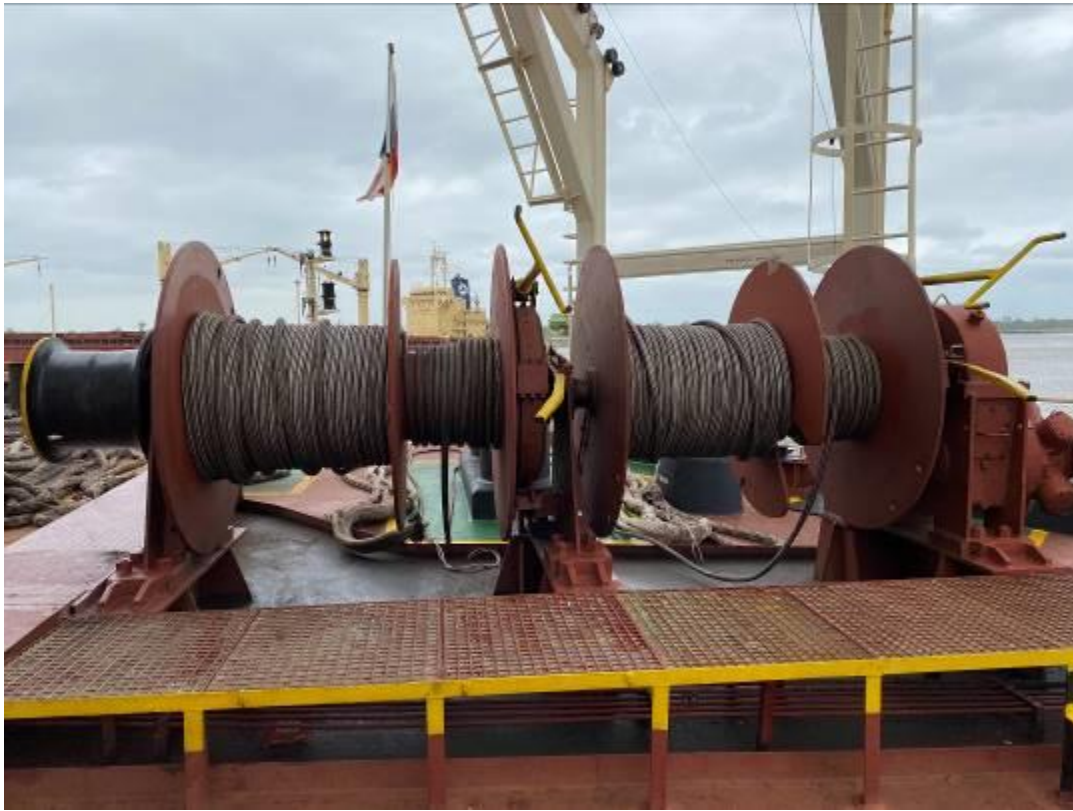
9. Port side mooring windlass.

4 HMPE-Polythene ropes present in good condition.

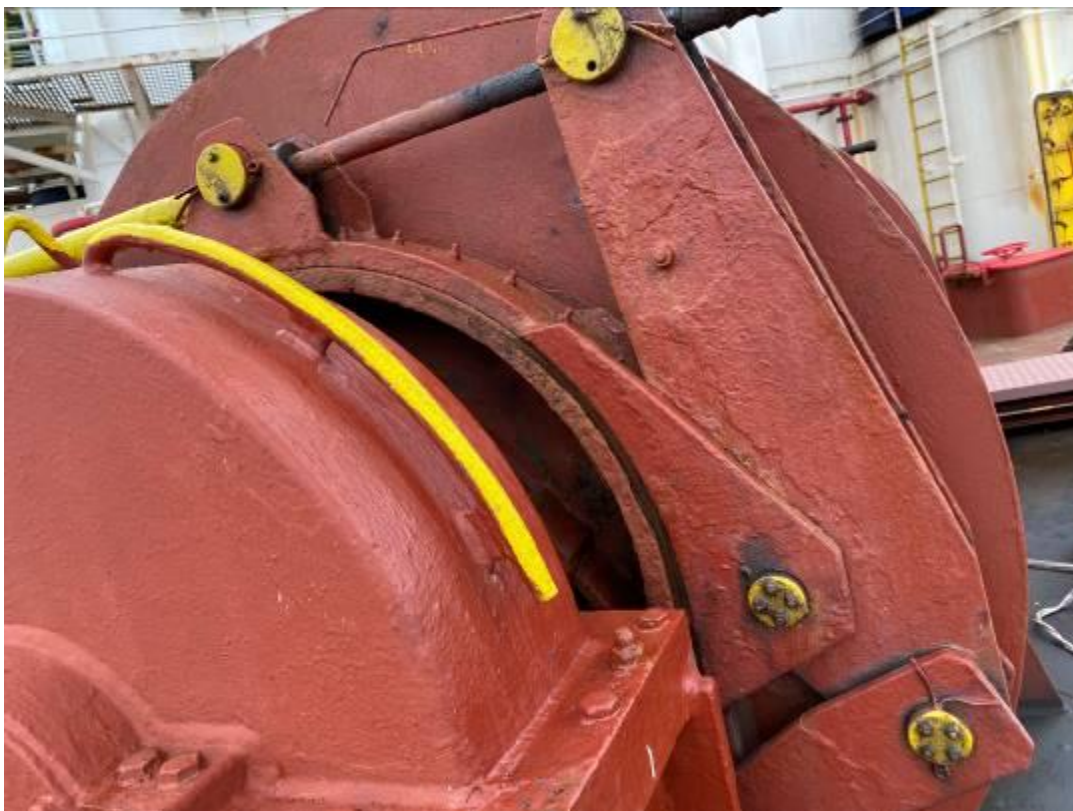
10. Port side mooring windlass close up of brake.

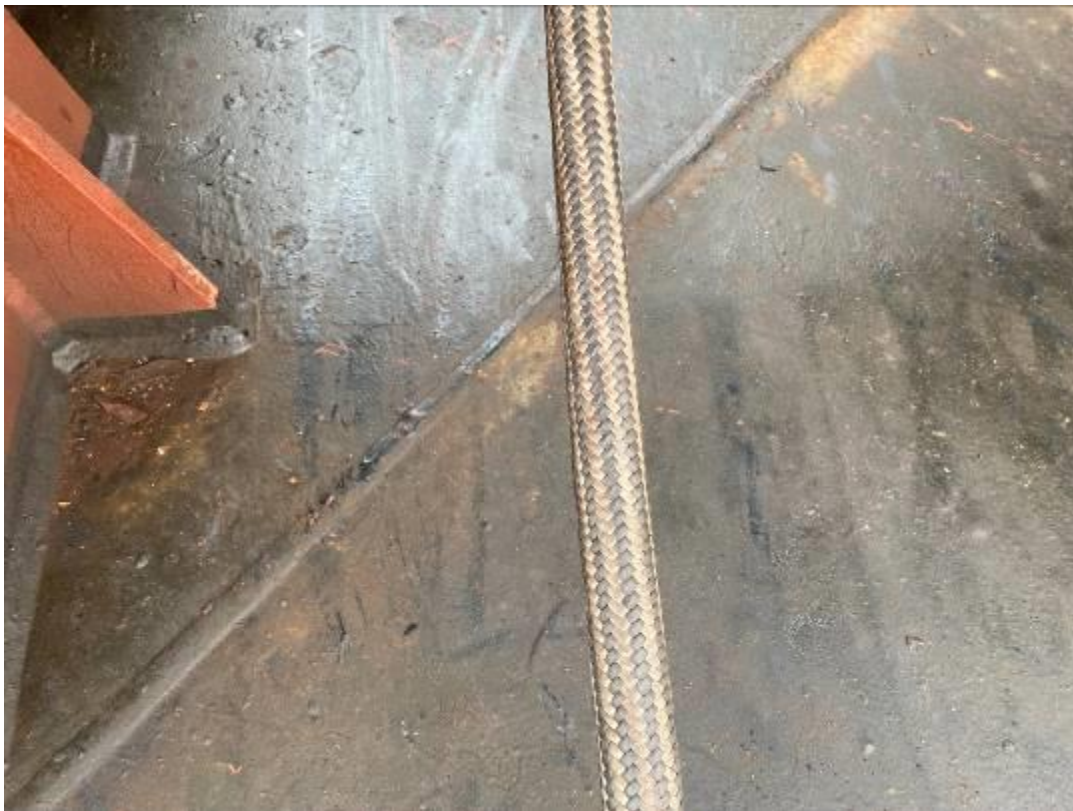
12. Port side mooring windlass condition of HMPE-Polythene rope.

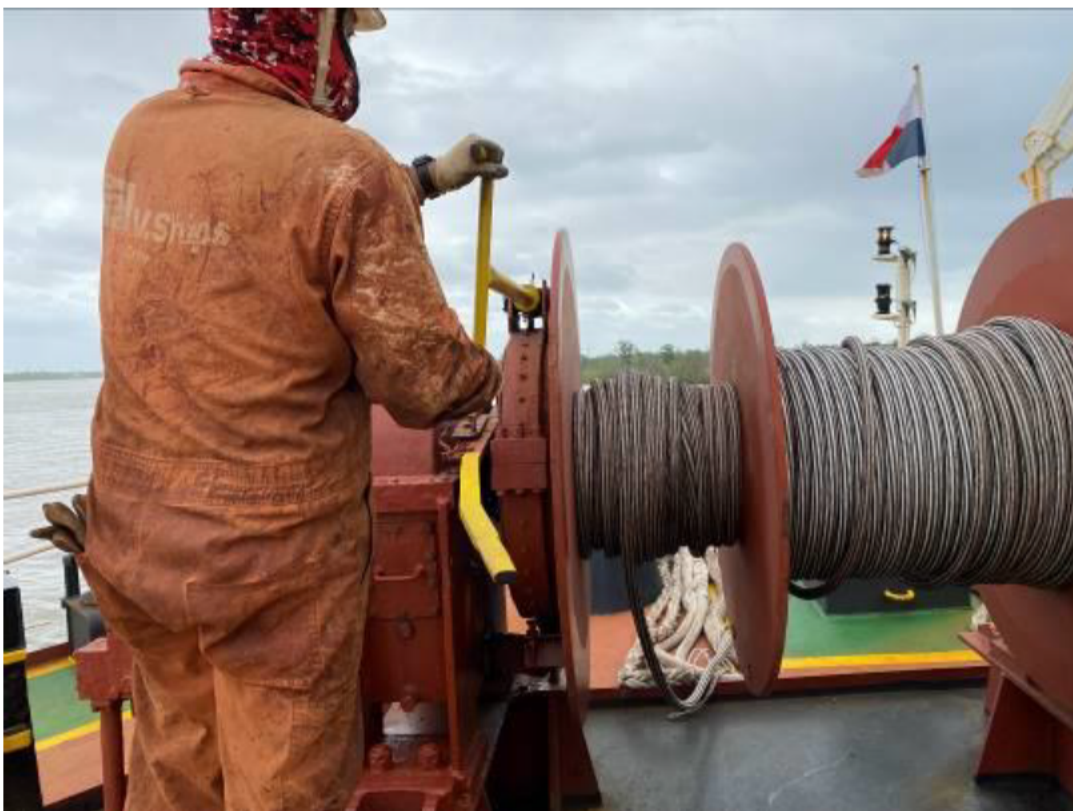
14. Port side mooring windlass break test.

2 HMPE-POLYETHENE lines present in good condition.

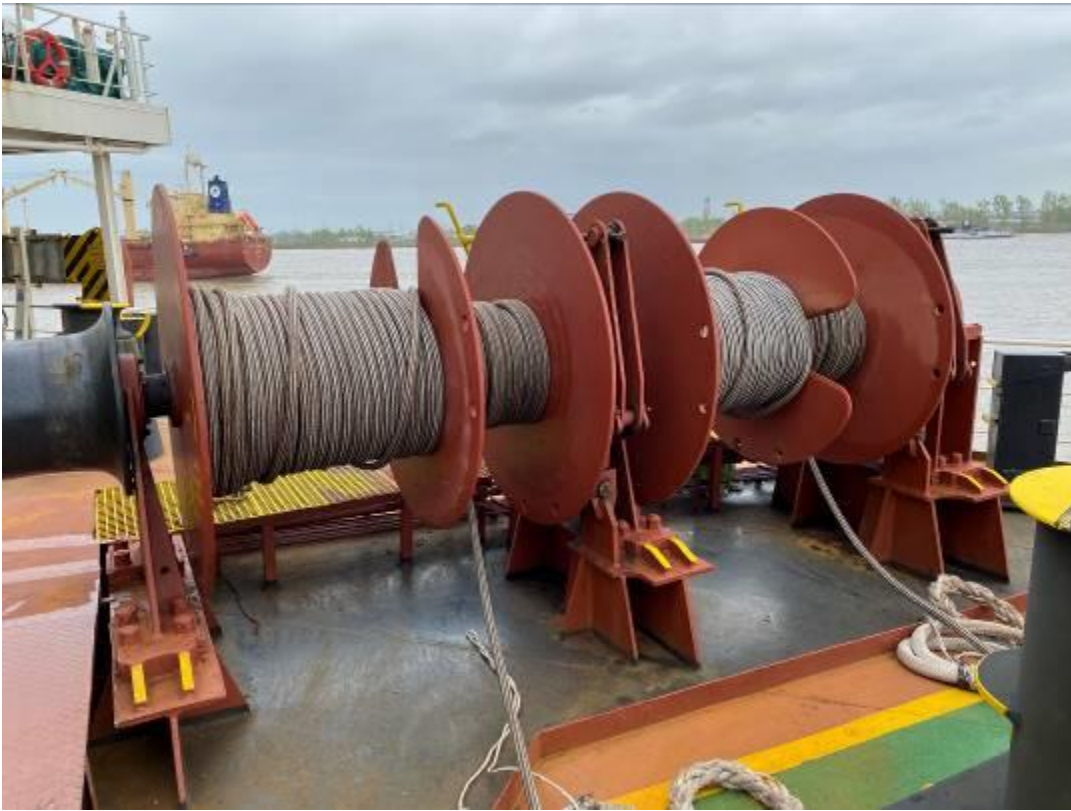
15. Starboard side mooring windlass.

4 HMPE-Polythene ropes present in good condition.

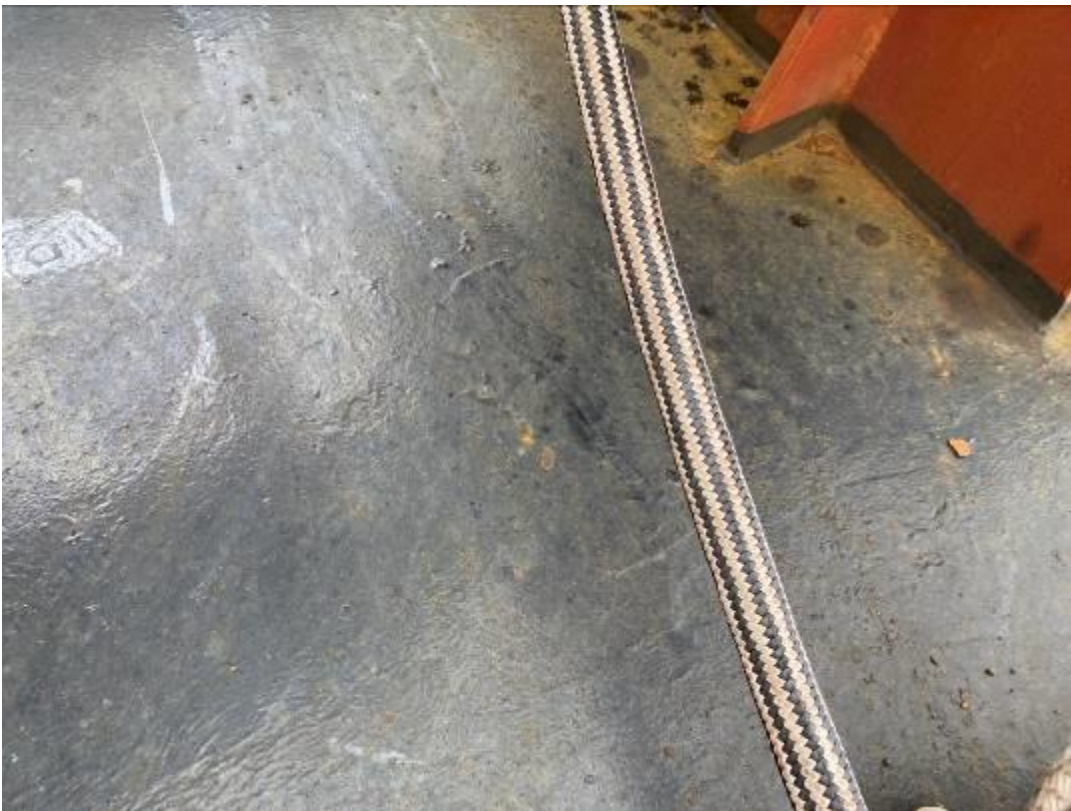
16. Starboard side mooring windlass close view of HMPE-Polythene rope.

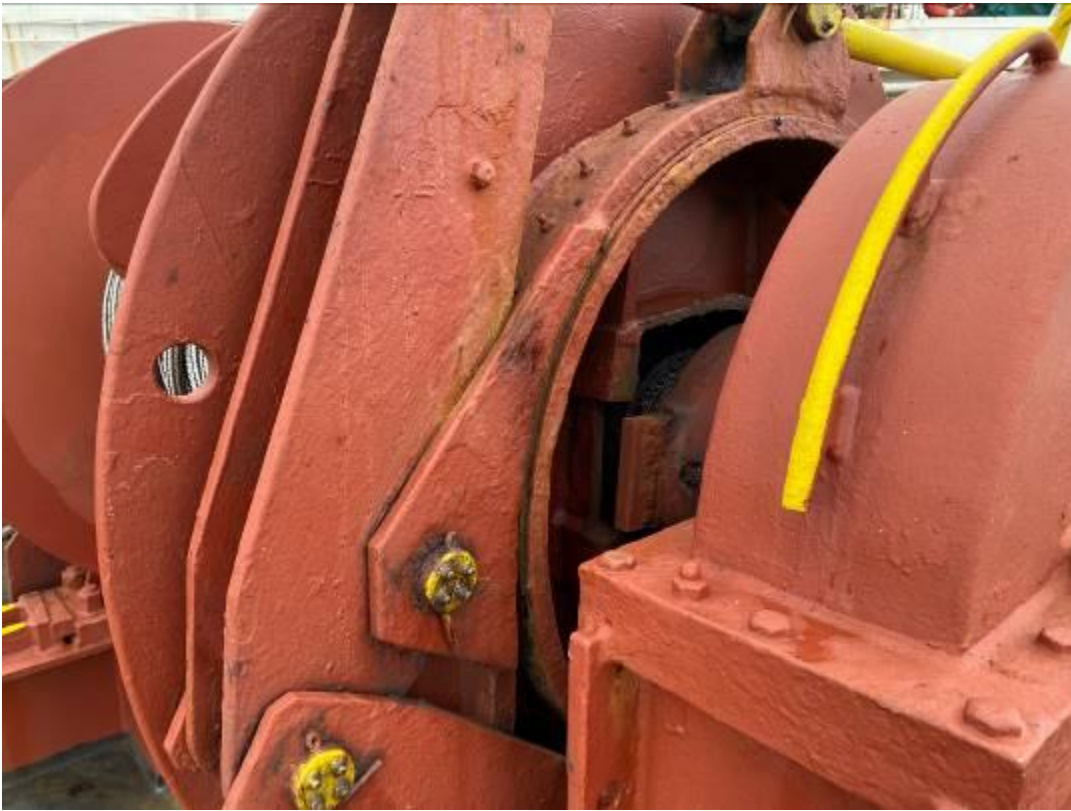
17. Starboard side mooring windlass close view of break.

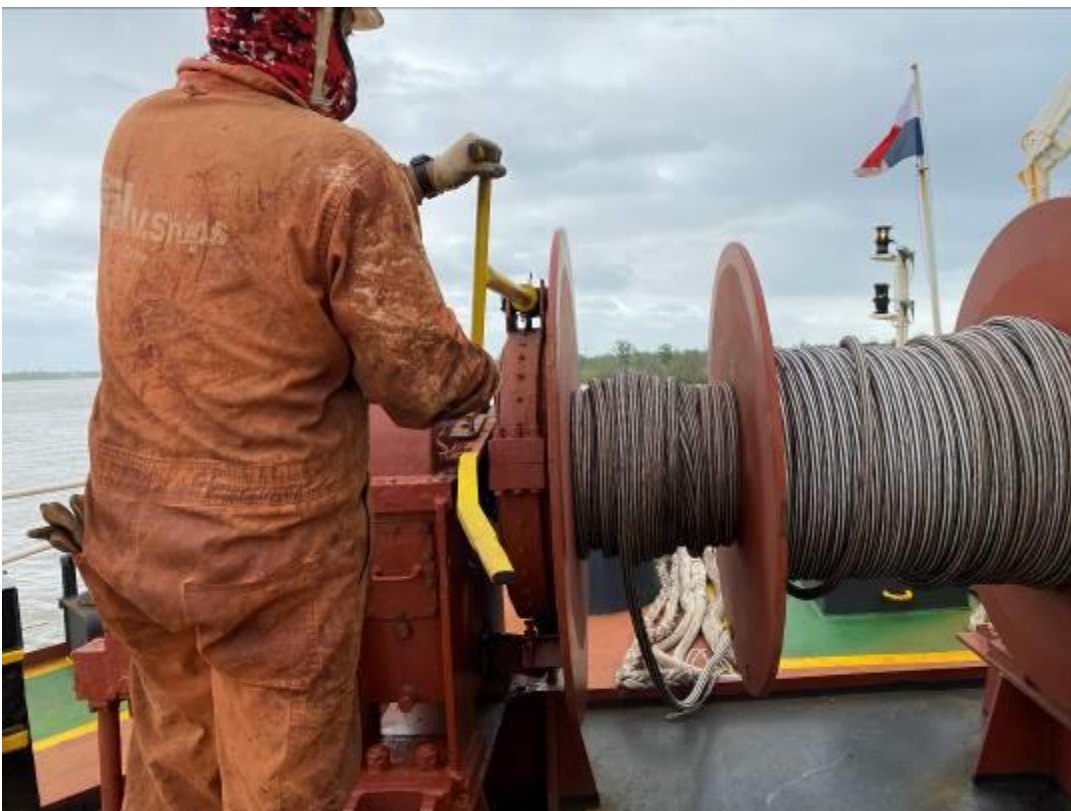
18. Starboard side mooring windlass testing of break.

2 HMPE-POLYETHENE lines present in good condition.

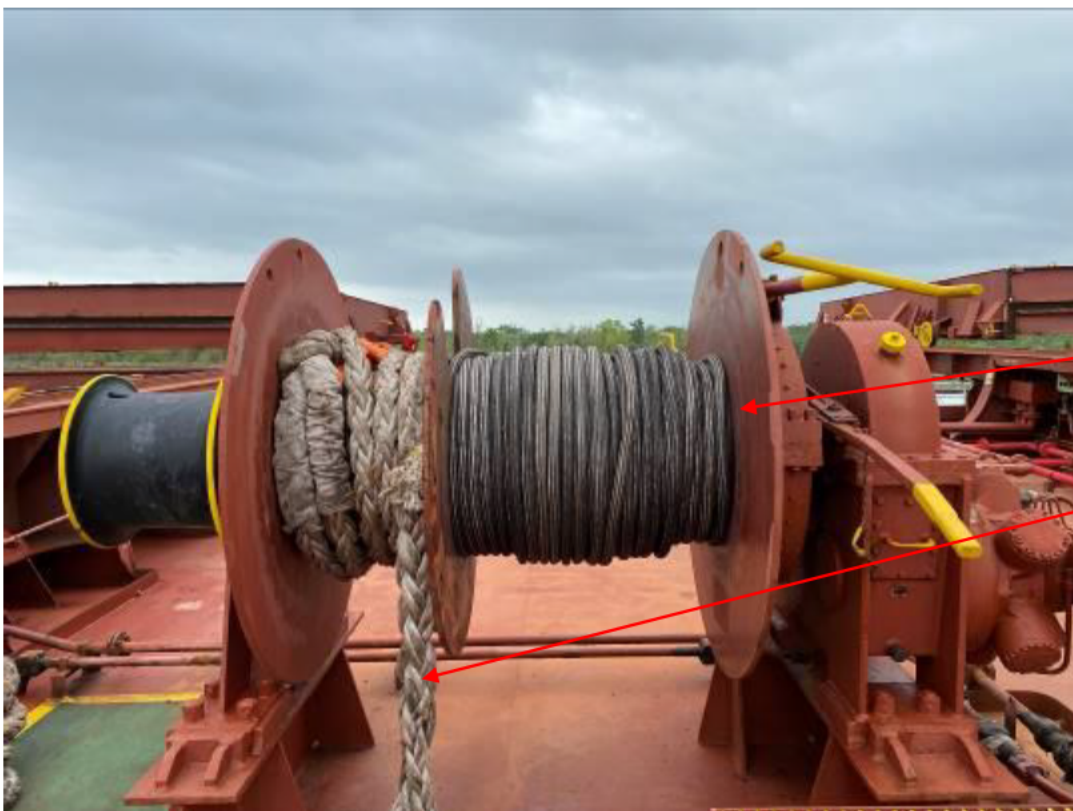
20. After Midship mooring winch.

1 HMPE-Polyethene in good condition

1 Polyester-Polypropylene moderate wear and tear present.

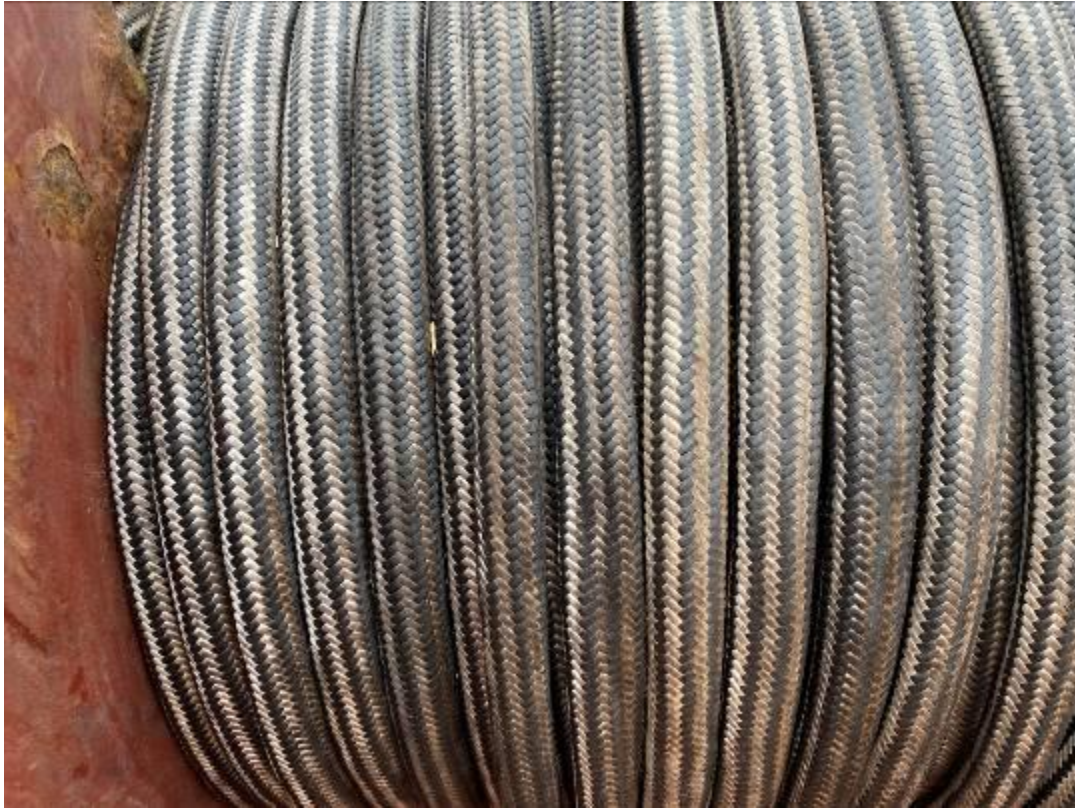
21. After Midship mooring winch close view of HMPE-Polyethene rope.

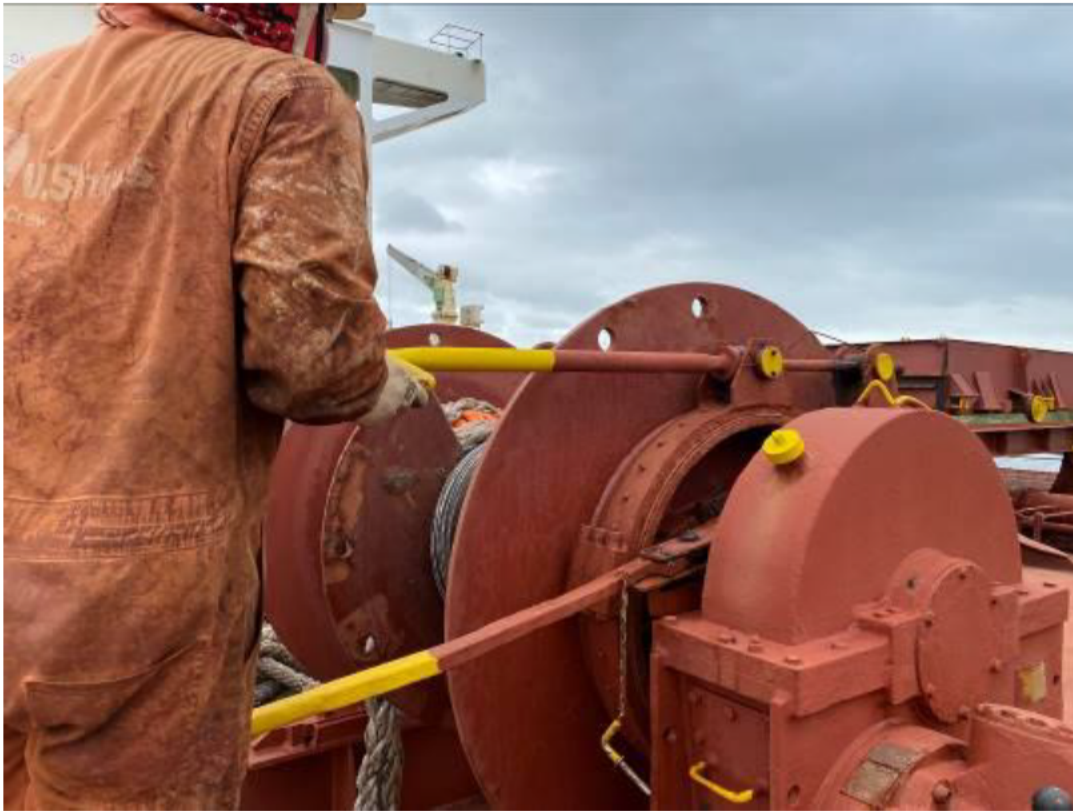
23. After Midship mooring winch break test.

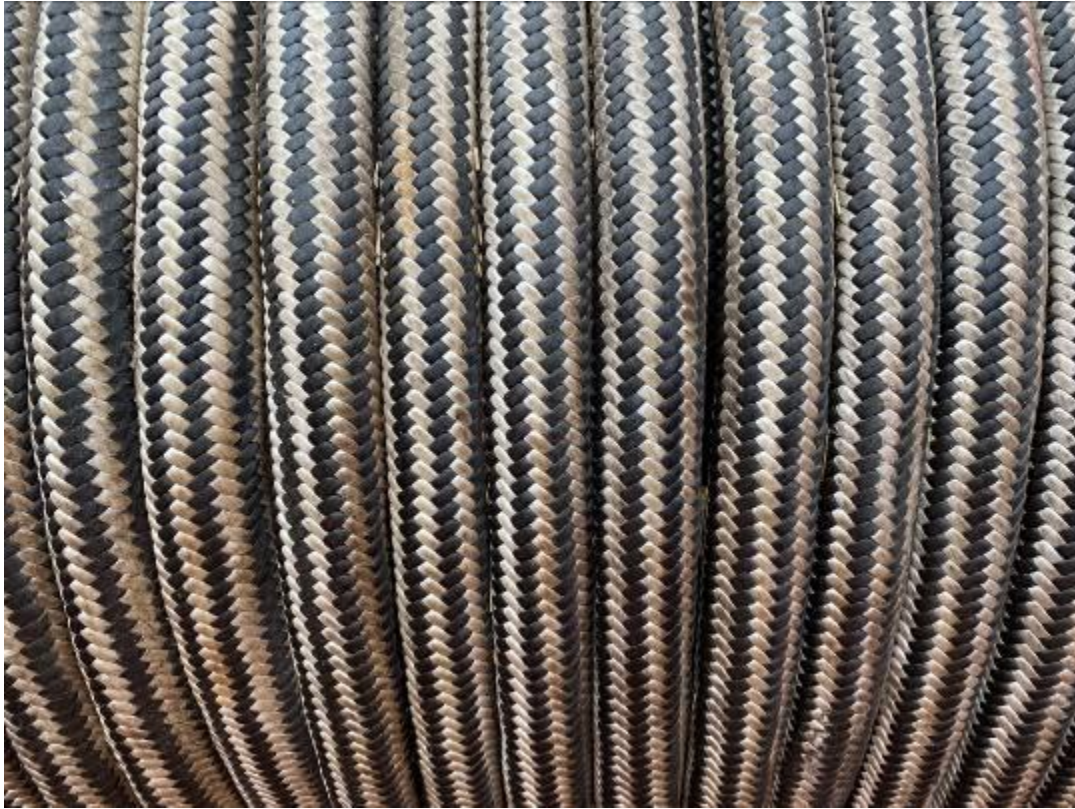
25. Forward Midship mooring winch close view of HMPE-Polyethylene rope.

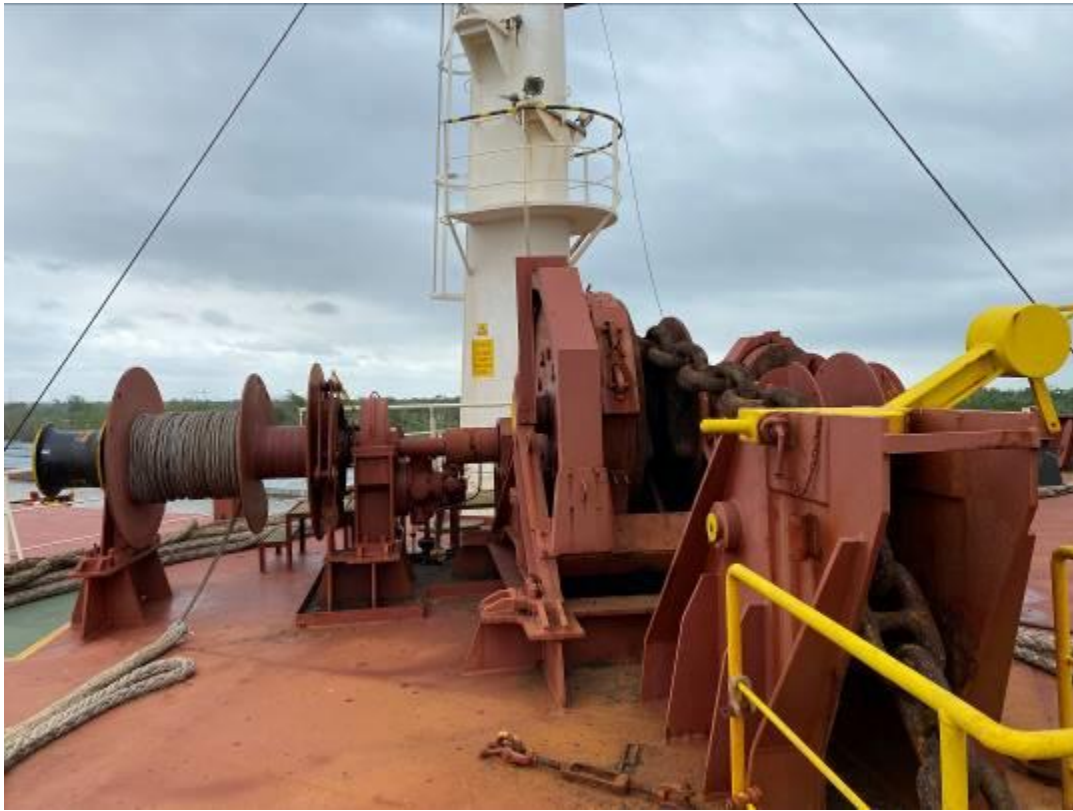
29. Mooring winch and anchor chain located at Port side forward mooring station.

2 HMPE-Polyethene in good condition.

2 Polyester-Polypropylene moderate wear and tear present on ground.

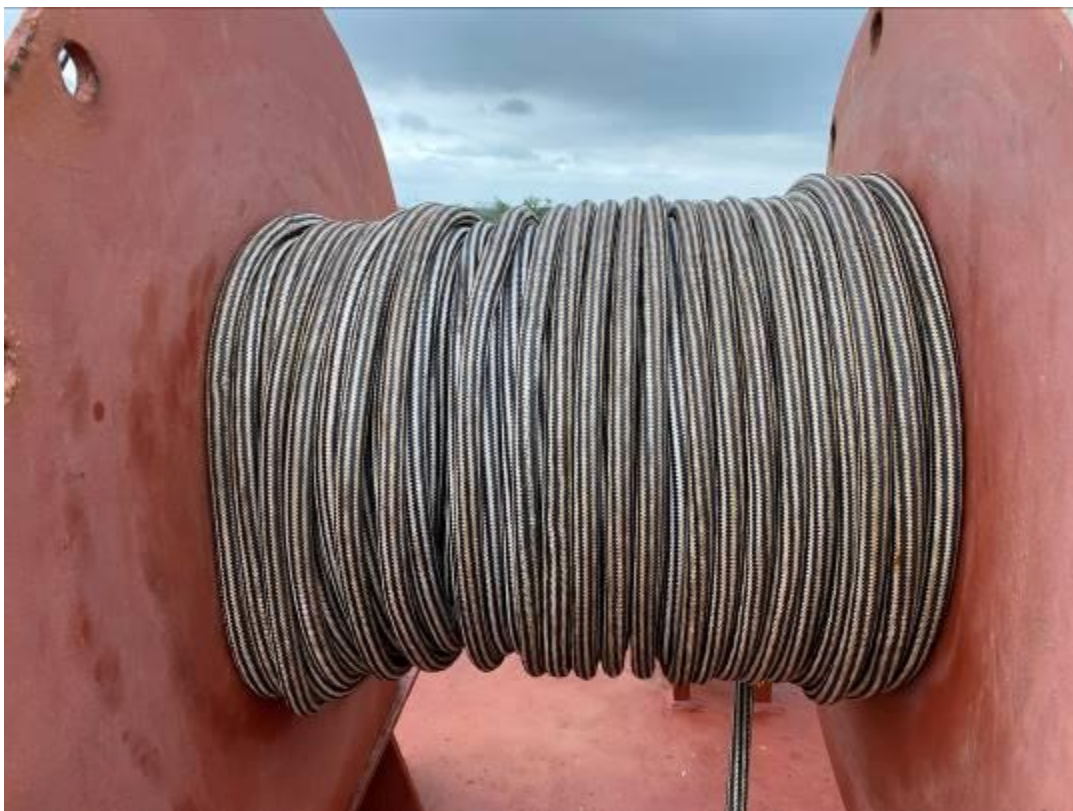
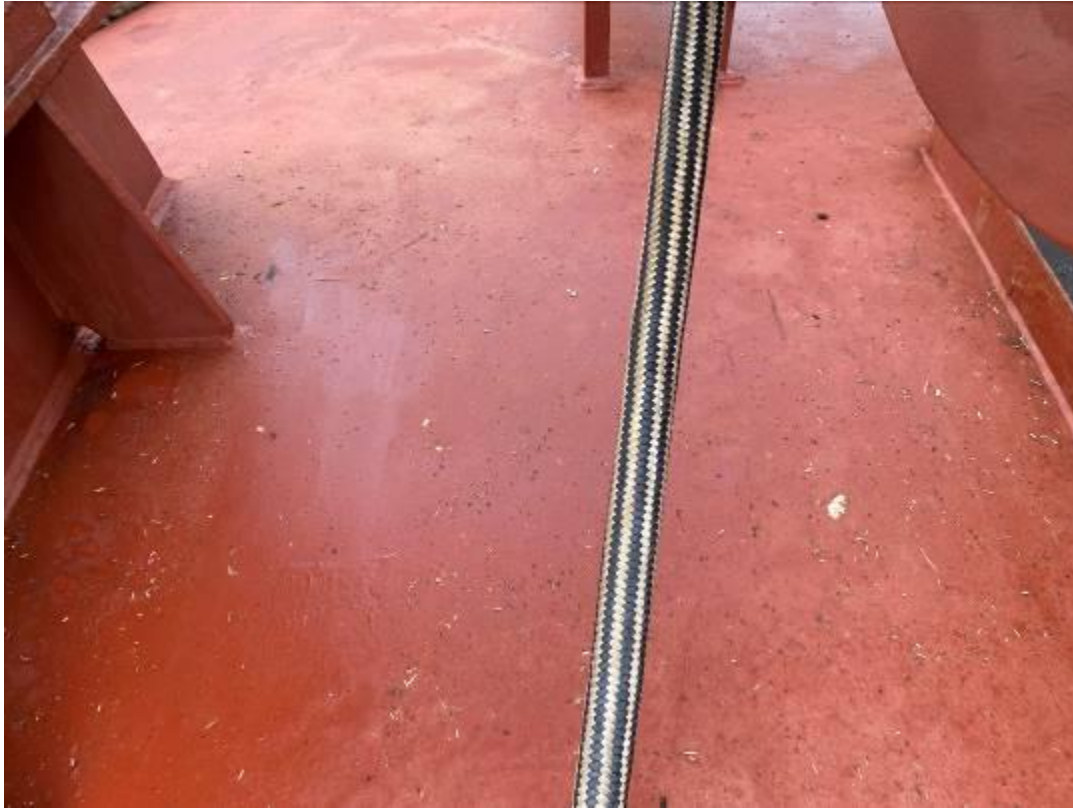
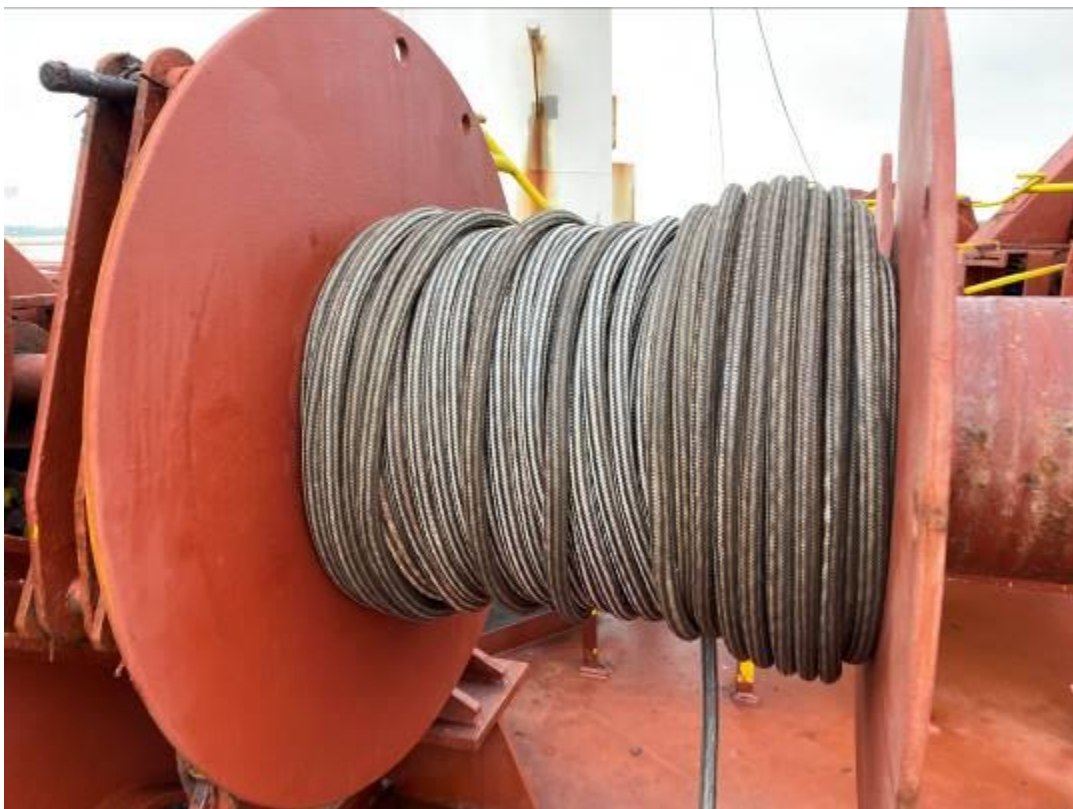
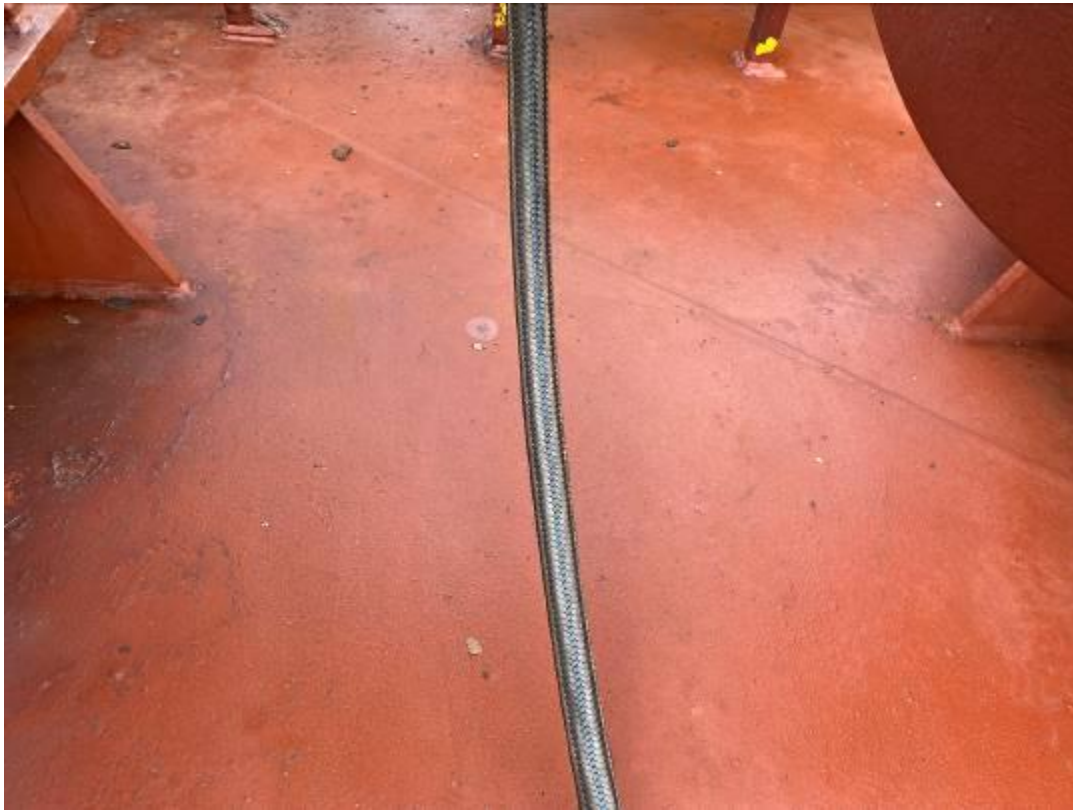
30. Close view of Mooring winch HMPE-Polyethene rope located at Port side forward mooring station.

31. Close view of Mooring winch HMPE-Polyethylene rope located at Port side forward mooring station.

32. Close view of Mooring winch HMPE-Polyethylene rope located at Port side forward mooring station.

33. Close view of Mooring winch HMPE-Polyethene rope located at Port side forward mooring station.

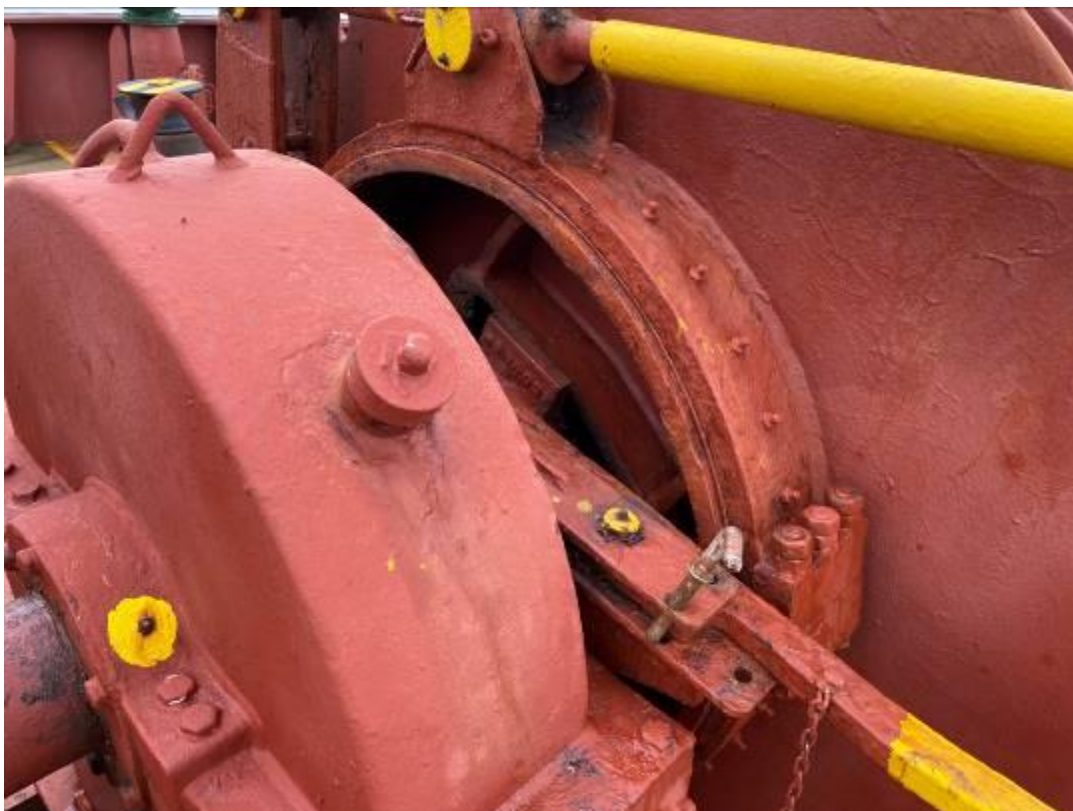
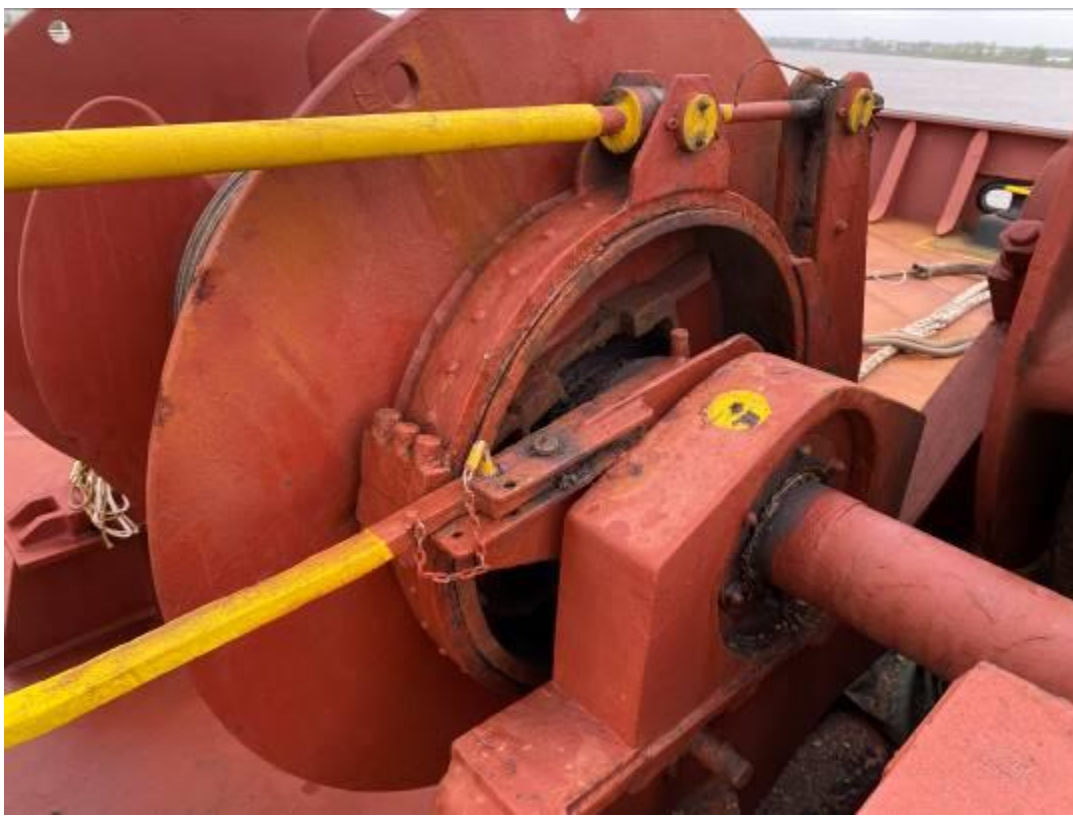
34. Close view of break located at Port side forward mooring station.

35. Close view of break located at Port side forward mooring station.

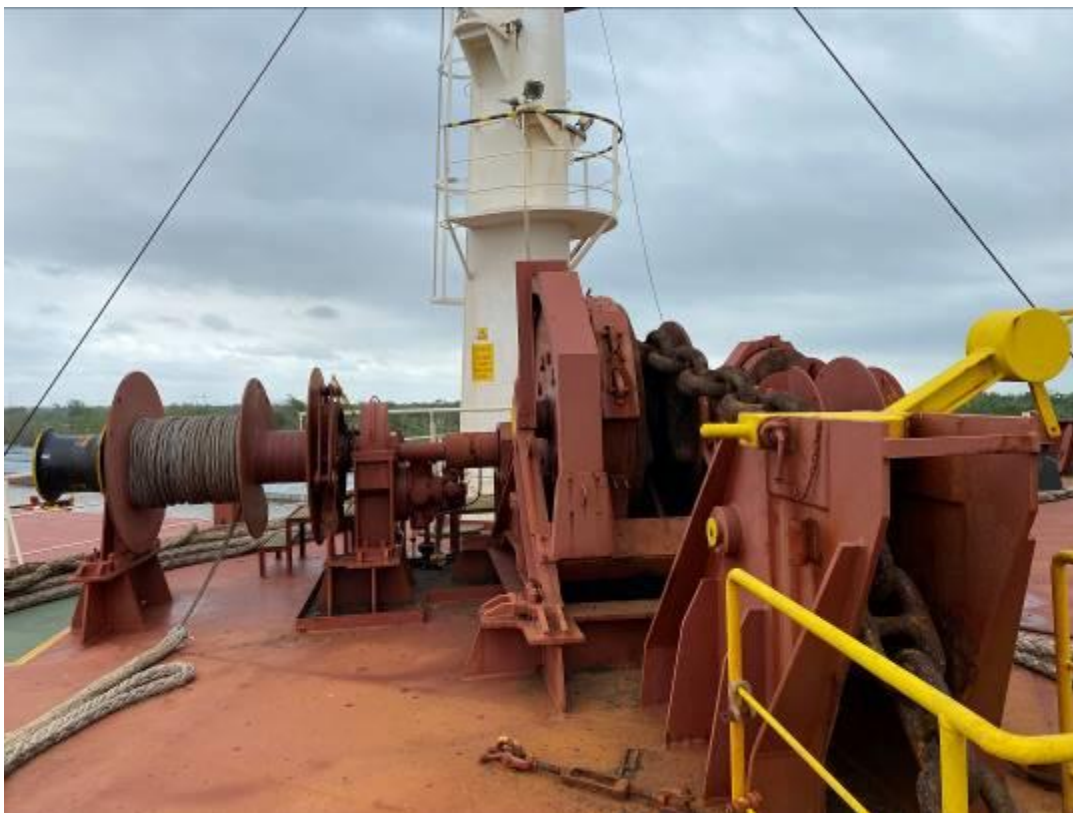
36. Mooring winch and anchor chain located at starboard side forward mooring station.

2 HMPE-Polyethene in good condition.

2 Polyester-Polypropylene moderate wear and tear present on ground.
