MARiTECH COMMERCIAL, INC.

Report No.: 185286

SURVEY REPORT

M/V "SIROCCO" (Voy.32L)

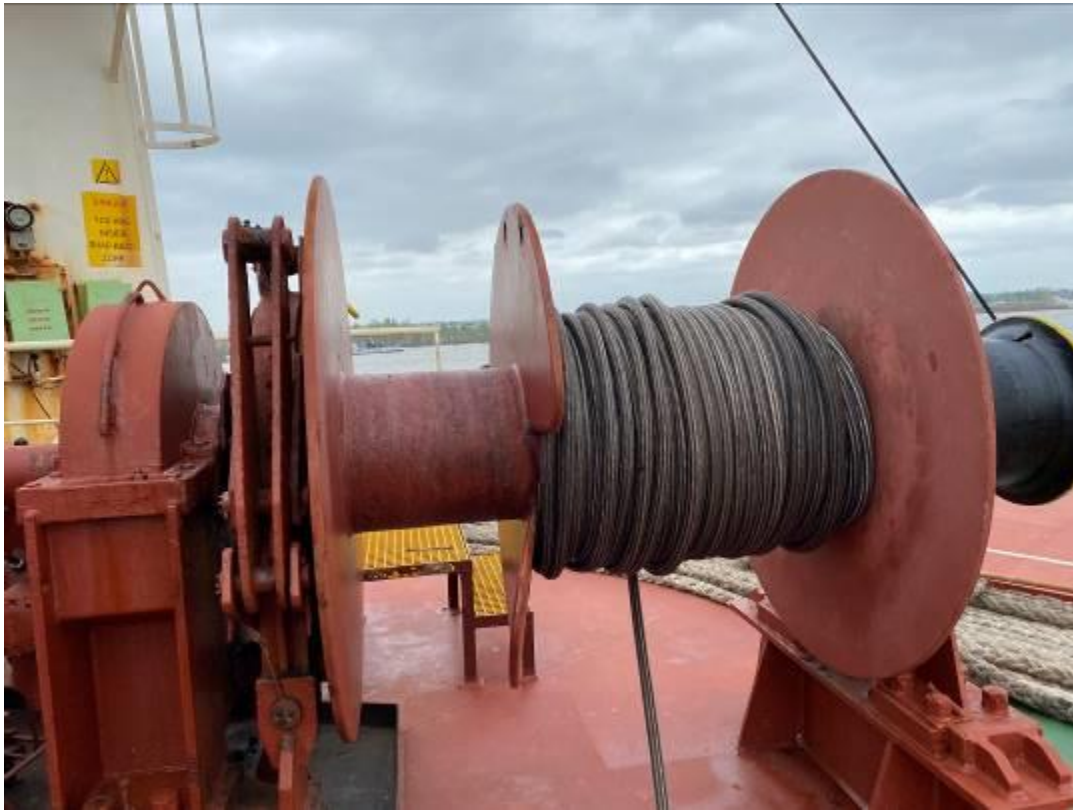
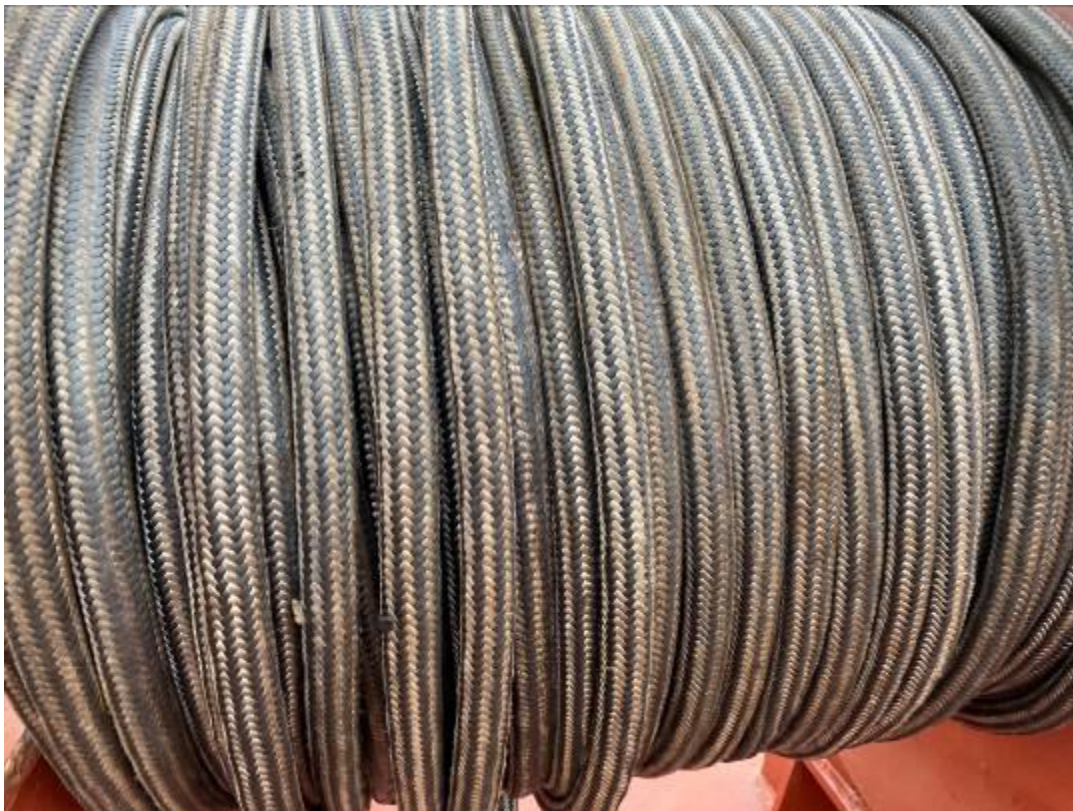
37. Close view of Mooring winch HMPE-Polyethylene rope located at starboard side forward mooring station.

38. Close view of Mooring winch HMPE-Polyethylene rope located at starboard side forward mooring station.

39. Close view of Mooring winch HMPE-Polyethene rope located at starboard side forward mooring station.

40. Close view of Mooring winch HMPE-Polyethene rope located at starboard side forward mooring station.

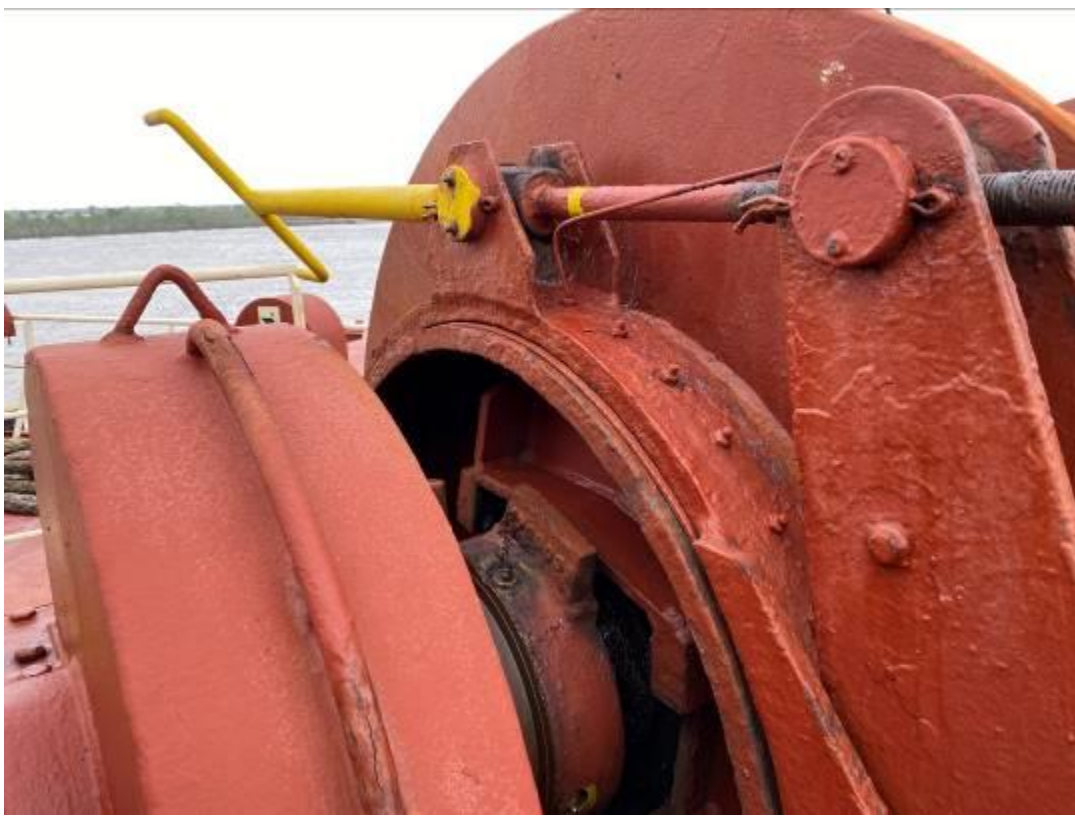
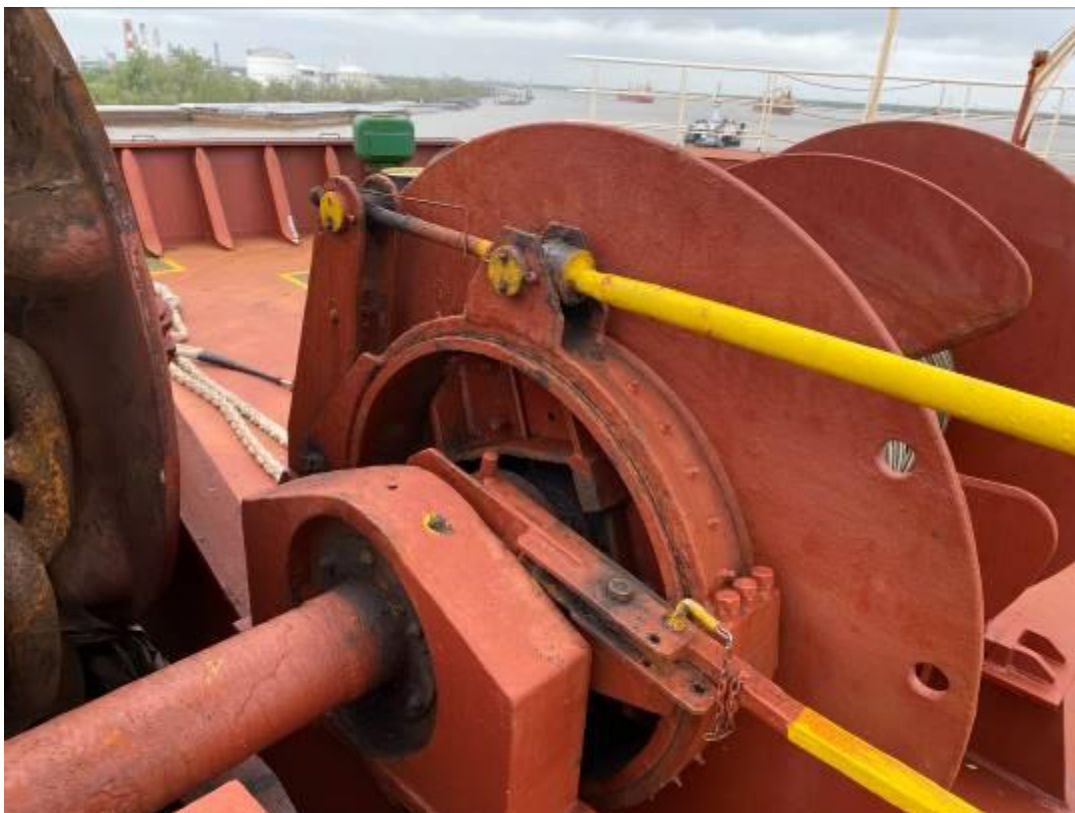
41. Close view of break located at starboard side forward mooring station.

42. Close view of break located at starboard side forward mooring station.

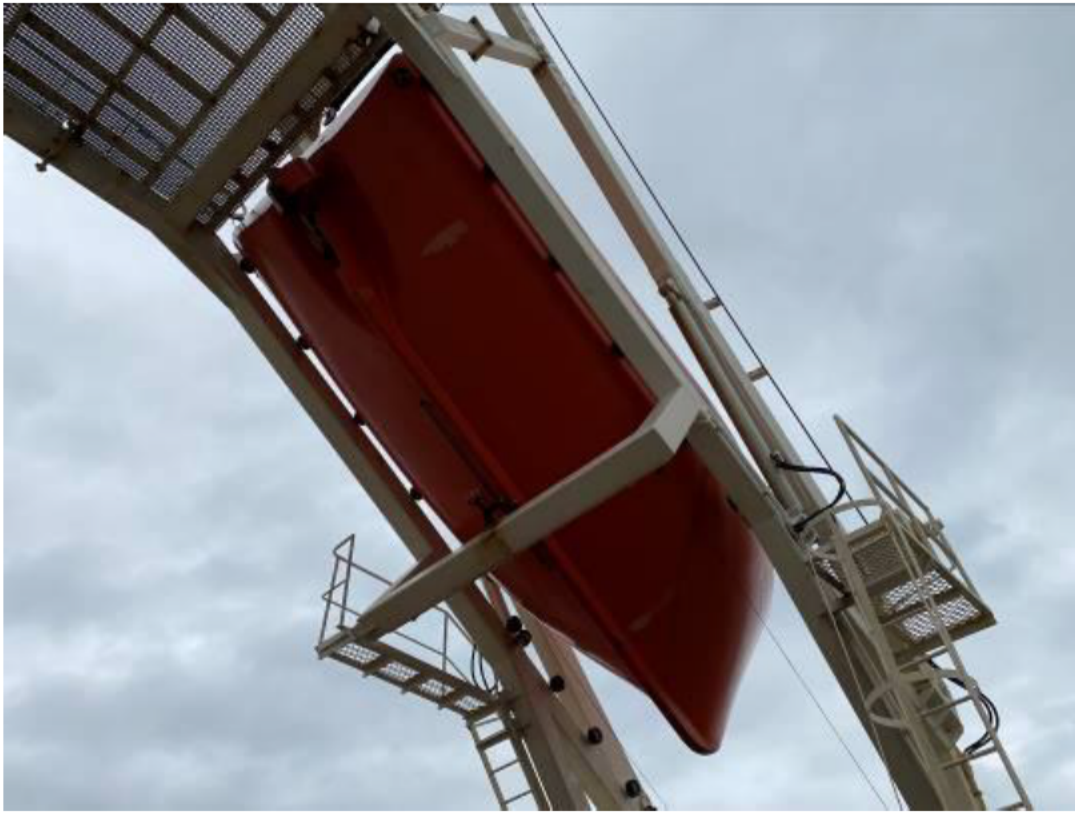
43. Viewing free fall lifeboat at after station.

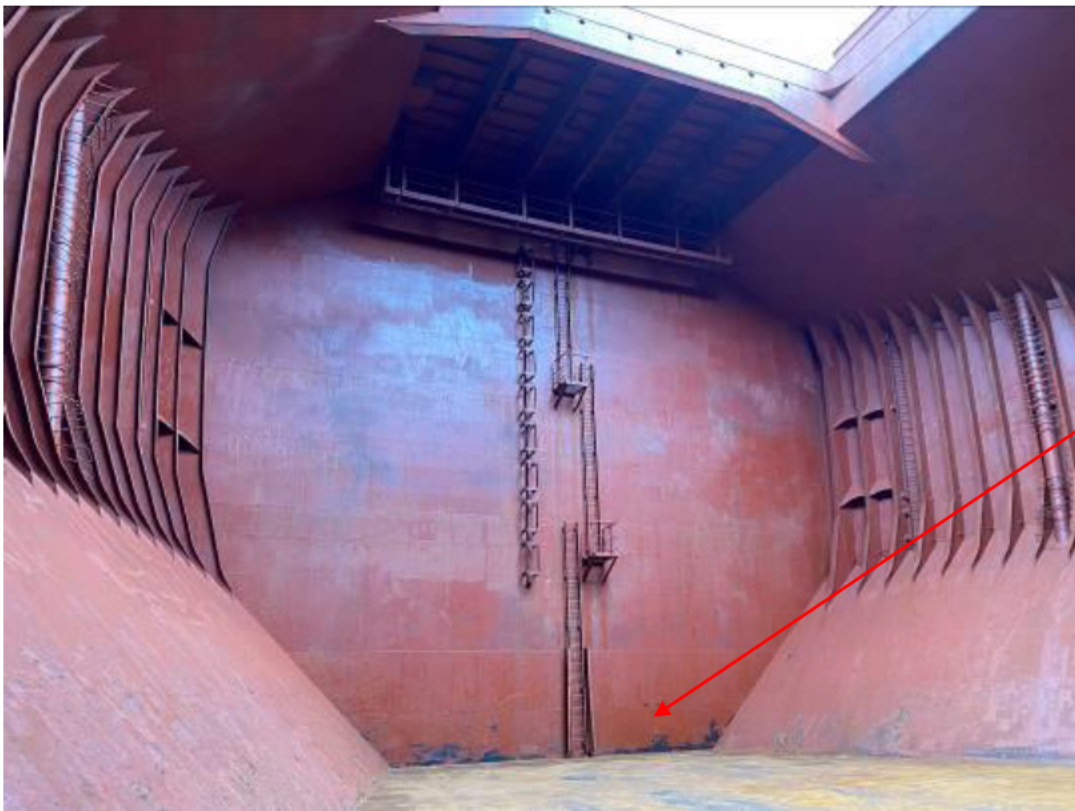
44. Hold #1 - Forward flush transverse Bulkhead.

Paint Fowling on lower section.

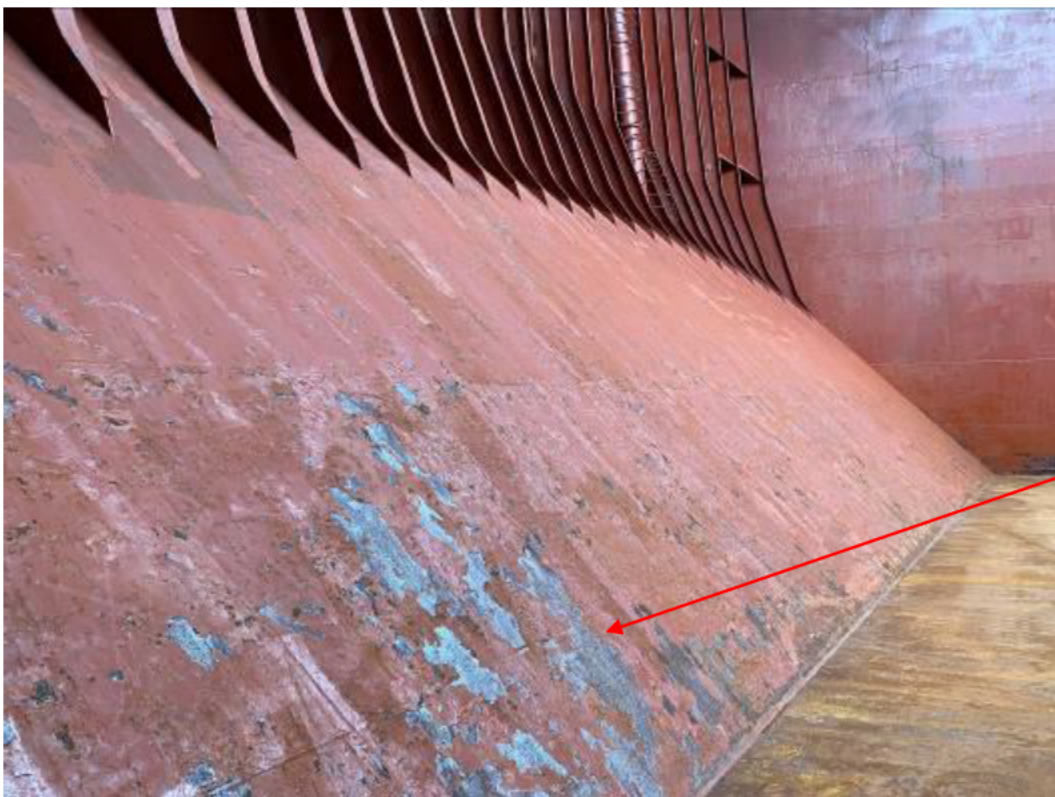
46. Hold #1 - Port side Lower hopper slope.

Paint fowling and exposed metal.

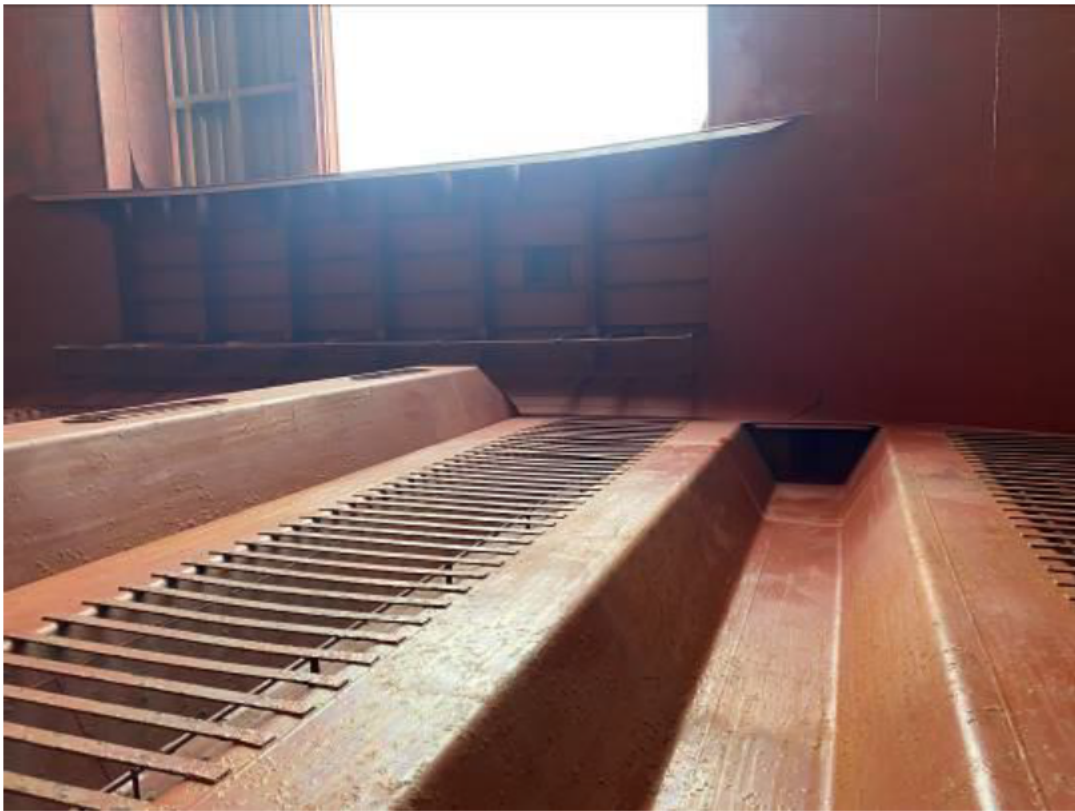
57. Hold #2 -
Port side
lower
hopper
slop.

Note: Paint
missing along
lower hopper
slope and rust
present.

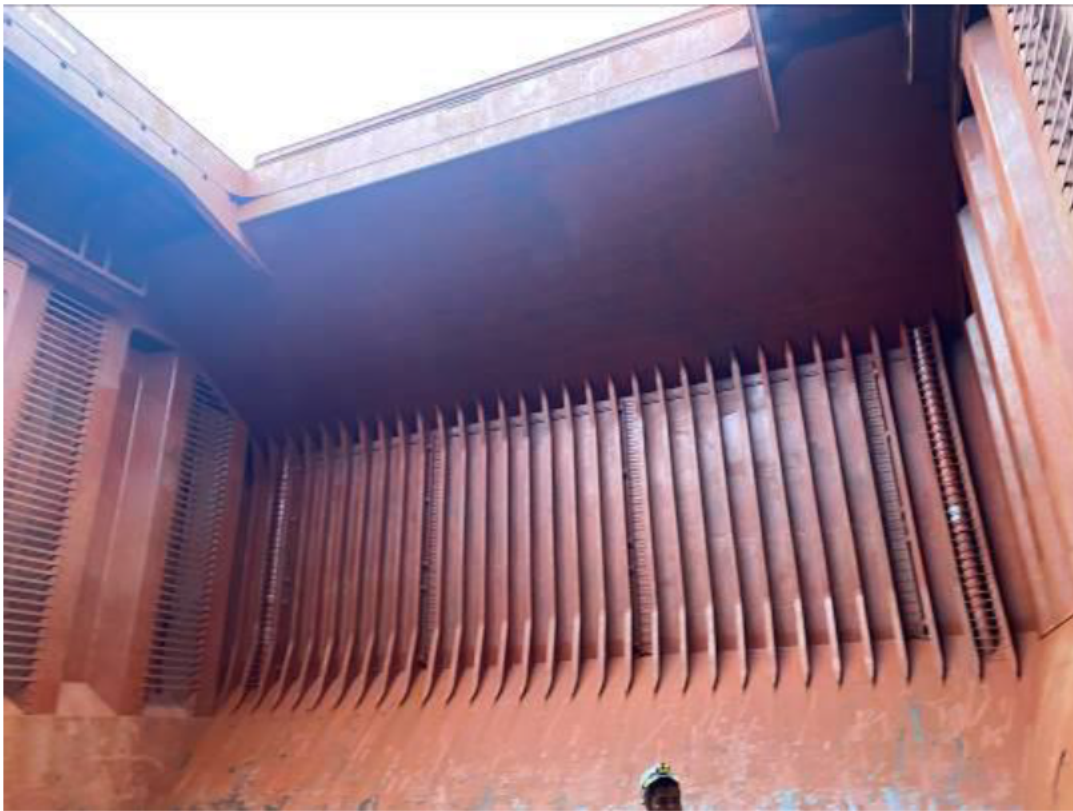
59. Hold #2 -
After
vertically
corrugated
transverse
bulkhead.

- **Lower access ladder frame bent on after bulkhead and paint fowling present. (Photo #64)**
- **Paint missing and flaking on lower section of bulkhead. (Photo #59)**

Note: Paint
missing along
lower hopper
slope.

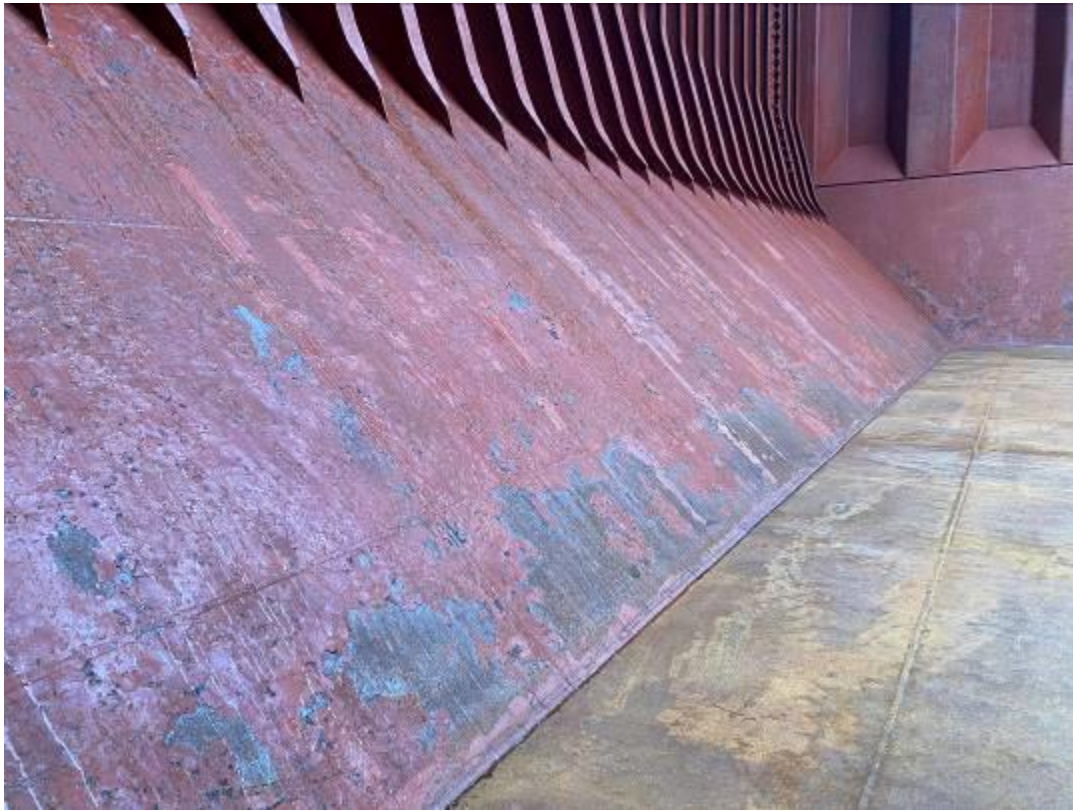
66. Hold #3 -
Starboard
side
bulkhead.

- **Paint missing and flaking along lower hopper slope. (Photo #66)**

Note: Paint
missing and
flaking along
lower hopper
slope.

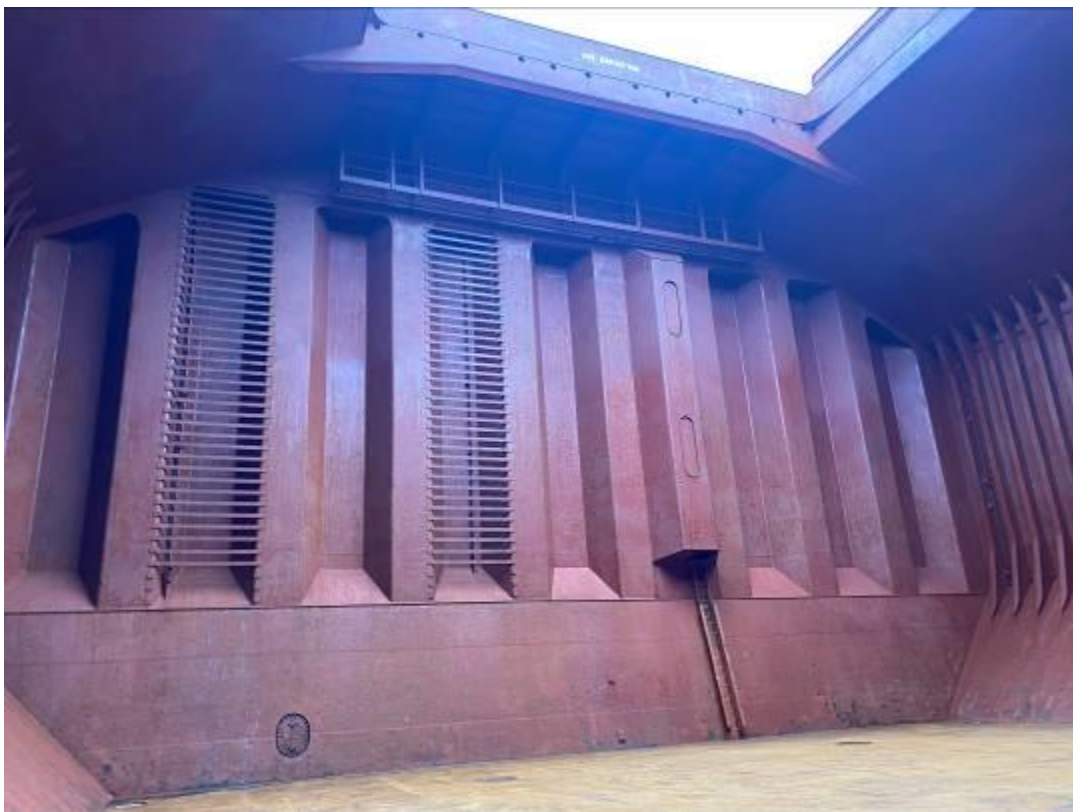
67. Hold #3 -
Port side
lower
hopper
slop.

Note: Paint
missing and
flaking along
lower hopper
slope.

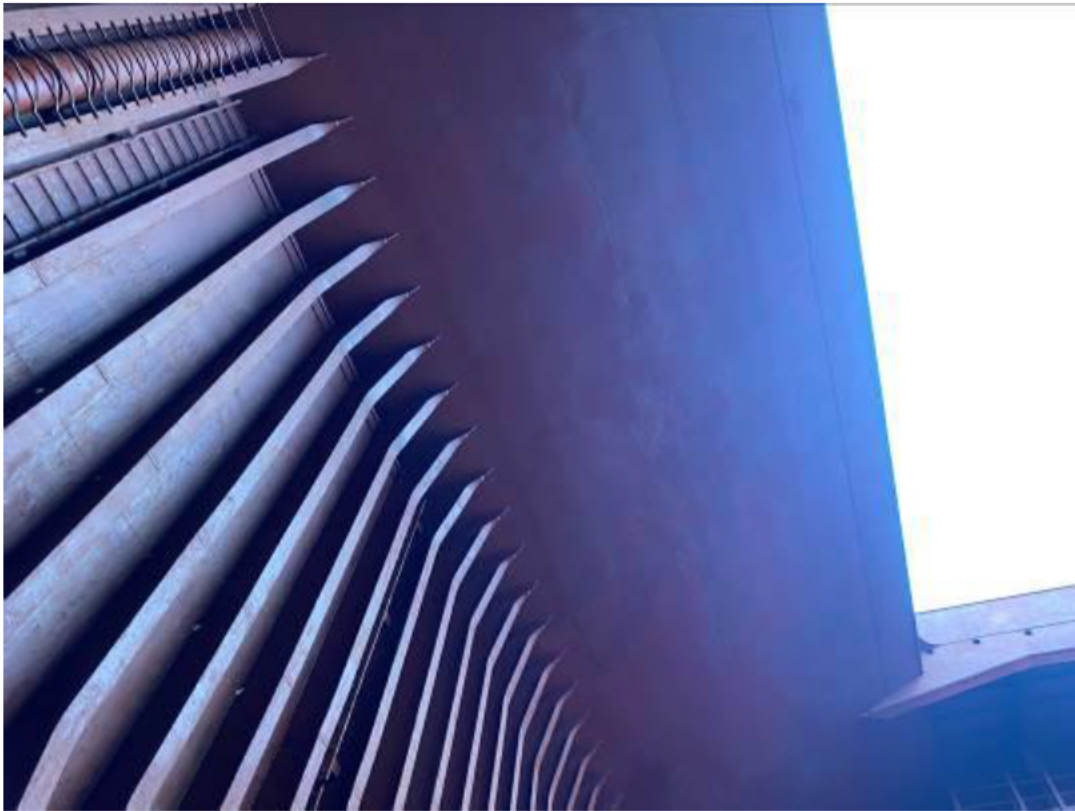
70. Hold #3 - Starboard side lower hopper slop.

Note: Paint missing and flaking along lower hopper slope.

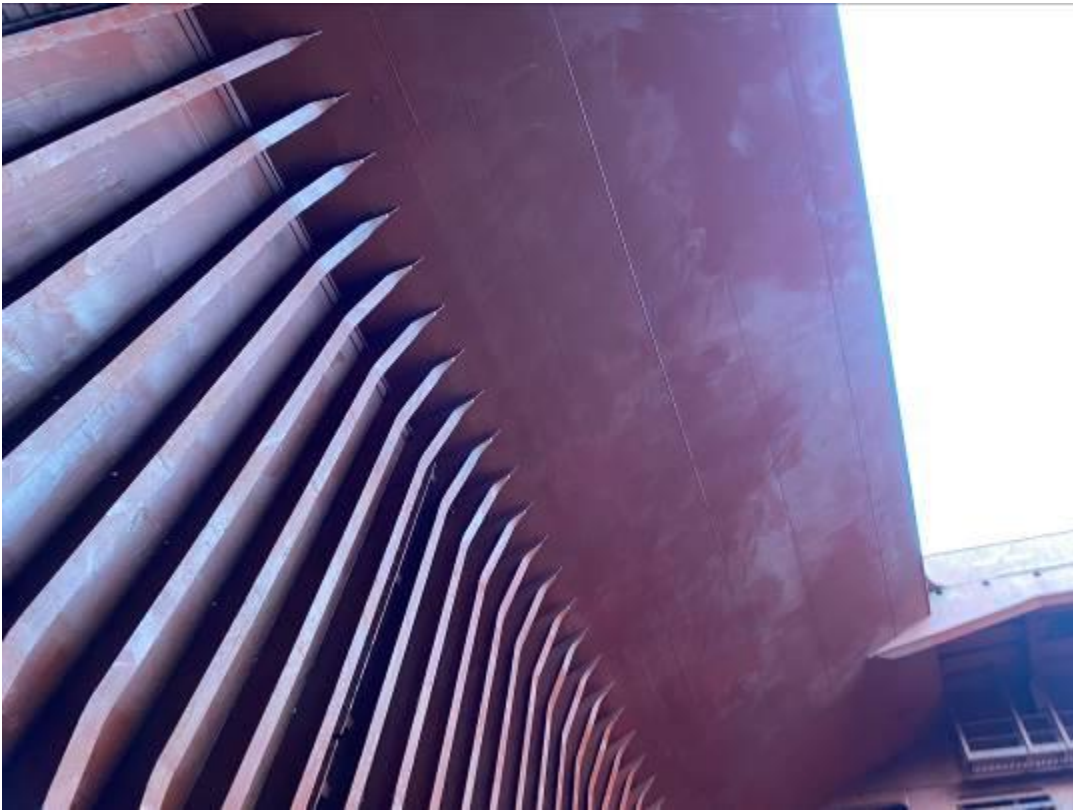
76. Hold #5 - Port side lower hopper slope.

- **Paint missing along lower hopper slope. (Photo #76)**

Note: Paint missing along lower hopper slope.

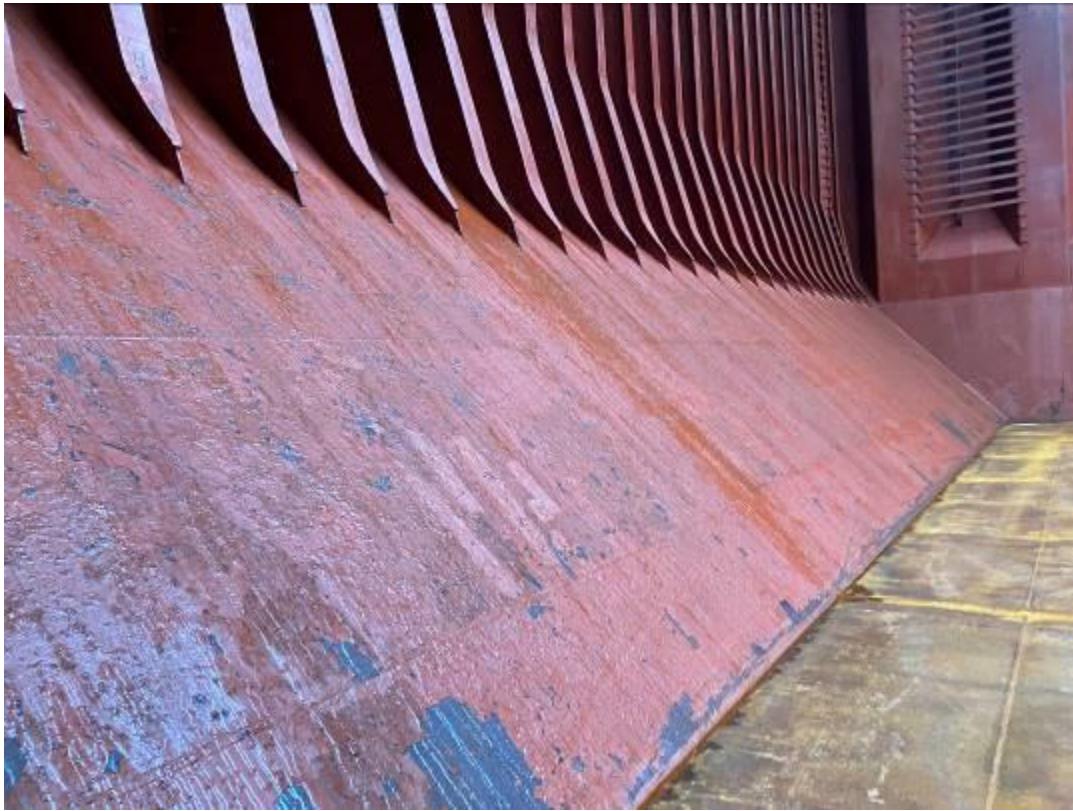
80. Hold #5 -
Full
viewing of
Port side
bulkhead.

Note: Paint
missing along
lower hopper
slope.

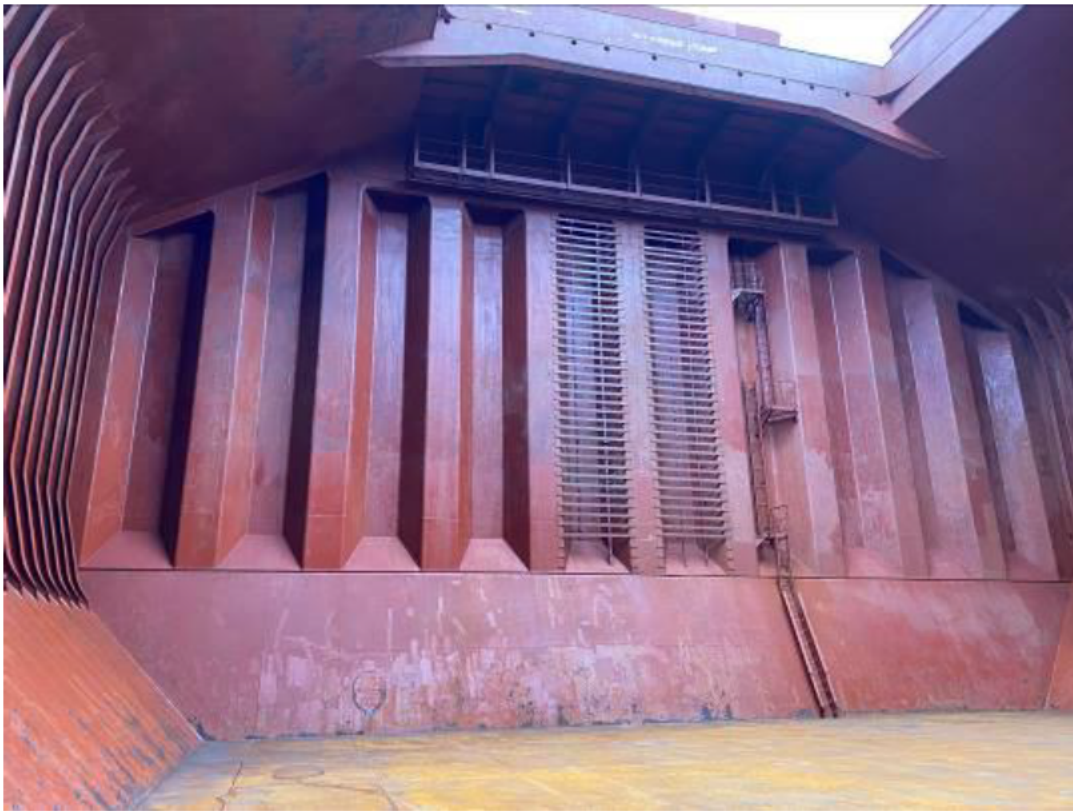
85. Hold #5 - Lower access ladder door broken and hanging.

- **Lower access ladder door broken and hanging. (Photo #85)**
- **Rust spots are present throughout bulkhead. (Photo #85)**

Note: Rust spots present throughout Bulkhead.

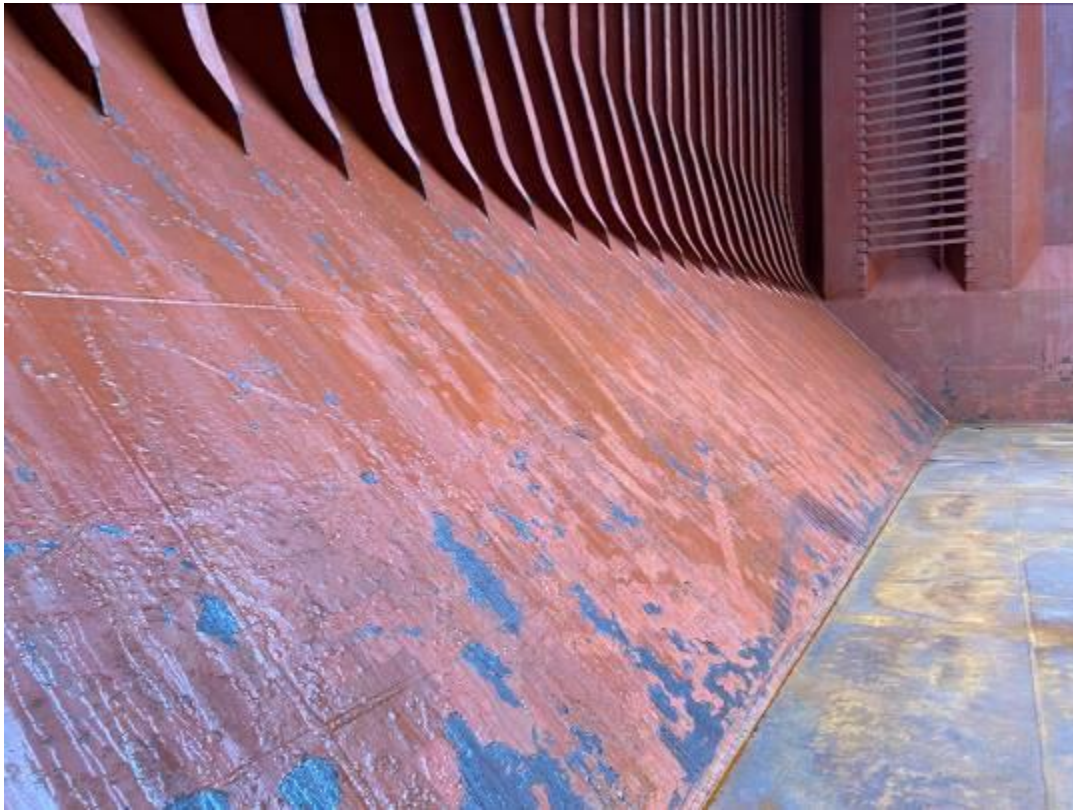
92. Hold #6 -
Full
viewing of
Port side
bulkhead.

Note: Paint
missing along
lower hopper
slope.

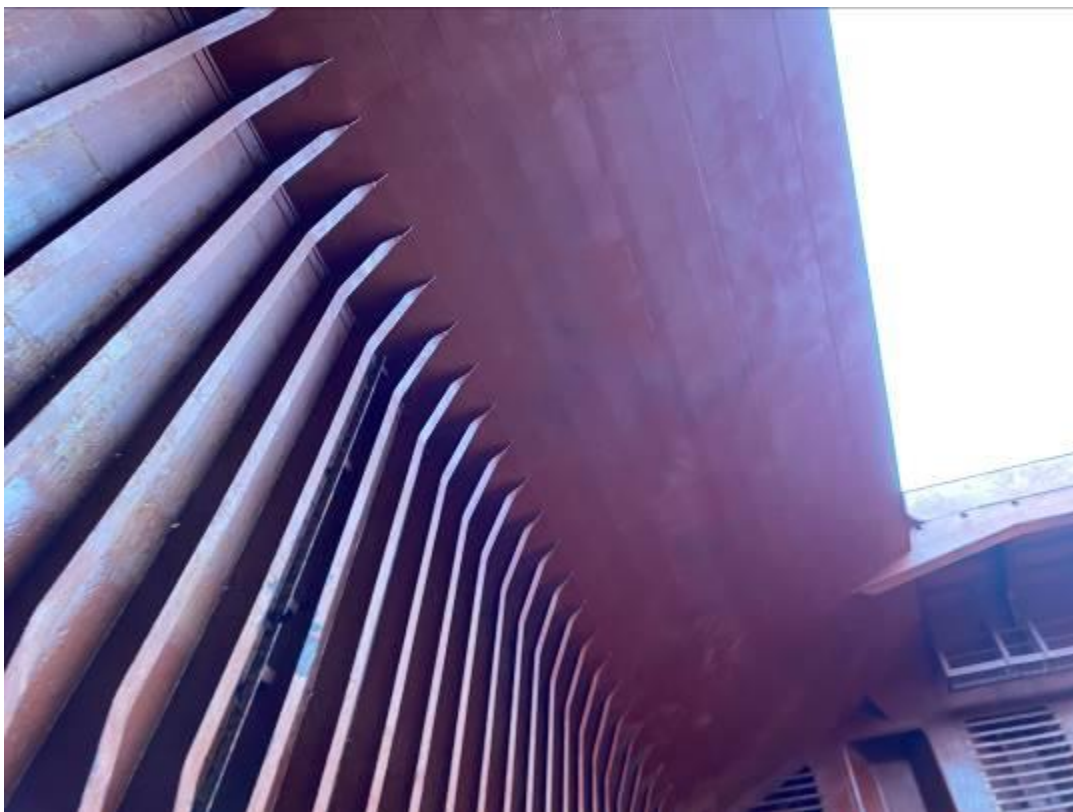
93. Hold #6 -
Starboard
side lower
hopper
slop.

Note: Paint
missing along
lower hopper
slope.

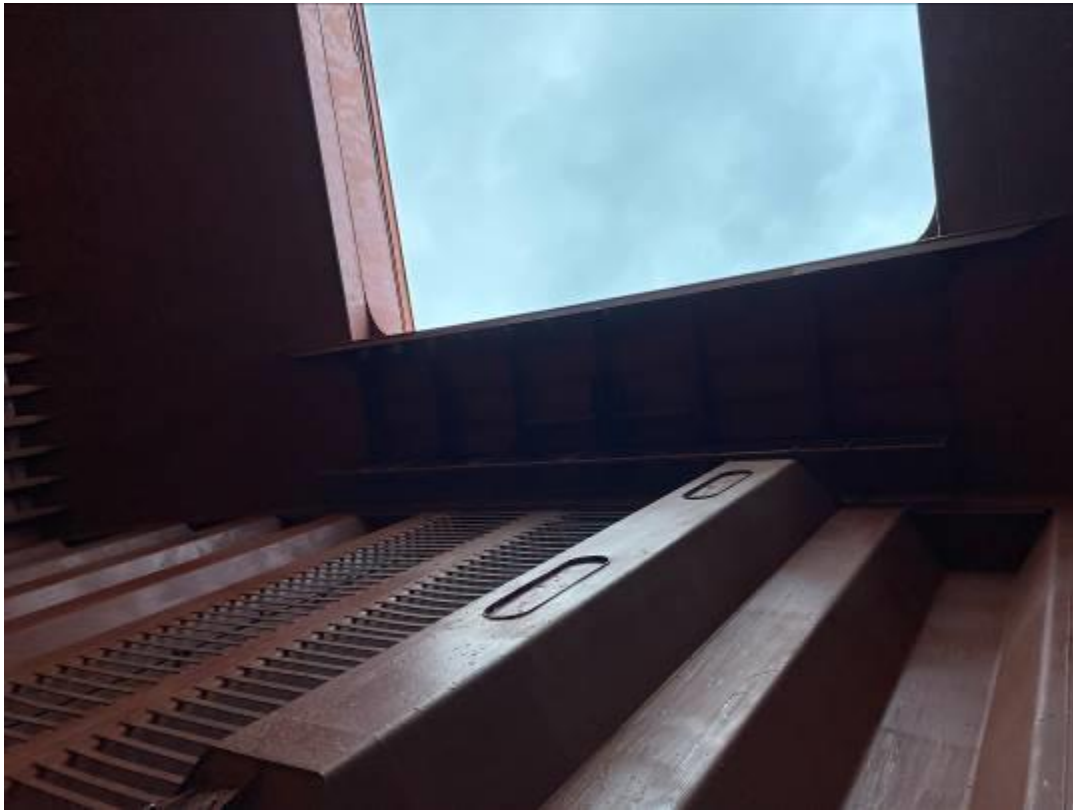
100. Hold #7 - Port Side Lower hopper slope.

- **Paint flaking and rust preset on lower sections. (Photo #100)**

Note: Paint missing along lower hopper slope.
